# MARINE FLOAT, DOCK AND PILE REPAIR CONDITION SURVEY & SCOPING REPORT

## **PUBLIC WORKS**

JULY 2012

Marine Structures Engineering, Inc.  
1004 Commercial Ave. #364  
Anacortes, WA 98221  
(360) 466-8627

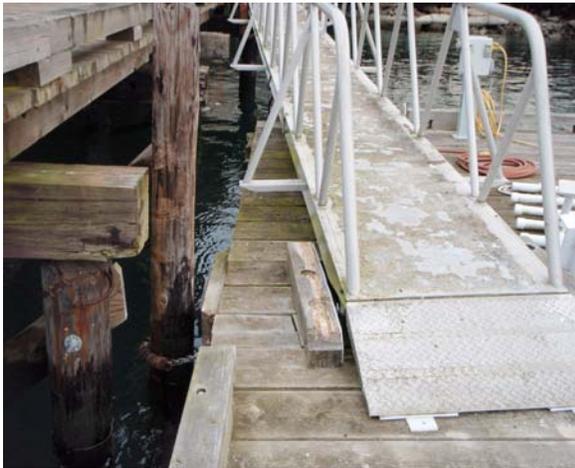
As noted above, the existing chain and roller pile retainers are causing damaged to the galvanizing of the steel pipe piles and have caused significant damage to the timber piles anchoring the Sheriff's float.

The creosote-treated timber piles anchoring the Sheriff's float are in poor condition and the creosote-treated timber pile dolphins around the Sheriff's float are in poor condition and are no longer necessary.

**Gangway & Timber Pile w/Chain Retainer**

It is recommended that the Sheriff's float be completely replaced with a new timber float that utilizes foam-filled HDPE flotation drums and high-traction fiberglass grate deck. In addition, the existing gangway should be replaced with a new, wider and longer aluminum gangway with barrier-free transition plates, handrails, guardrails and high-traction fiberglass grate deck. Along with the float and gangway, the existing timber anchor piles should be removed and replaced with new galvanized steel pipe piles with energy absorbing, polyethylene lined pile retainers.

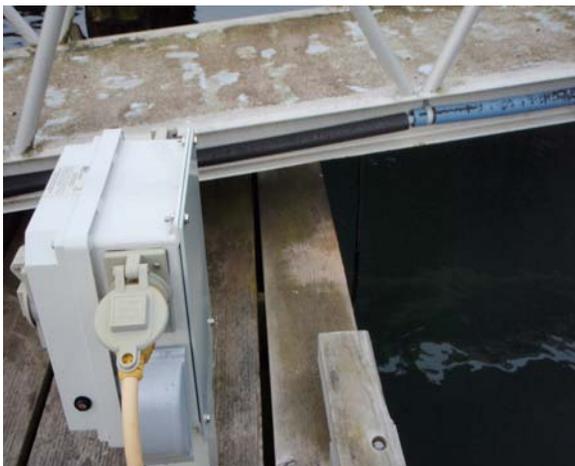
**Electrical Box (note creosote in water)**

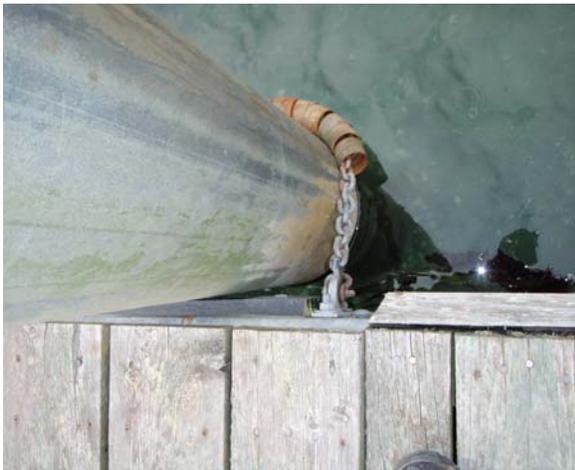
The transient moorage floats are in good condition with no structural problems observed; however, the hinges between the floats allow excessive float motions and will require repair or replacement in the future. The moorage float anchor piles are in good condition, but the chain and roller pile retainers are causing damage to the galvanizing which leads to corrosion and a reduced service life of the piles.

**Steel Pile w/Chain Retainer**

It is also recommended that the chain and roller pile retainers on the transient floats be replaced with polyethylene lined, steel pile retainer hoops.

In 2012, remove and replace chain and roller pile retainers with new UHMW lined pile retainers to prevent additional damage to float anchor piles. The construction cost for these repairs is \$6,000 to \$7,000 with an additional \$1,500 for engineering and project administration for a total of \$7,500 to \$8,500.

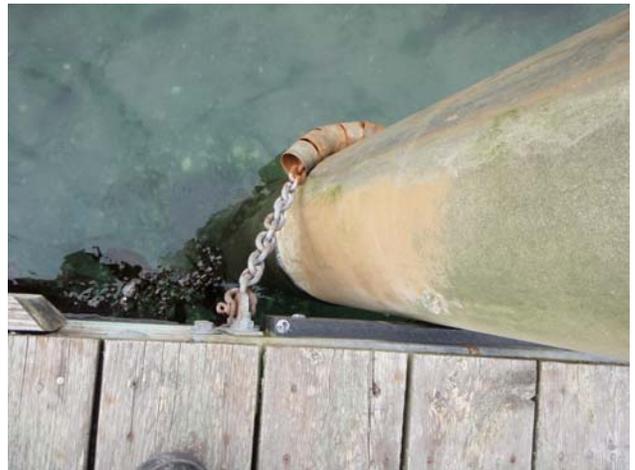
**Steel Pile w/Chain Retainer**

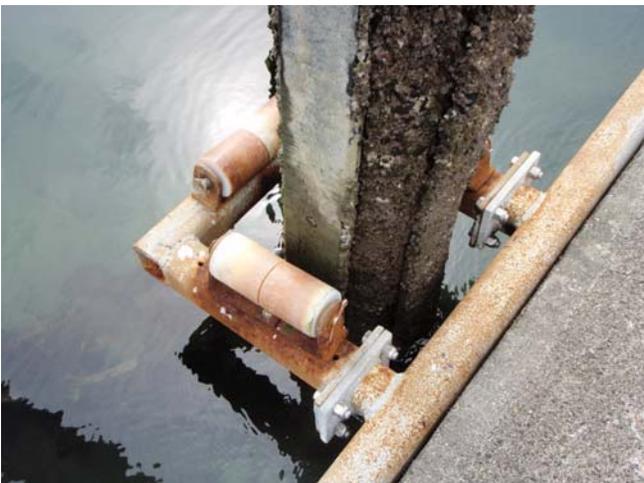
The concrete float was observed to be in good condition without damage or significant cracking in the deck. The timber wales were observed to be in fair condition with minor wear and tear. The pile retainers on the ends of the float were observed to be in fair to good condition with some wear and some surface corrosion evident. The pile retainers were observed to not fit the width of the float well and were prone to shearing of the rods holding the pile retainers to the float during storm events.

The main issue with the facility is high maintenance demands of the float pile retainers. Since the 10' wide float was installed in 1990 or 1991, the pile restrainer system has been repaired or replaced at least three times due to damage or failure from wind and wave induced float motions during storms.

**Single Pile Retainer at Outboard Float End**

It is recommended that the existing float and piles be completely replaced (Option 1). It is recommended that the concrete float be replaced with a lighter and more flexible timber float with foam-filled HDPE floatation drums and high traction fiberglass grate deck. The timber float will be less buoyant and will ride out storm events better than a concrete float. It is also recommended that new 12 3/4" diameter steel pile piles be used to anchor the new timber float.

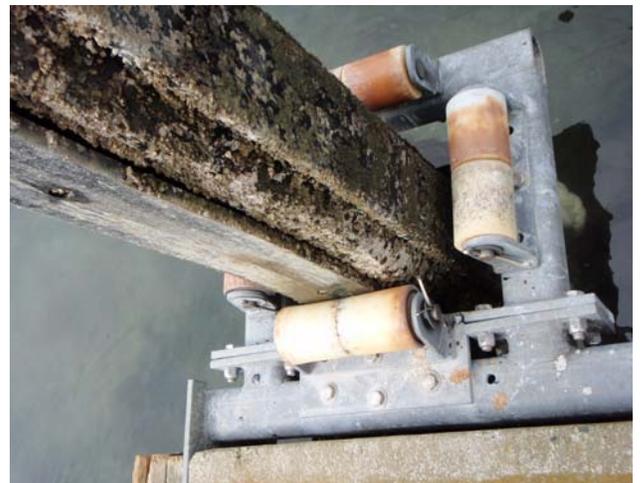
**Pile Retainer at Shoreward Float End**

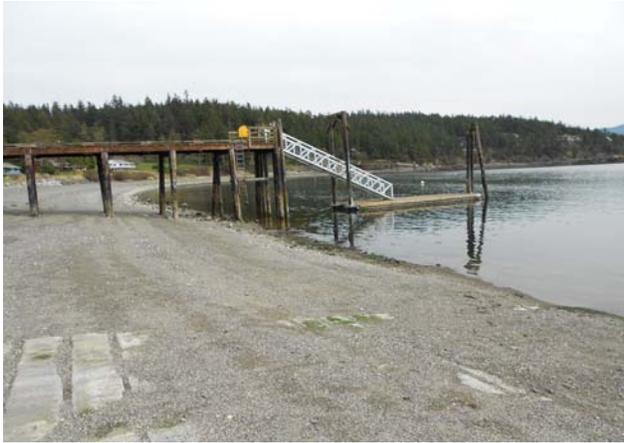
In 1982, a 16' x 100' long ramp was constructed consisting of a 16' x 58' cast-in-place concrete ramp with the remainder consisting of precast concrete logs 16' long x 15" wide x 6.5" thick. In the fall of 2004, new precast concrete logs of the same dimension were laid over the existing ramp in an effort to eliminate the accumulation of sand, which required frequent clearing and removal.

**Marine Ramp Covered with Sand**

It is recommended that the ramp be relocated towards the east so that it is equidistant from the existing ramp and the adjacent fixed dock to the east (Option 1). It is also recommended that the new ramp utilize a heavier-duty 12" thick plank design and concrete specification with wet

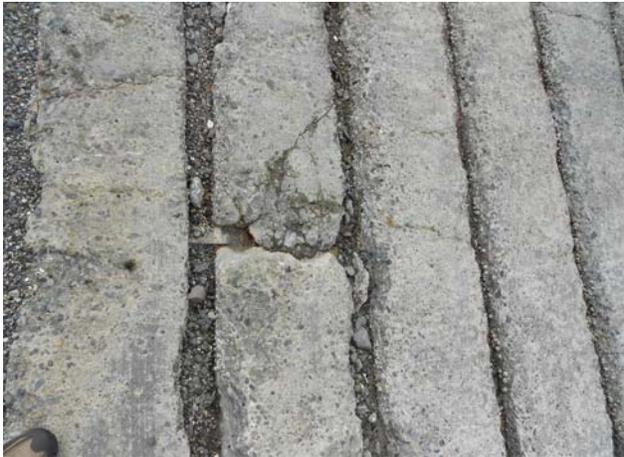
The existing ramp logs are in fair to poor condition. Concrete spalling and large cracks were observed in the tops and sides of several ramp logs. Rebar was observed to be exposed in several logs and corroding.

As the steel connections between the concrete logs deteriorate, large gaps will open up between the logs, and together with spalling of concrete surfaces, leading to further deterioration and creation of potholes causing problems with trucks achieving sufficient traction while driving on and off barges.

**Typical Concrete Spall at Steel Connectors**

As an alternate, the existing ramp could be repaired in its original location (Option 2). In this option, the existing ramp planks would be removed and replaced with heavier-duty, 12" thick precast concrete planks using improved concrete mix designs. The main advantage of this option would be to eliminate the extra costs and time required for the design, permitting, earthwork and other construction costs of moving the ramp location.

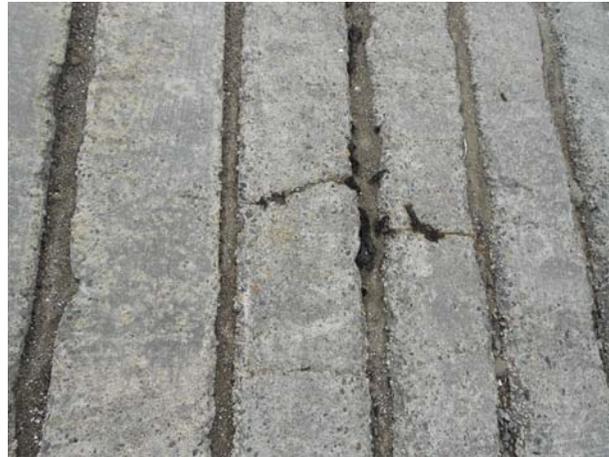
**Concrete Log Cracking**

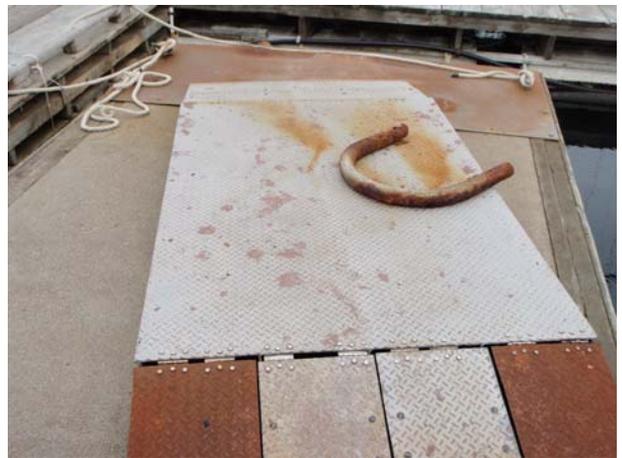
The steel transition bridge and steel wear plates mounted to the floats under the transition bridge were observed to be in fair condition with moderate corrosion. Both the transition bridge and the wear plates were damaged by excessive float motion causing the bridge to fall in the gap between the floats and becoming jammed.

The main issue at the West Sound facility is the high maintenance of the transition bridge that spans the gap between the two independent floats. Because the floats are not connected together and are free to move independently, the difference in elevations between the floats can be quite large during a storm. It is difficult for the transition bridge to handle the range of float motion and the bridge has required major repairs several times since its original installation.

**Transition Span Between Floats**

It is recommended that the existing independent concrete floats be replaced with a lighter and more flexible full-length timber float with foam-filled HDPE floatation drums and high traction fiberglass grate deck (Option 1). The full-length timber float will be less buoyant and ride out storm events better than the concrete floats. Since the new float is full length, without gaps, there will not be heave differences between floats and a transition bridge spanning between float sections is not required. The new timber float will use new 12 3/4" diameter steel pipe anchor piles with energy absorbing pile retainers.

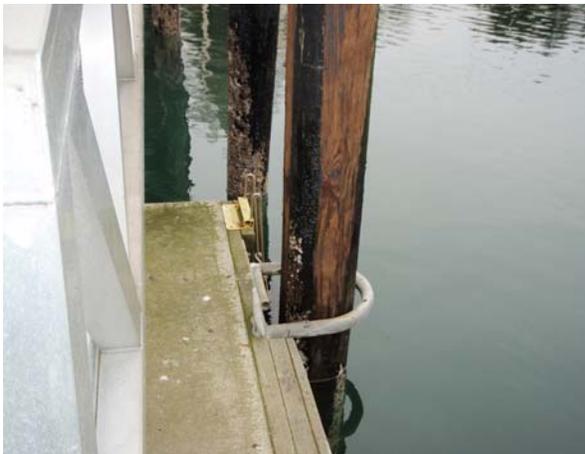
The float piles were found to be in fair condition with moderate to severe wear observed caused by the pile retainer hoops. The tops of the braced piles appeared to be in good condition but it was noted that at high tide, there is only a minimum of clearance above the float to the bottom of the pile braces.

The weight of the floats and the large motions they experience during storms also causes the pile retainer forces to be large and leads to the hoop faces damaging the piles. As calculated in Appendix C, that natural period of the float modules, restrained by timber piles, is in the range of wave periods that regularly hit the float system.

**Inboard Pile Hoop Retainer**

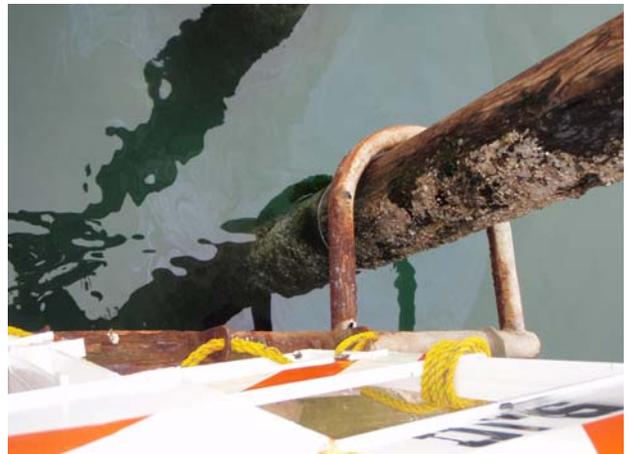
**Outboard Pile Hoop Retainer**

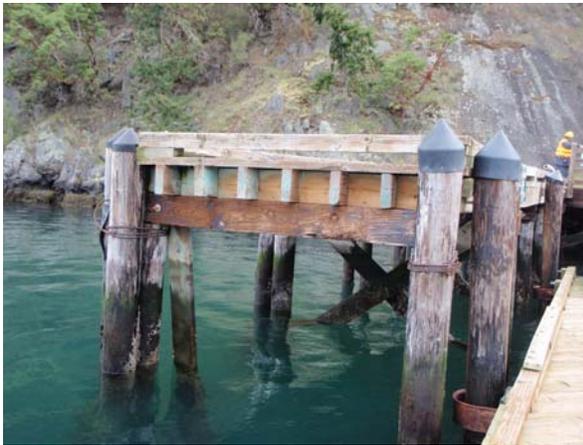
**Dock and Float to Pile Retainer  
(Note Missing Cross Bracing at Outboard Pile Bent)**

Since it has been almost 20 years since the first major pier repair, it is recommended that a comprehensive condition inspection and load rating study be performed for the timber pier structure and piles. An overall visual inspection should be performed and soundings, core samples and diver inspections completed as necessary to evaluate the condition and capacity of the pier structure and piles.
