# 2019 Annual Bridge Report

Prepared by:  
San Juan County  
Public Work Department  
June 4, 2020

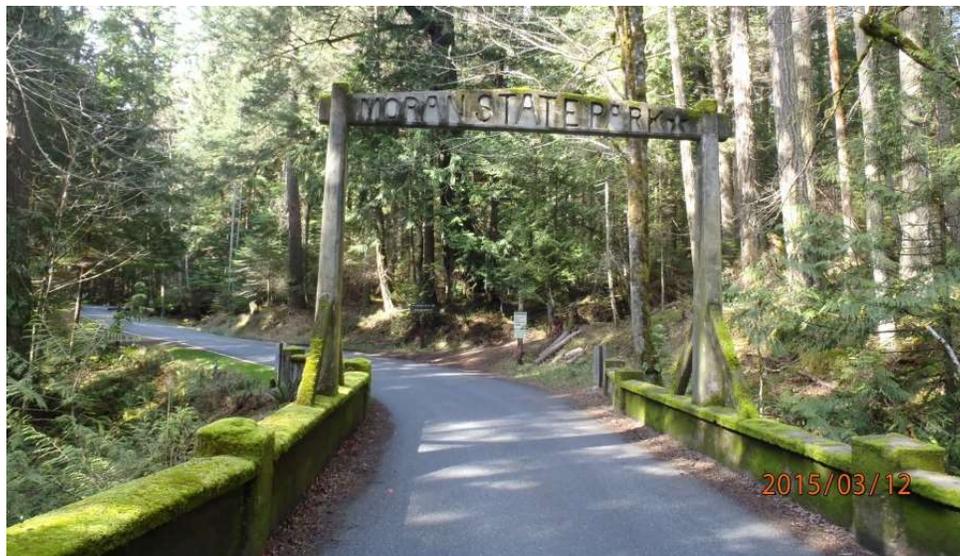
The Moran State Park Bridge is classified as functionally obsolete but structurally sufficient.

**Overhead Concrete Arch at the Moran State Park Bridge (March 2015)**

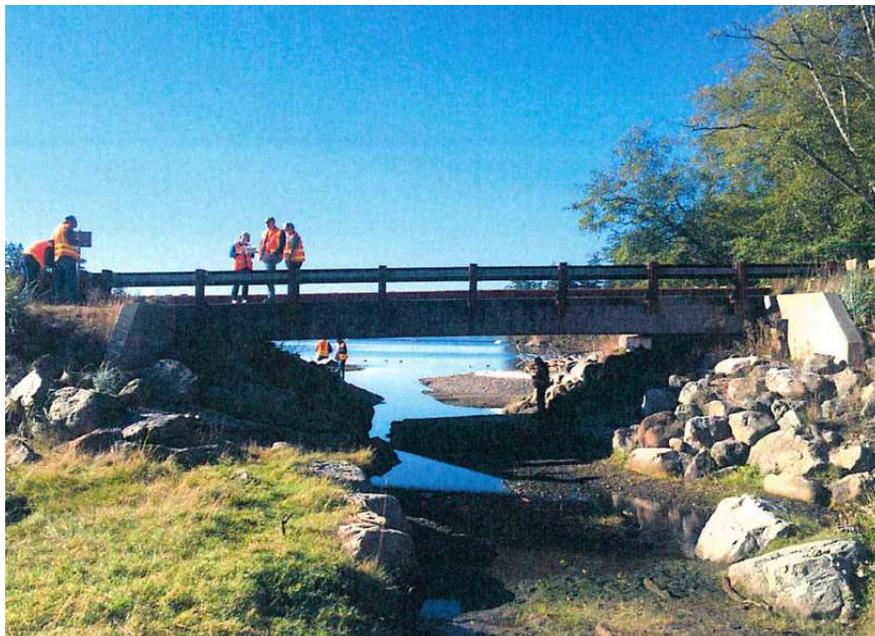
The Buck Bay Bridge scour rating was dropped from SR=7 to SR=5 in 2015 in 2015 due to the changing streambed. In 2017, Northwest Hydraulic Consultant (NHC) completed the hydraulic and scour assessment. NHC recommended that the bridge keep its current scour rating of SR=5.

**Buck Bay Bridge Inspection (September 2016)**

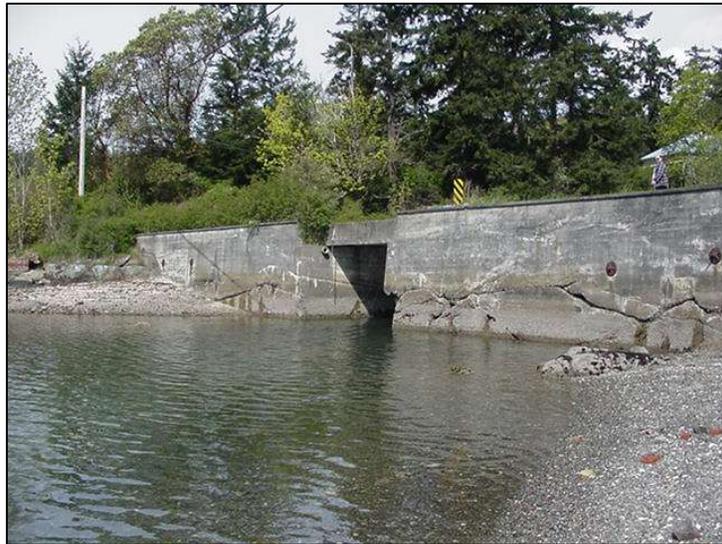
### Westsound Bridge (Planning)

In 2001, the existing bridge was replaced with new 25 foot wide by 24 foot long precast prestressed concrete bridge deck units. The deck is supported on cast-in-place reinforced concrete cap beams supported by cast-in-place reinforced piles. The bridge crosses a small inlet to a saltwater estuary. The concrete abutment retaining walls, which no longer provide structural support for the bridge, has deteriorated in several places. The spall is monitored and lost concrete removed if necessary. Public Works is planning to study options for repairing the concrete abutment retaining walls.
