MEMORANDUM

DATE: November 8, 2013

FROM: Jon Houghton, Diane Hennessey, Hart Crowser, Inc.

RE: **Ordinary High Water at Runstad Property on Blakely Island**
17921-00

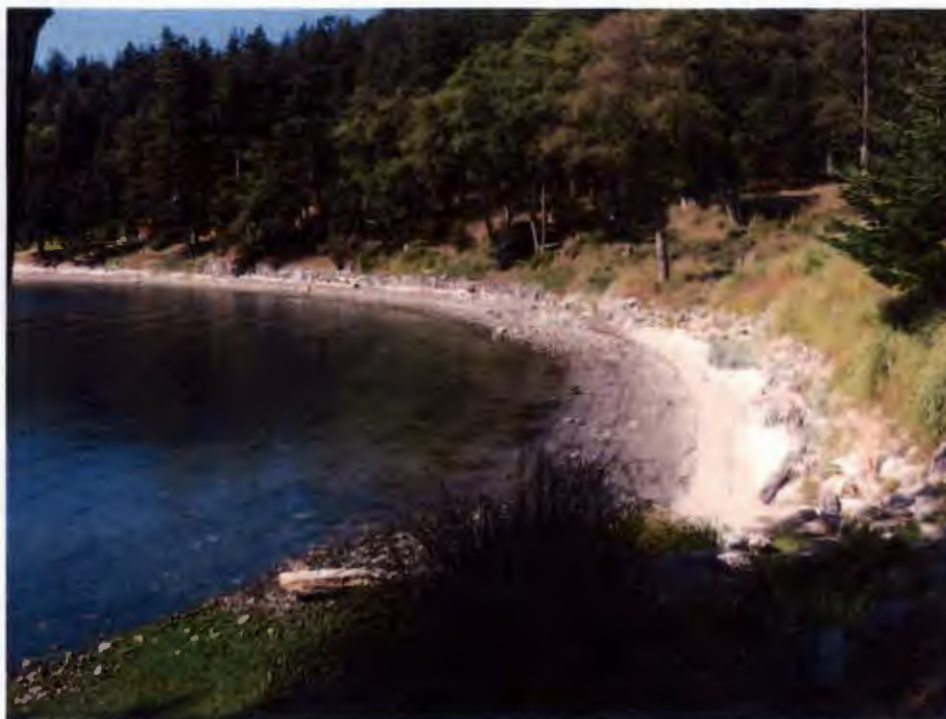
A perspective of the beach in question is provided in Photographs 1 and 2, taken from near the top and bottom, respectively, of a pathway that leads to the beach east of the new wall area. In the foreground is a sandy patch of beach below previously existing “old” riprap. From the base of the path (lower two steps in the lower right corner of Photograph 2), a number of drift logs are evident at the base of the old wall, with several patches of dune grass (*Leymus mollis*) visible both among and in front of the logs. Based on the vegetation indicator species in Appendix B of Olson and Stockdale (2010), this species is expected to be found at or above OHW. Other species in this area include common velvetgrass (*Holcus lanatus*), Siberian wheatgrass (*Agropyron fragile*), and reed canarygrass (*Phalaris arundinacea*). This vegetation distribution, coupled with the highest wrack line visible, clearly indicate the location of the OHW line at this point on the beach.

Photograph 1 – Runstad Beach overview

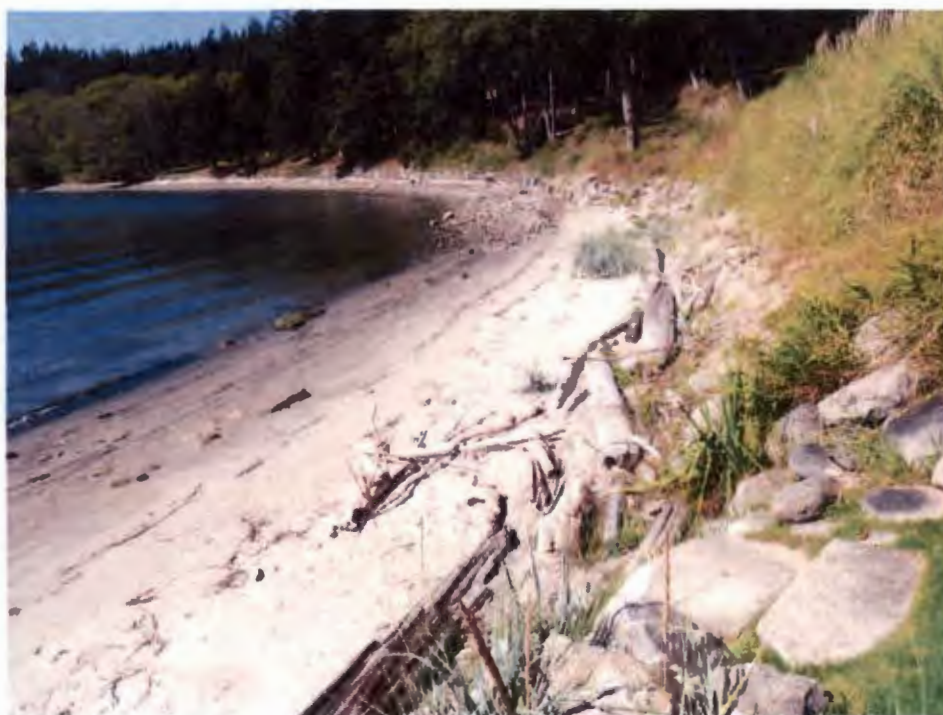
Photograph 2 – Runstad Beach shoreline

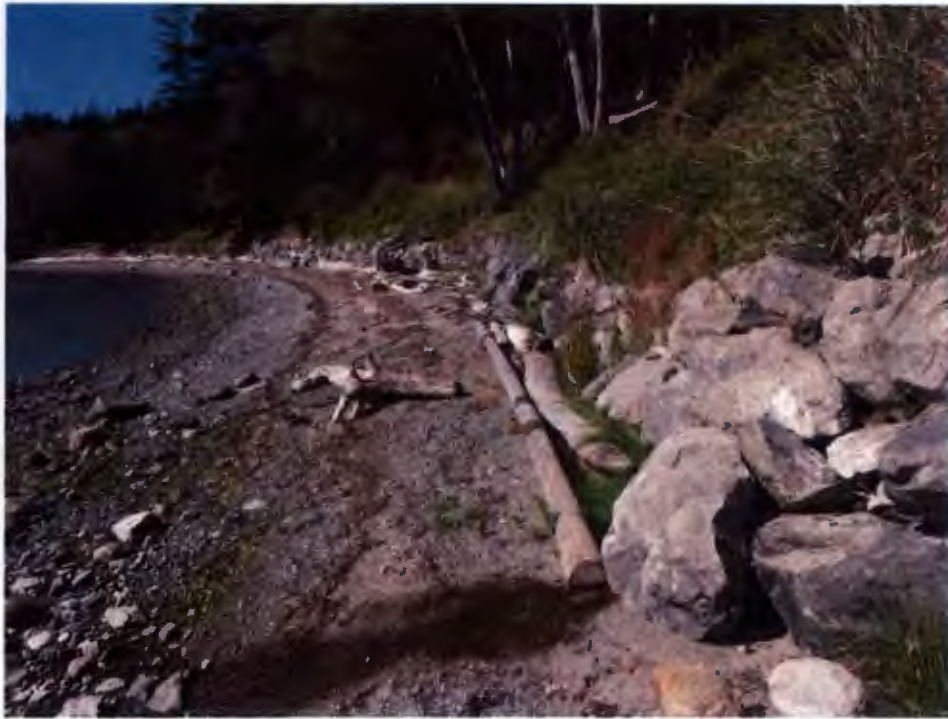
The new wall section in question begins just beyond (west) of the patch of cobble upper beach that is evident in both Photographs 1 and 2. That transition area is shown in Photograph 3 (just in front of first clump of alders [*Alnus rubra*] above the wall). Closer views of the eastern most section of the new wall (Photographs 4 and 5) show multiple lines of drift logs and herbaceous vegetation that has grown since the wall was installed. Plants that were interspersed within the logs at the base of the new wall include dune grass, bedstraw (*Gallium sp.*), European searocket (*Cakile maritima*), trailing blackberry (*Rubus ursinus*), common velvetgrass (*Holcus lanatus*), Siberian wheatgrass, and reed canarygrass (*Phalaris arundinacea*). While a few of these plants (e.g., European searocket) may

Photograph 3 – Transition from old to new wall (at base of alders)

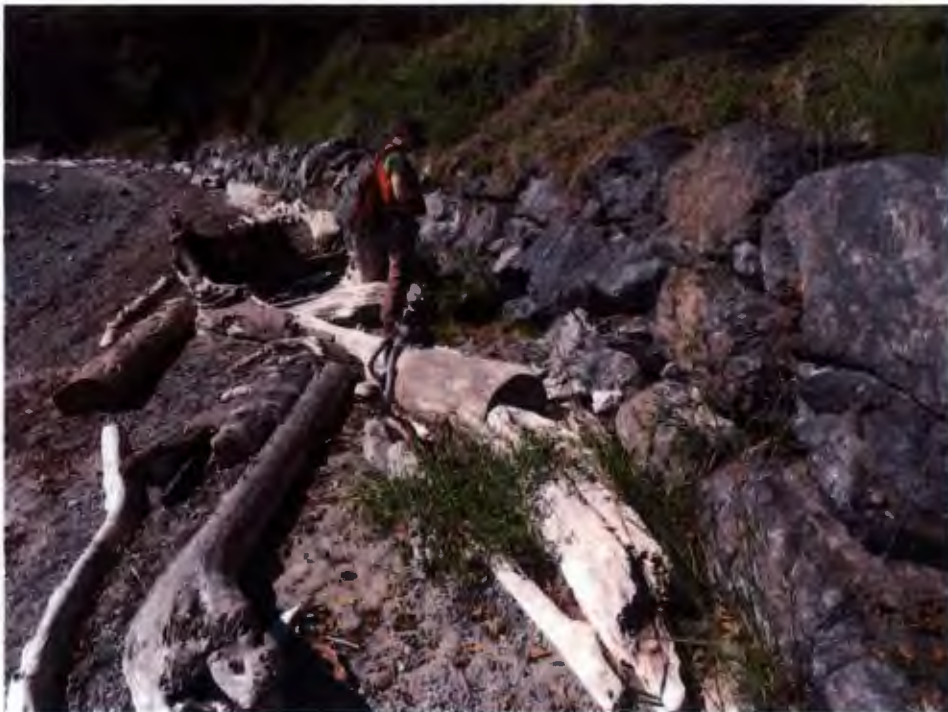
Photograph 4 – New wall east end (1)

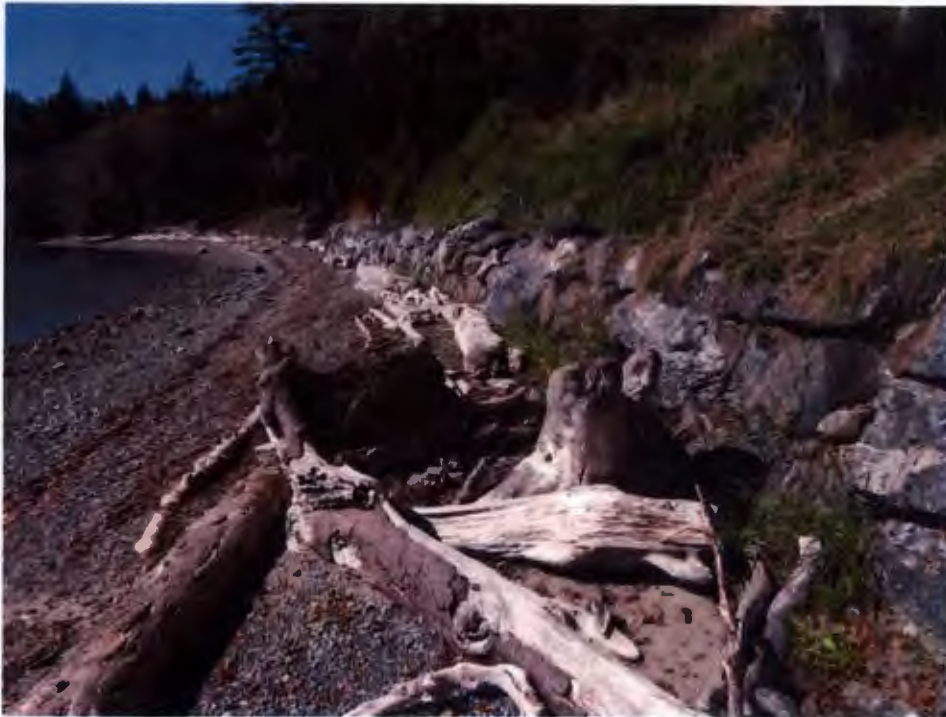
Photograph 5 illustrates that there is a near-continuous line of drift logs along the base of the new section of the wall stretching to the west. Although the line of logs is narrower in the central part of the new wall (Photographs 6 through 8), dune grass, trailing blackberry, and Siberian wheatgrass continue to be found on the beach below the wall. Photographs 7 and 9 show the blackberry vines descending down the wall and trailing along the upper sand at the base of the wall in this area. Photograph 9A is a closeup showing green leaves on the vine at beach level; in other places, the tips of this species were blackened where they had extended down the beach to OHW. Photograph 8 shows a reach of beach (approximately 20 linear feet) that lacked embedded logs at the time of the survey, however, the highest line of old wrack is shown to lie out from the toe of the wall. We therefore conclude that the OHW line is this area, while closer to the toe of the wall than it is in the adjacent areas, remains below the toe of the wall.

Photograph 5 – New wall east end (2)

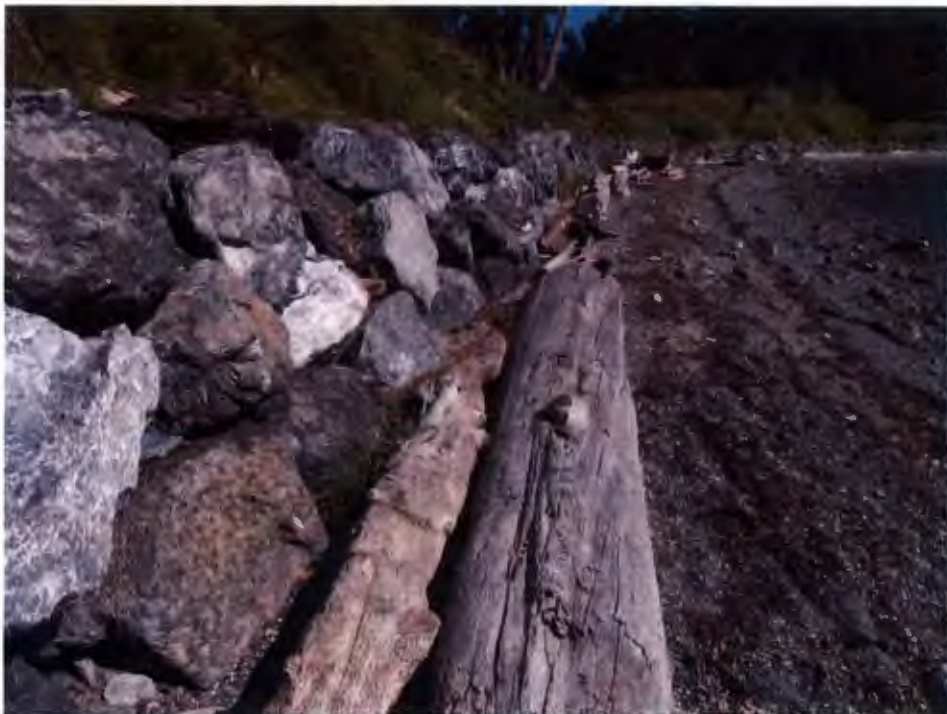
Photograph 6 – New wall center to east

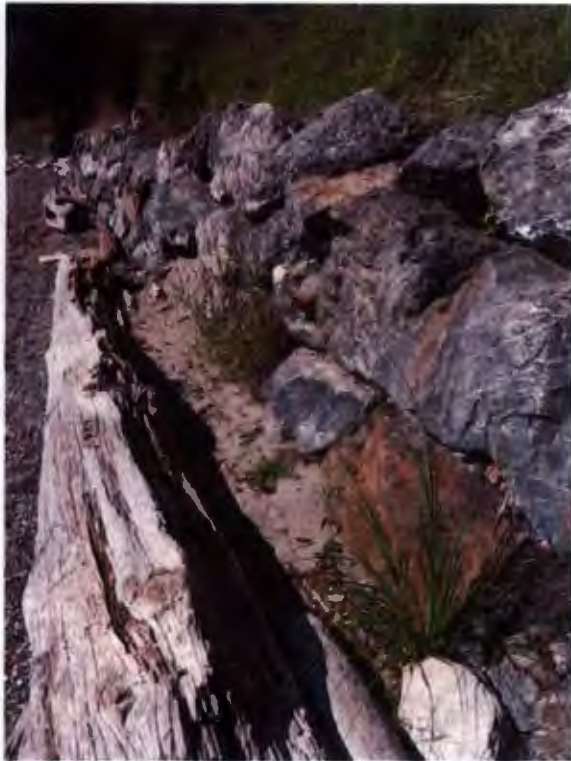
Photograph 7 – New wall center to west

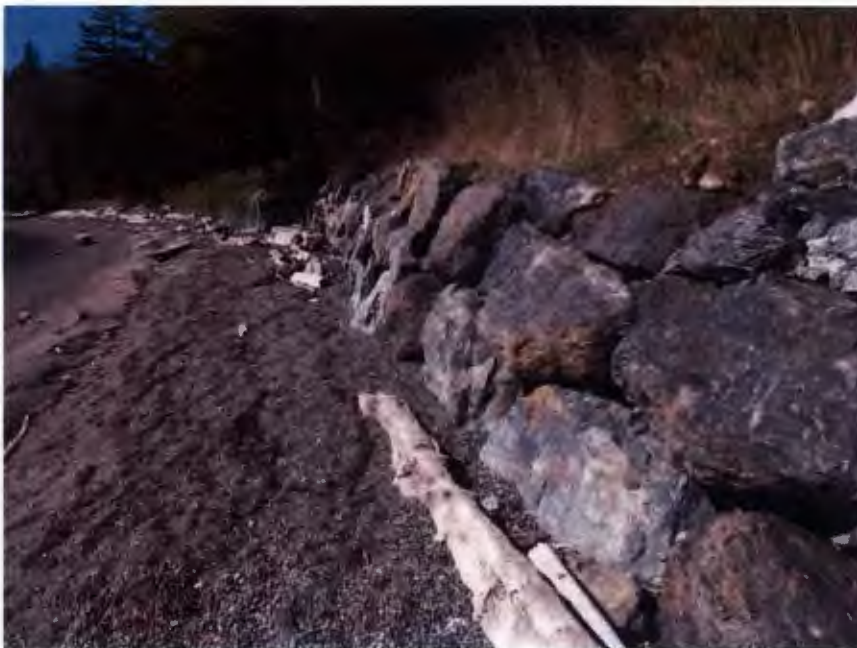
Photograph 8 – New wall center; farther west

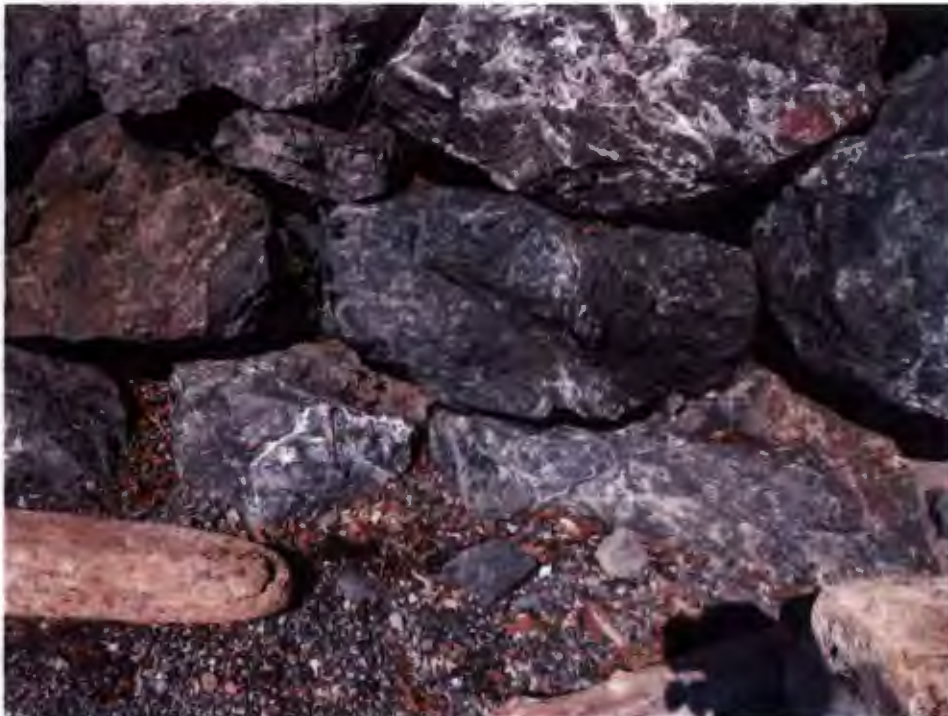
Photograph 9 – New wall blackberry shoot

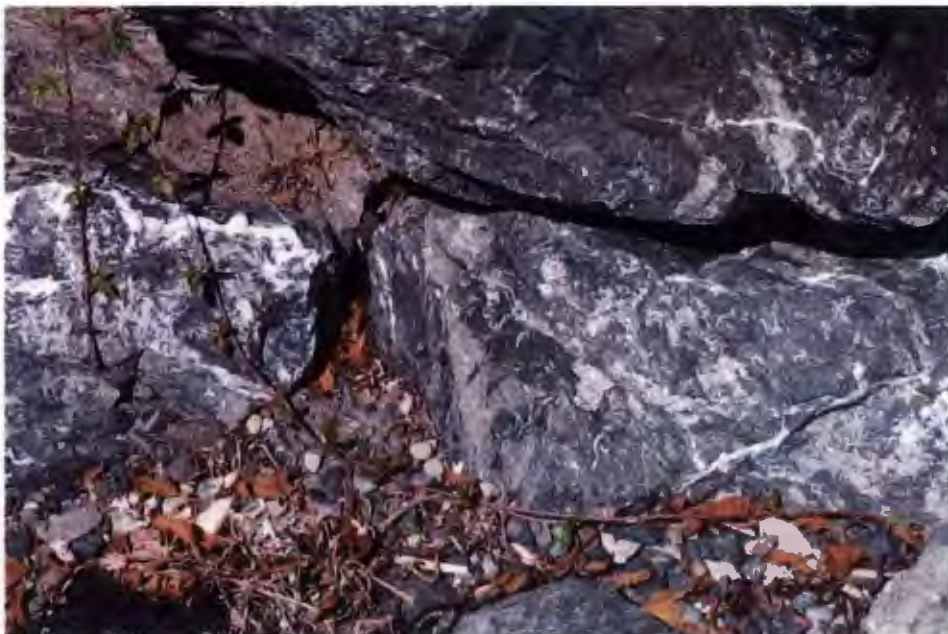
Photograph 9A – Blackberry shoot closeup

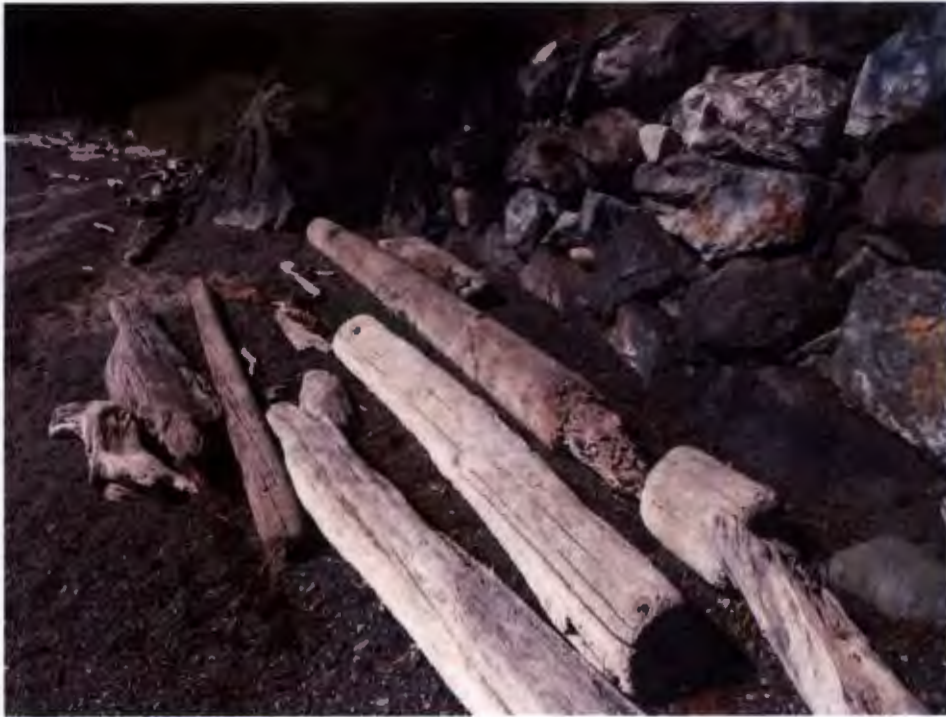
In the area immediately east (Photograph 10) and west (Photograph 11) of the bedrock outcrop the toe of the new wall is approximately 1 foot above OHW as indicated by the multiple lines of embedded drift logs and the variety of vegetation species found among those logs. Vegetation observed in this area included most species listed above, plus salt grass (*Distichlis spicata*), lance-leaved plantain (*Plantago lanceolata*), maritime plantain (*Plantago maritima*), hawkweed (*Hieraceum sp.*), curley dock (*Rumex crispus*), and field horsetail (*Equisetum arvense*).

Photograph 10 – Toward west end bedrock

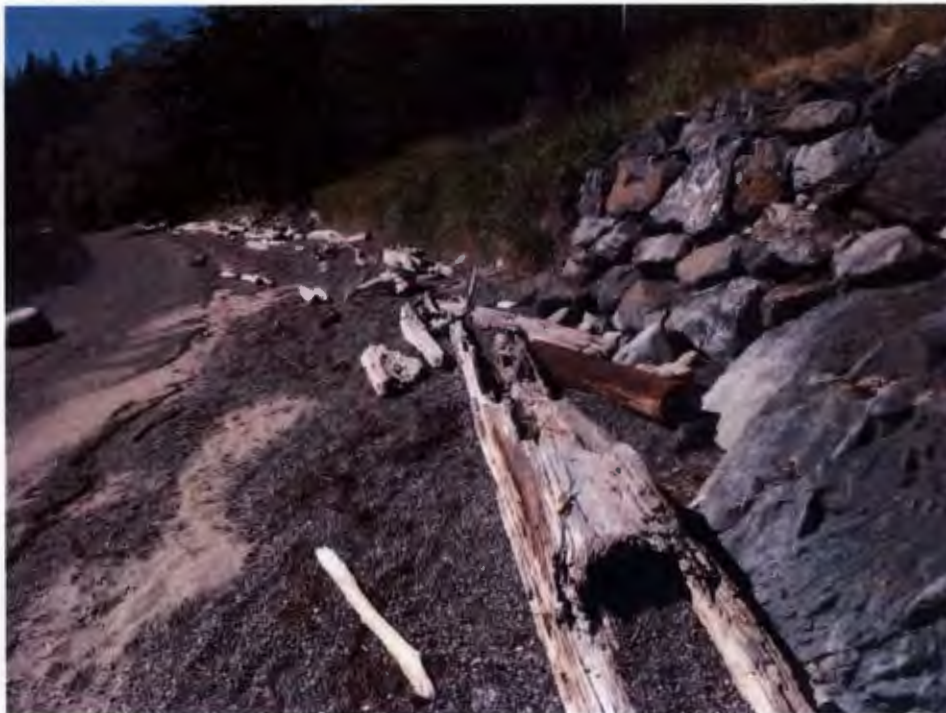
Photograph 11 – From bedrock to west

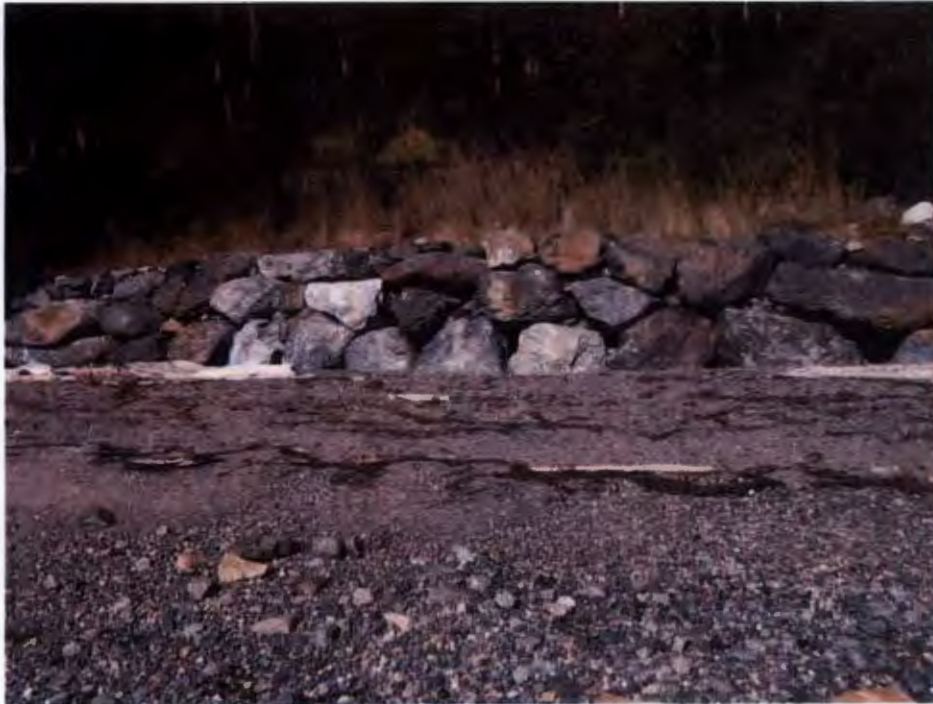
2013. In several reaches of the central portion of the constructed wall, we can identify specific boulders incorporated into the wall in both photograph sets (compare Photograph 12 with Needham Photograph 2). In all such cases, the recent line of beach sediments is higher on the boulders in the more recent photographs. This again suggests that the wall was constructed behind the then extant OHW line and that ongoing natural processes have rebuilt the beach face and storm berm up to re-establish the OHW line in front of the wall.

Photograph 12 – Center of new wall
