SAN JUAN COUNTY  
RESPONSE TO SHORELINE INVENTORY REPORT

PROPERTY OWNERS: John and Jamie Casey

STREET ADDRESS 1607 Yacht Haven Road

TAX PARCEL NUMBER(S) 462650024 + 462650025 J.C. COMMUNITY

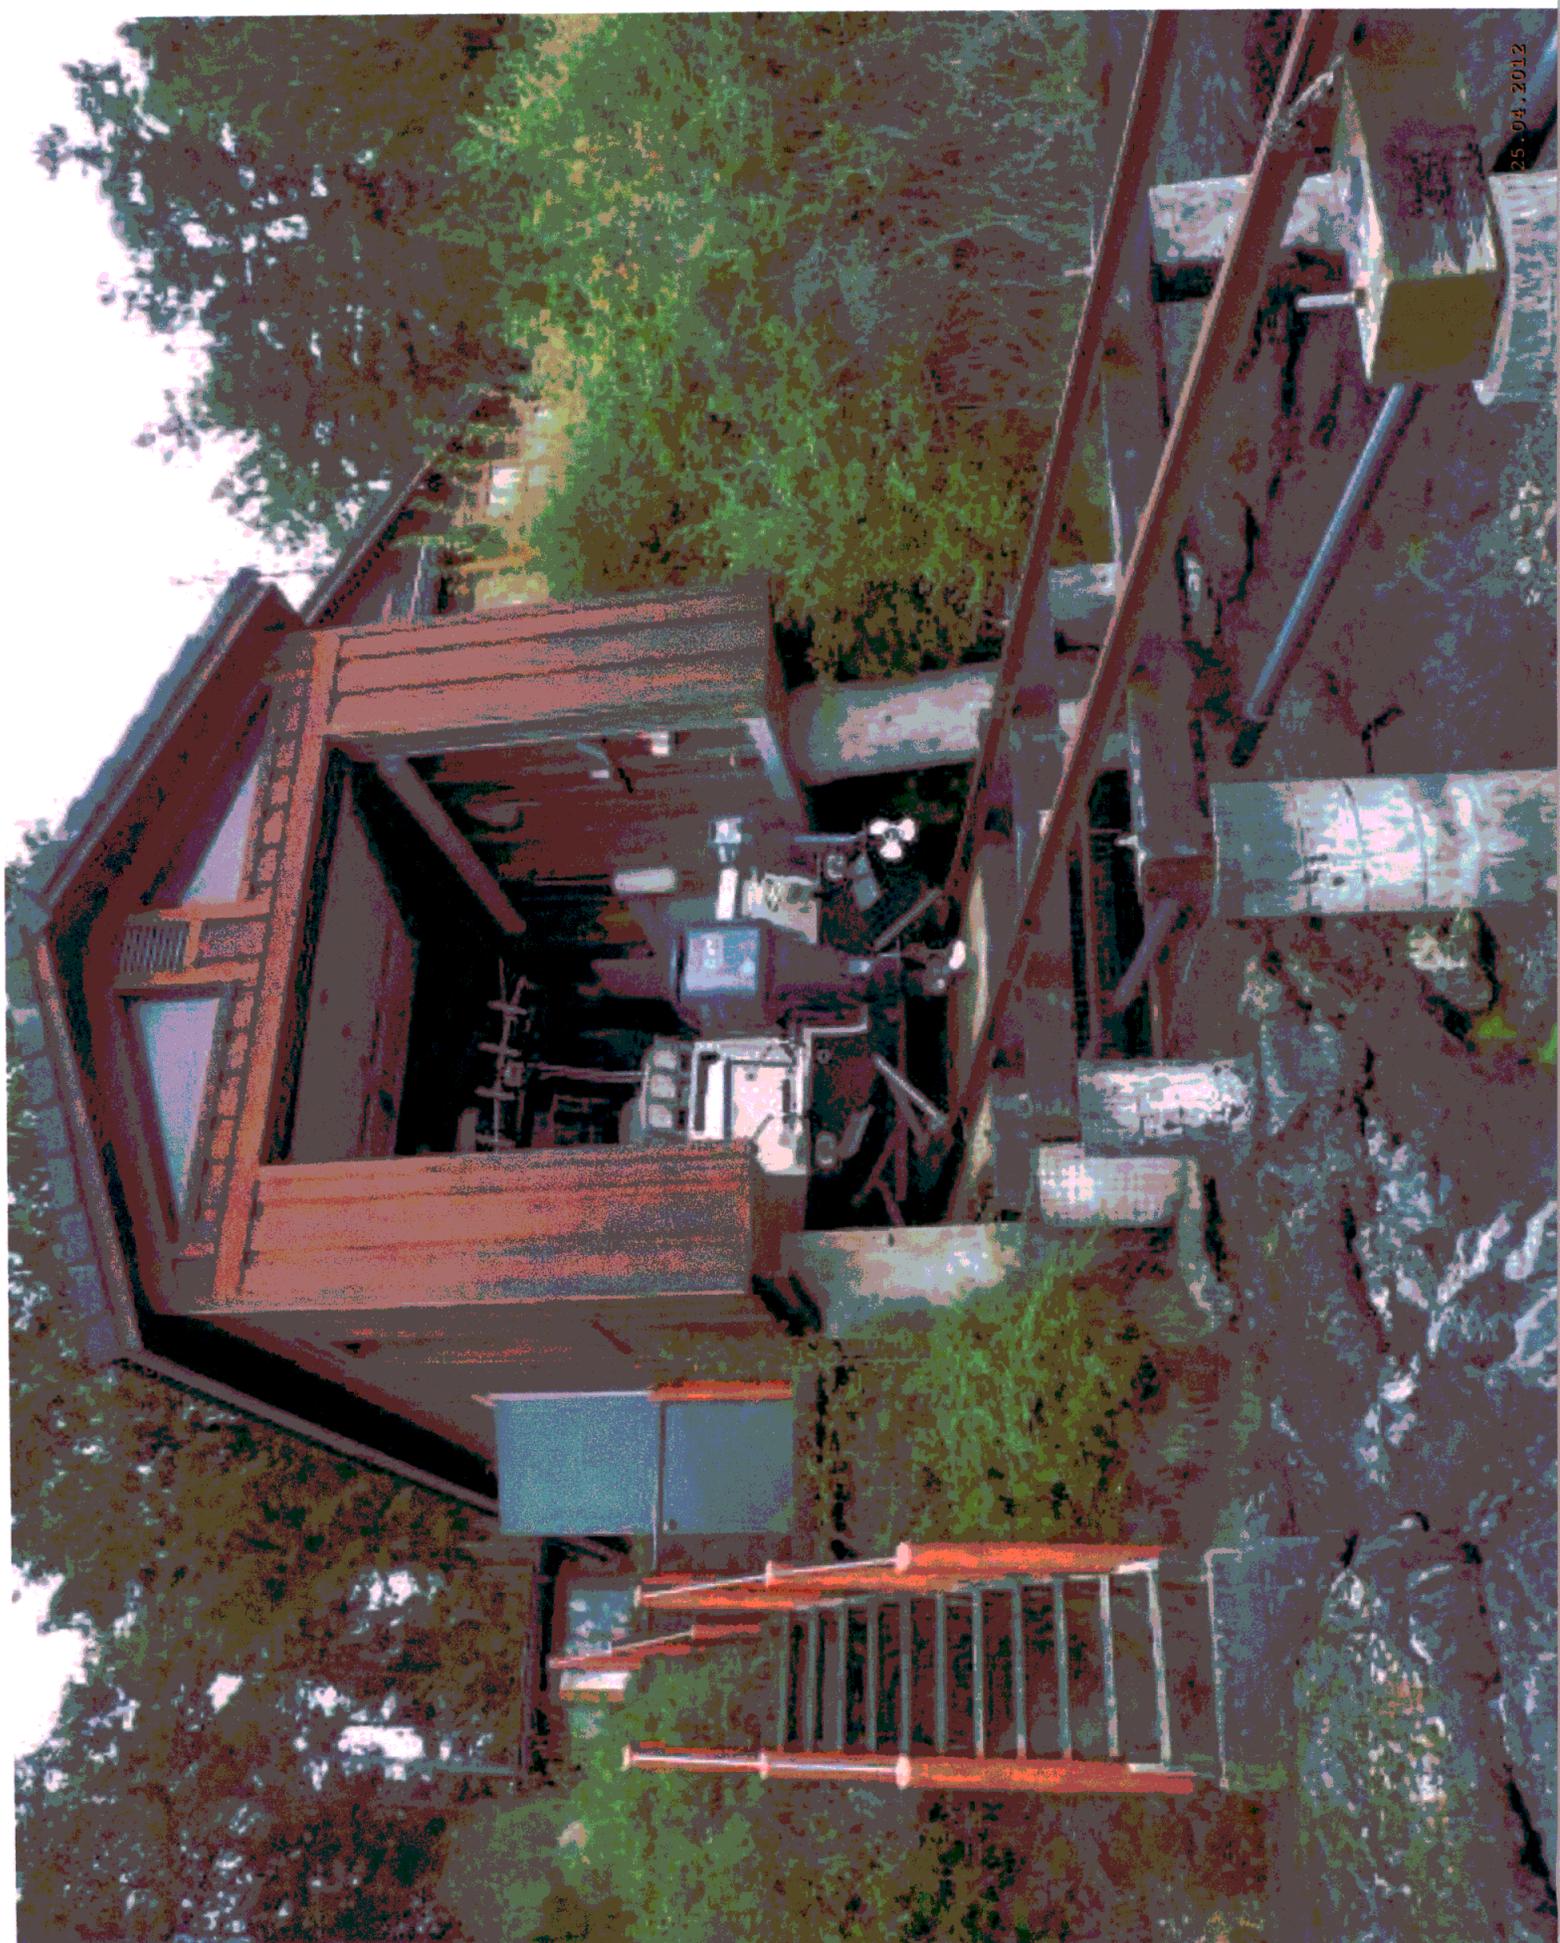
TPN 462650024  
dated 4-25-12

1. Map 9A does not recognize the existence of a boat house on the property but only the associated marine railway and a mooring buoy. (Please see the attached photographs.)
2. Map 12A indicates the properties are located in a Zone A FEMA Flood Plain. There has been no history or evidence of these properties experiencing flooding. In fact, these properties include a medium to high rocky shoreline bank. (See attached photograph.)

EXISTING Boat House +  
Marine Railway System

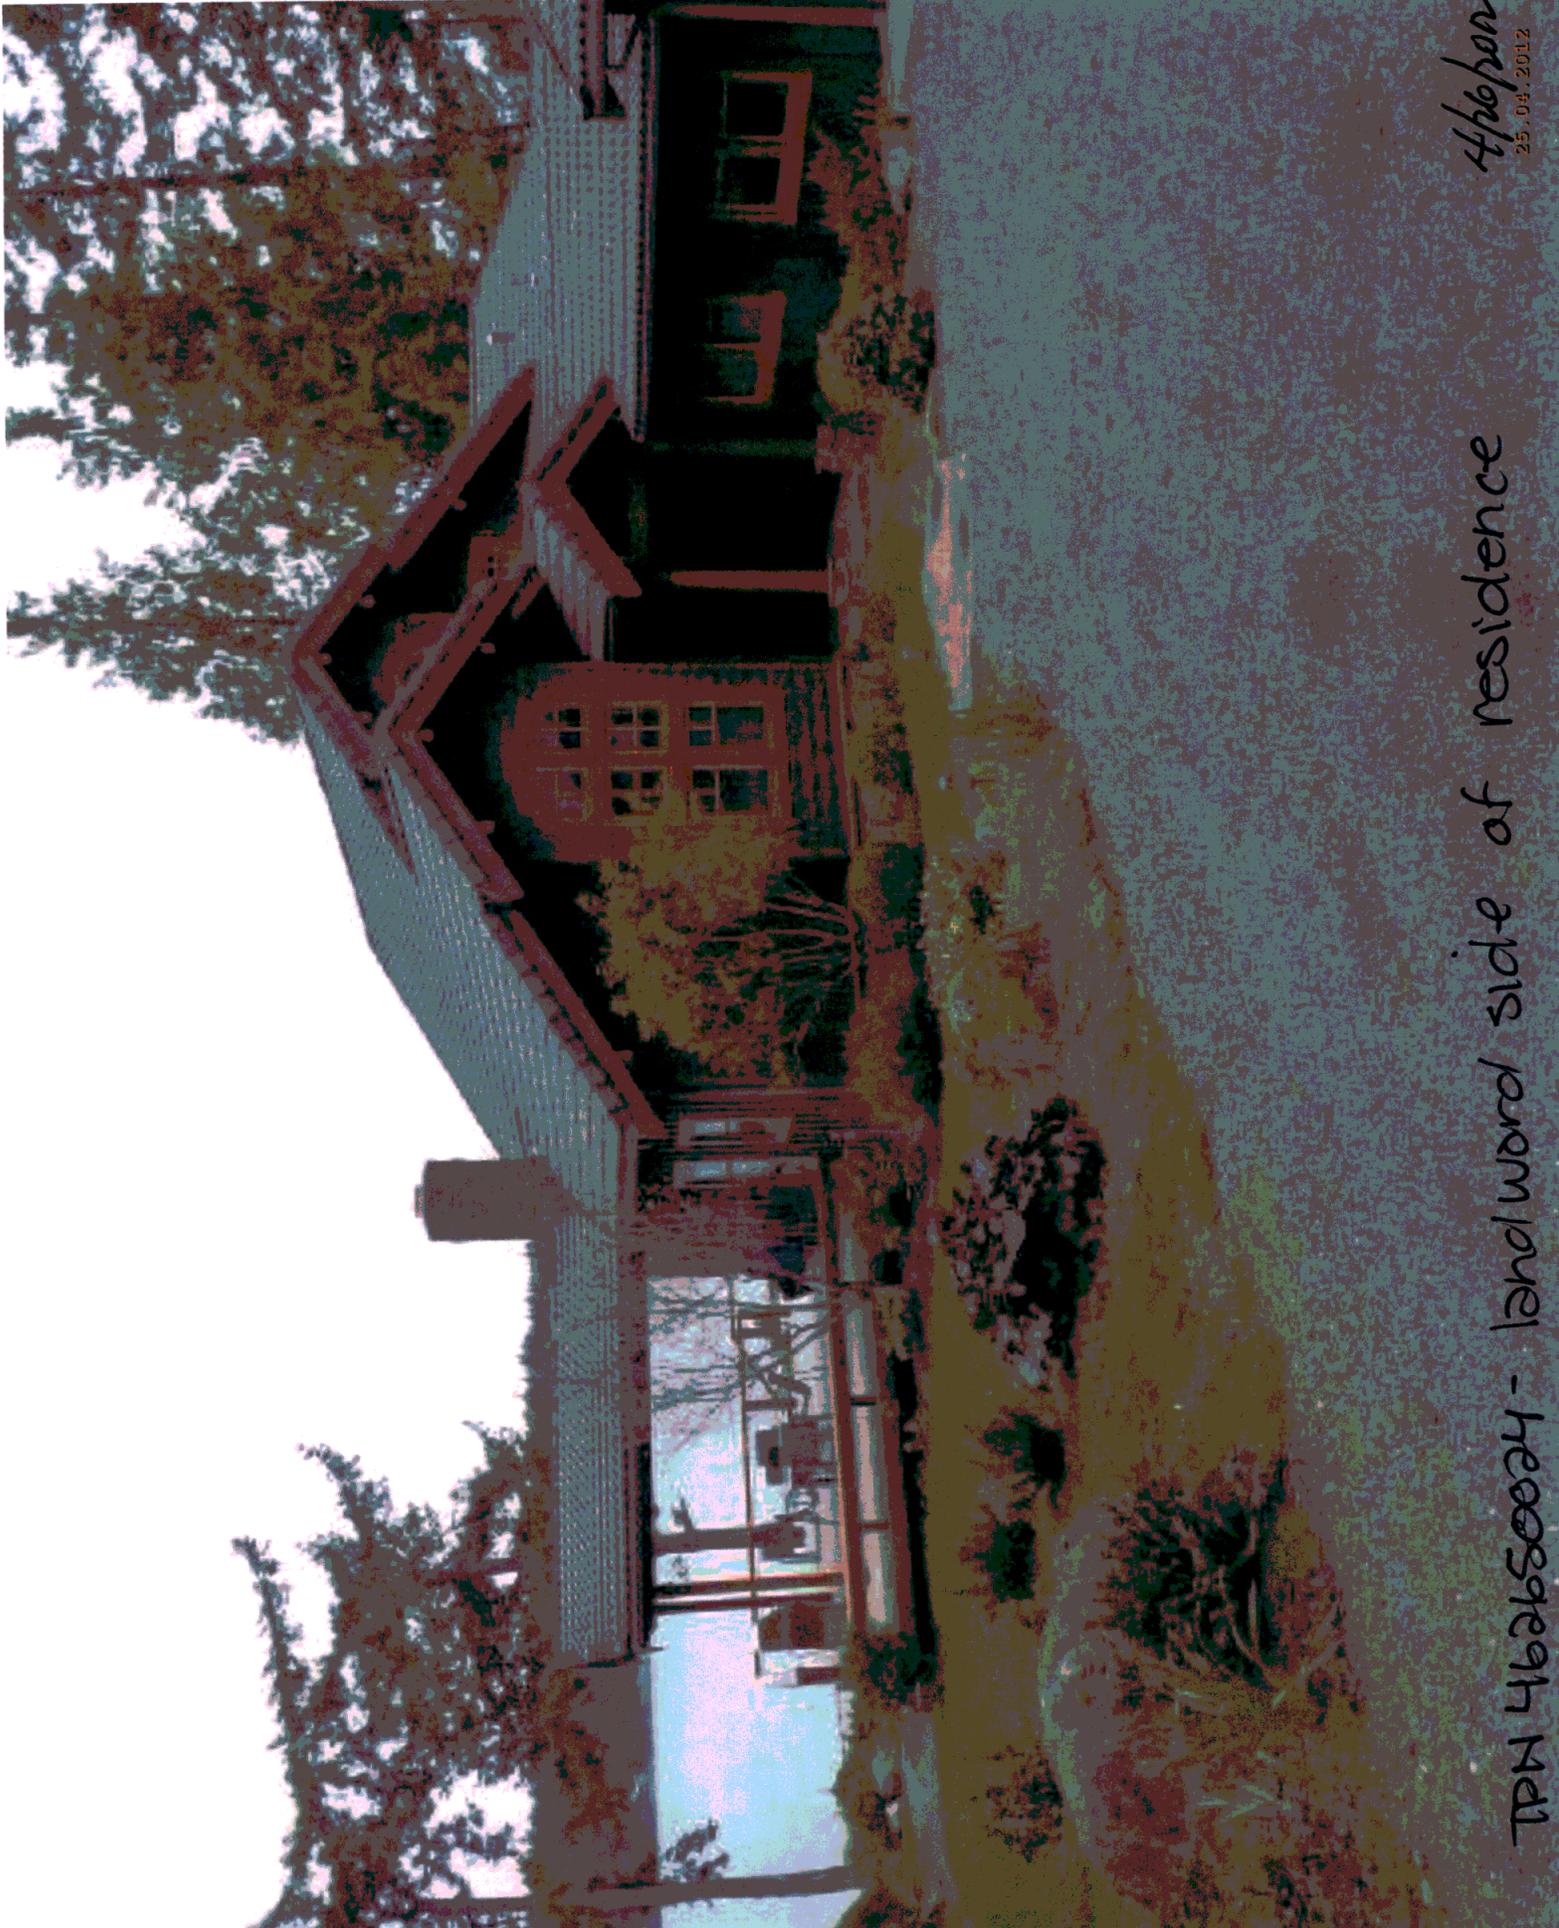
Assessor’s records indicate the house was first constructed in 1954 at a time when no development standards existed for shoreline developments. The existing residence is less than 50-feet from the Top-of-Bank. There is no vegetative screening along the shoreline of this parcel.

The “Top-of Bank” has been described in the past by San Juan County as the area along a sloping shoreline where “you would no longer drive your Mercedes.” It is clear that the residence does meet a 100-foot setback from the Top-of-Bank as is required to day causing the residence to be considered non-conforming.

TPN 462650024 - landward side of residence

TPN 46950024 - Seaward side of residence 4-26-12

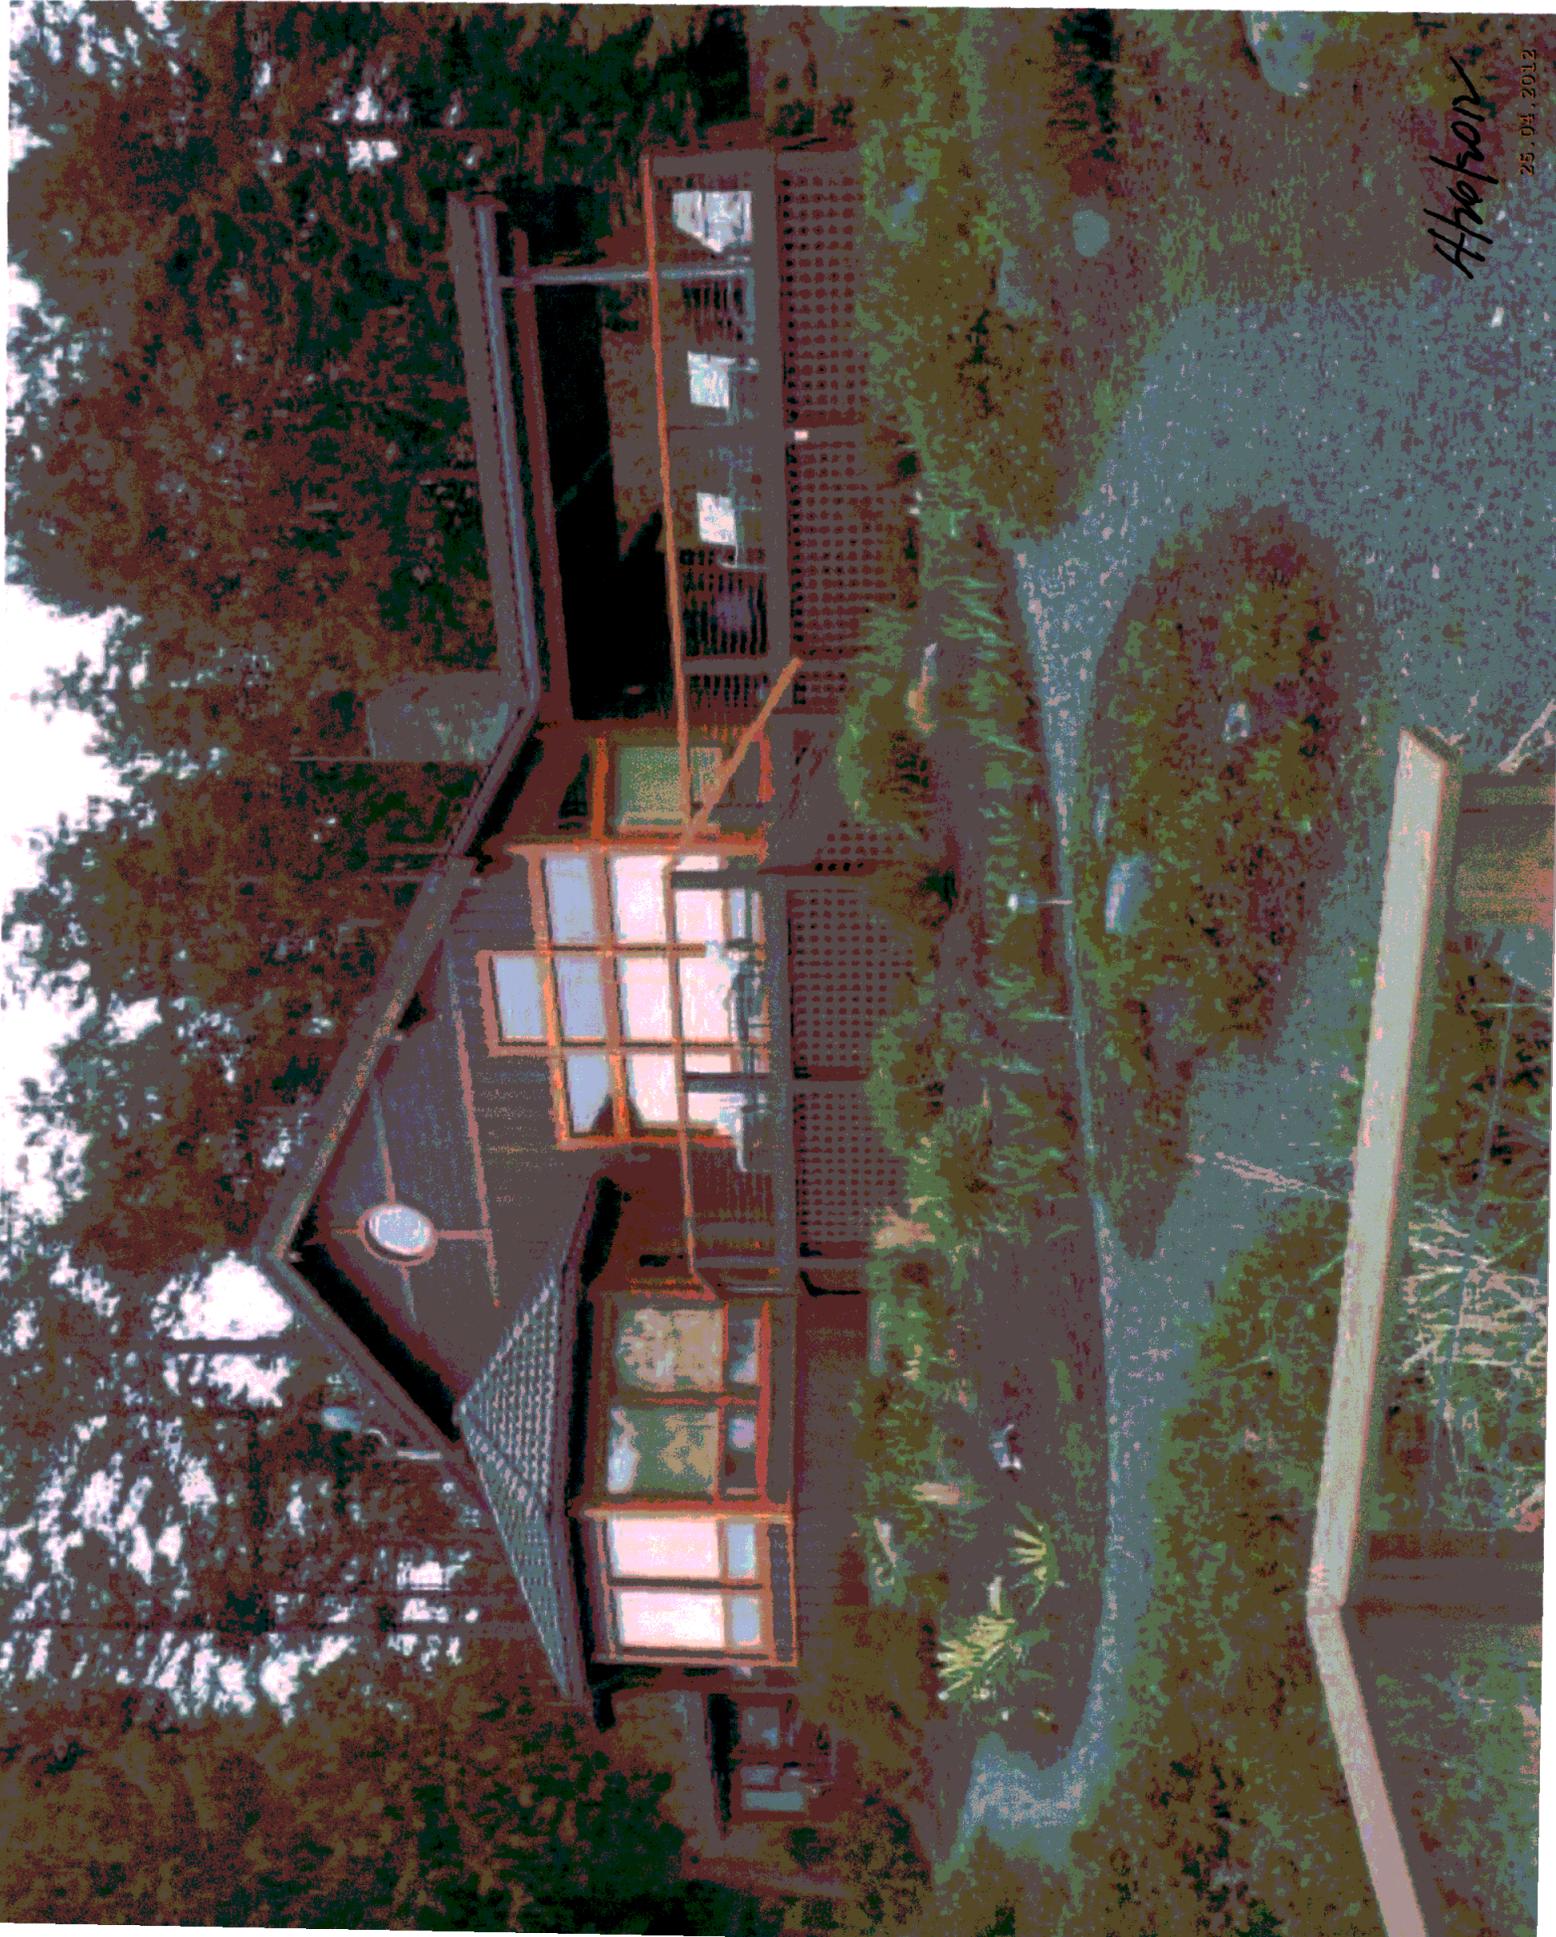
Two other non-conforming structures that exist on site are the wildlife observation deck which is constructed at the Top-of Bank and a detached garage located north of the residence. (See attached photographs.) This deck and garage is considered an accessory structure which would not be allowed to be constructed on the property in these locations today. They would have to be either physically connected to the residence outside the 100-foot shoreline setback or placed landward of the most landward point of the residence. The location of these structures makes them non-conforming.

wildlife observation deck

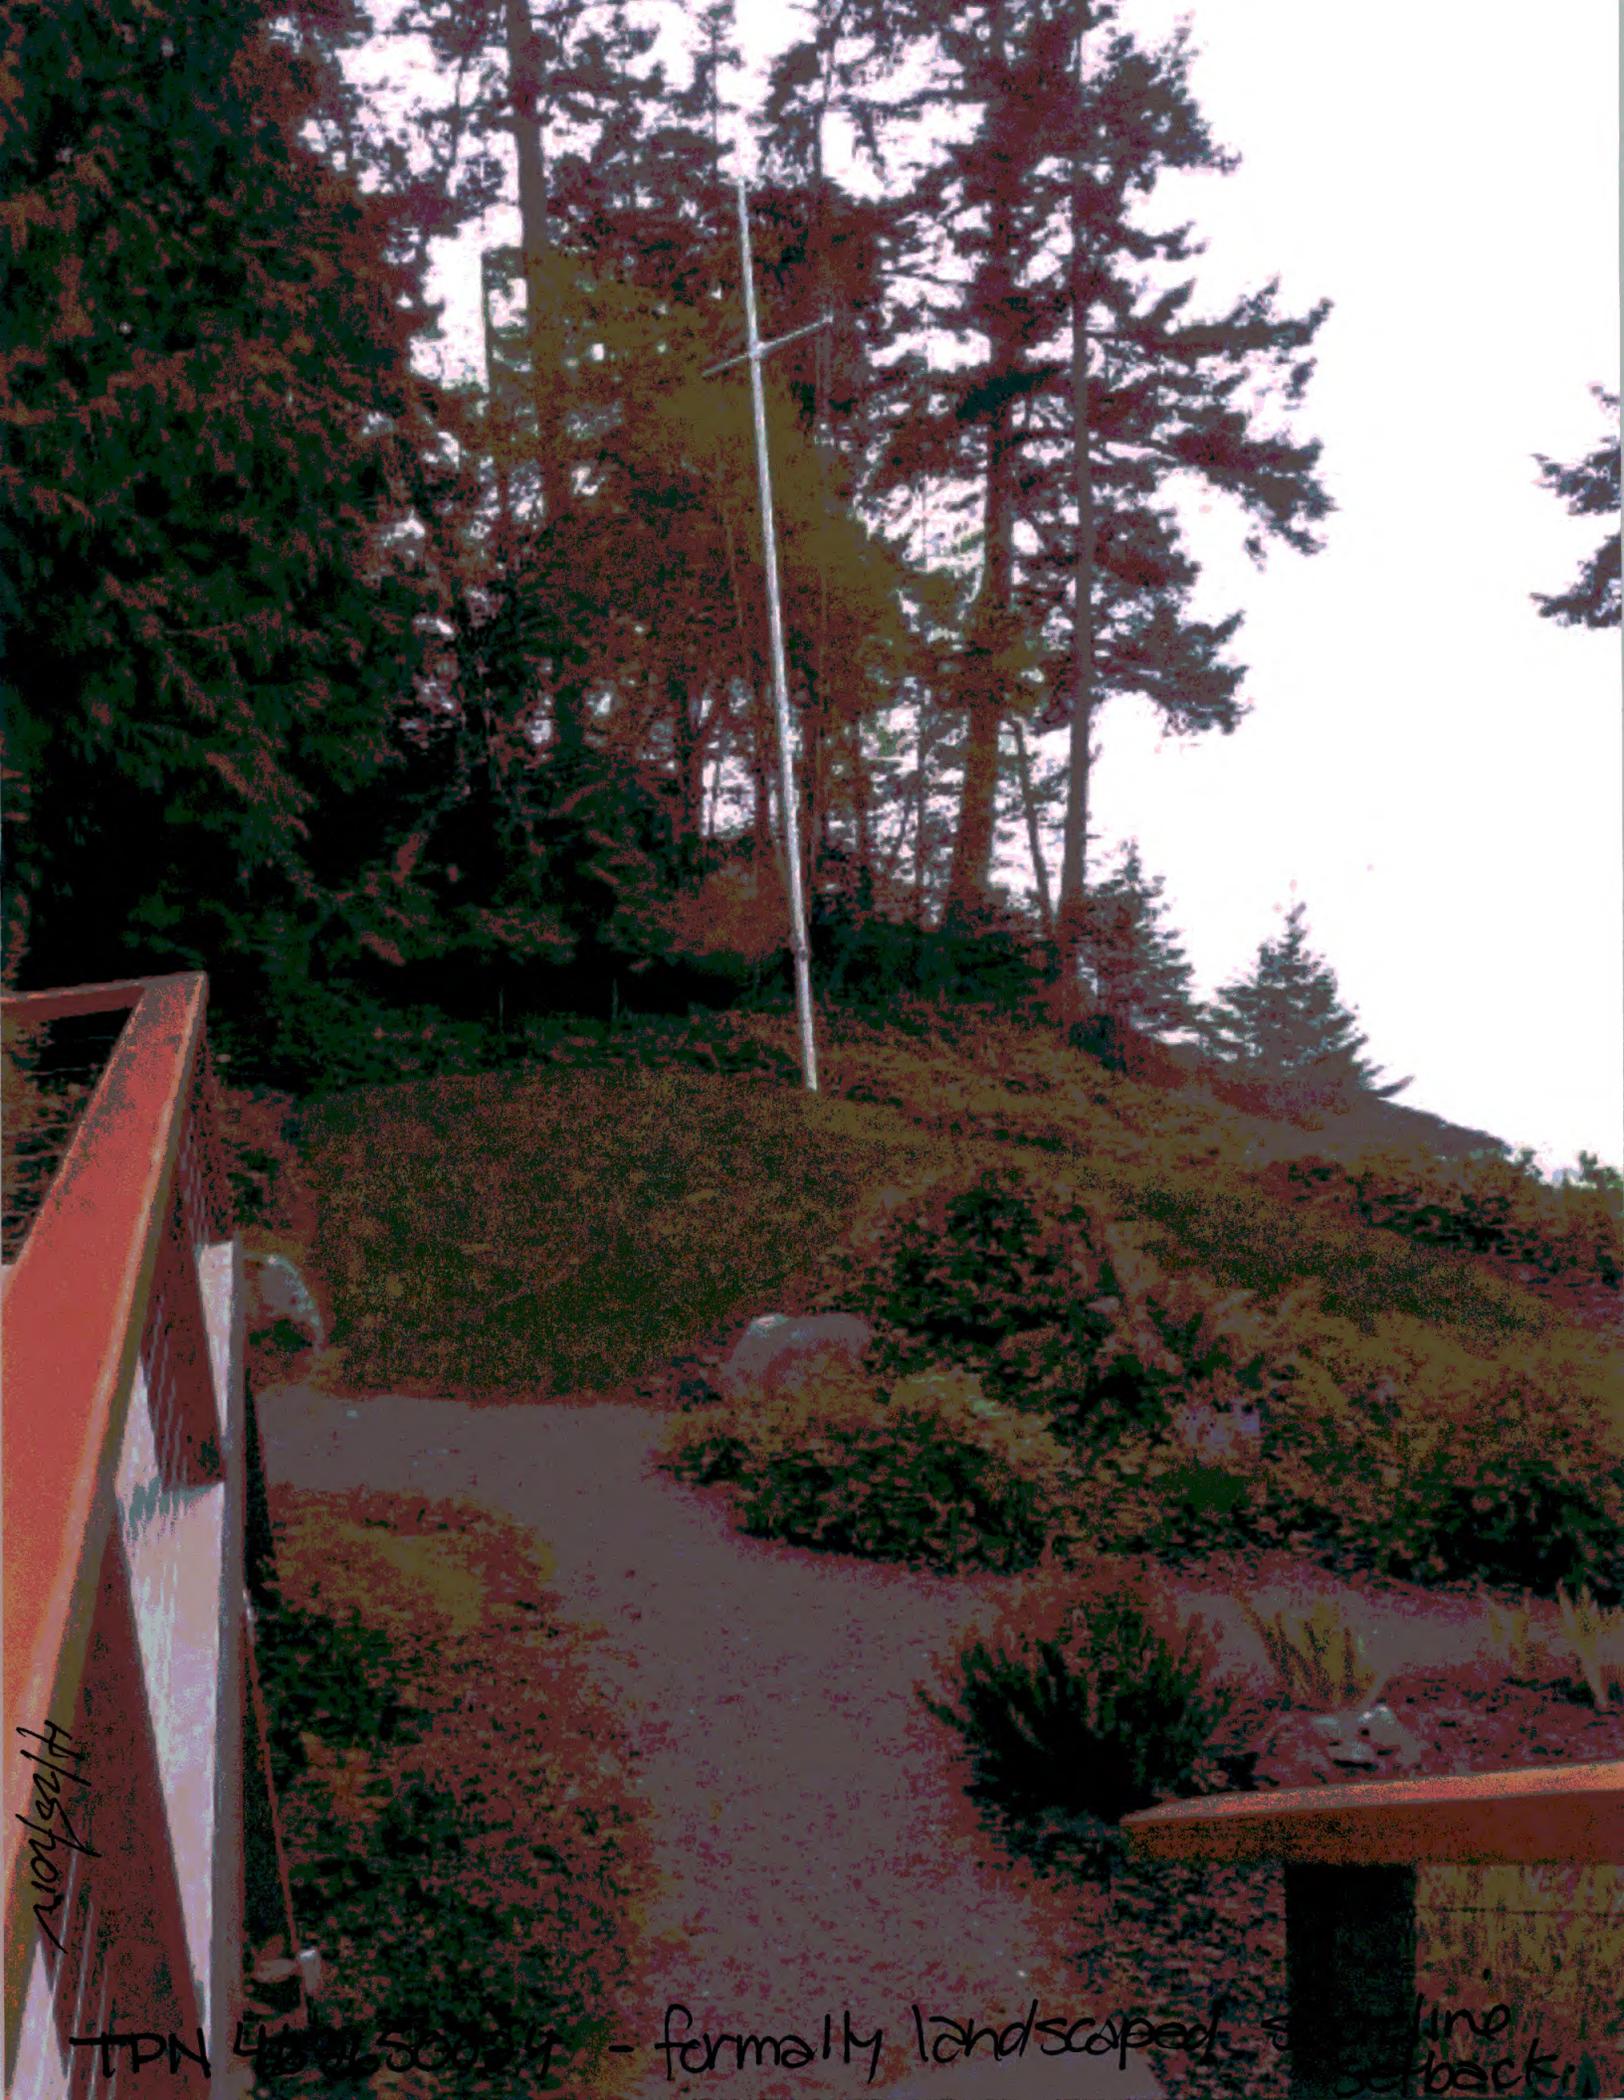
Finally, under the current SMP, no native vegetation removal is allowed seaward of the shoreline setback. The attached photographs clearly show a well maintained formally landscaped yard located between the residence and the Top-of-Bank. This formally landscaped yard is considered non-conforming.

TPN 450250004 - formally landscaped side yard line setback

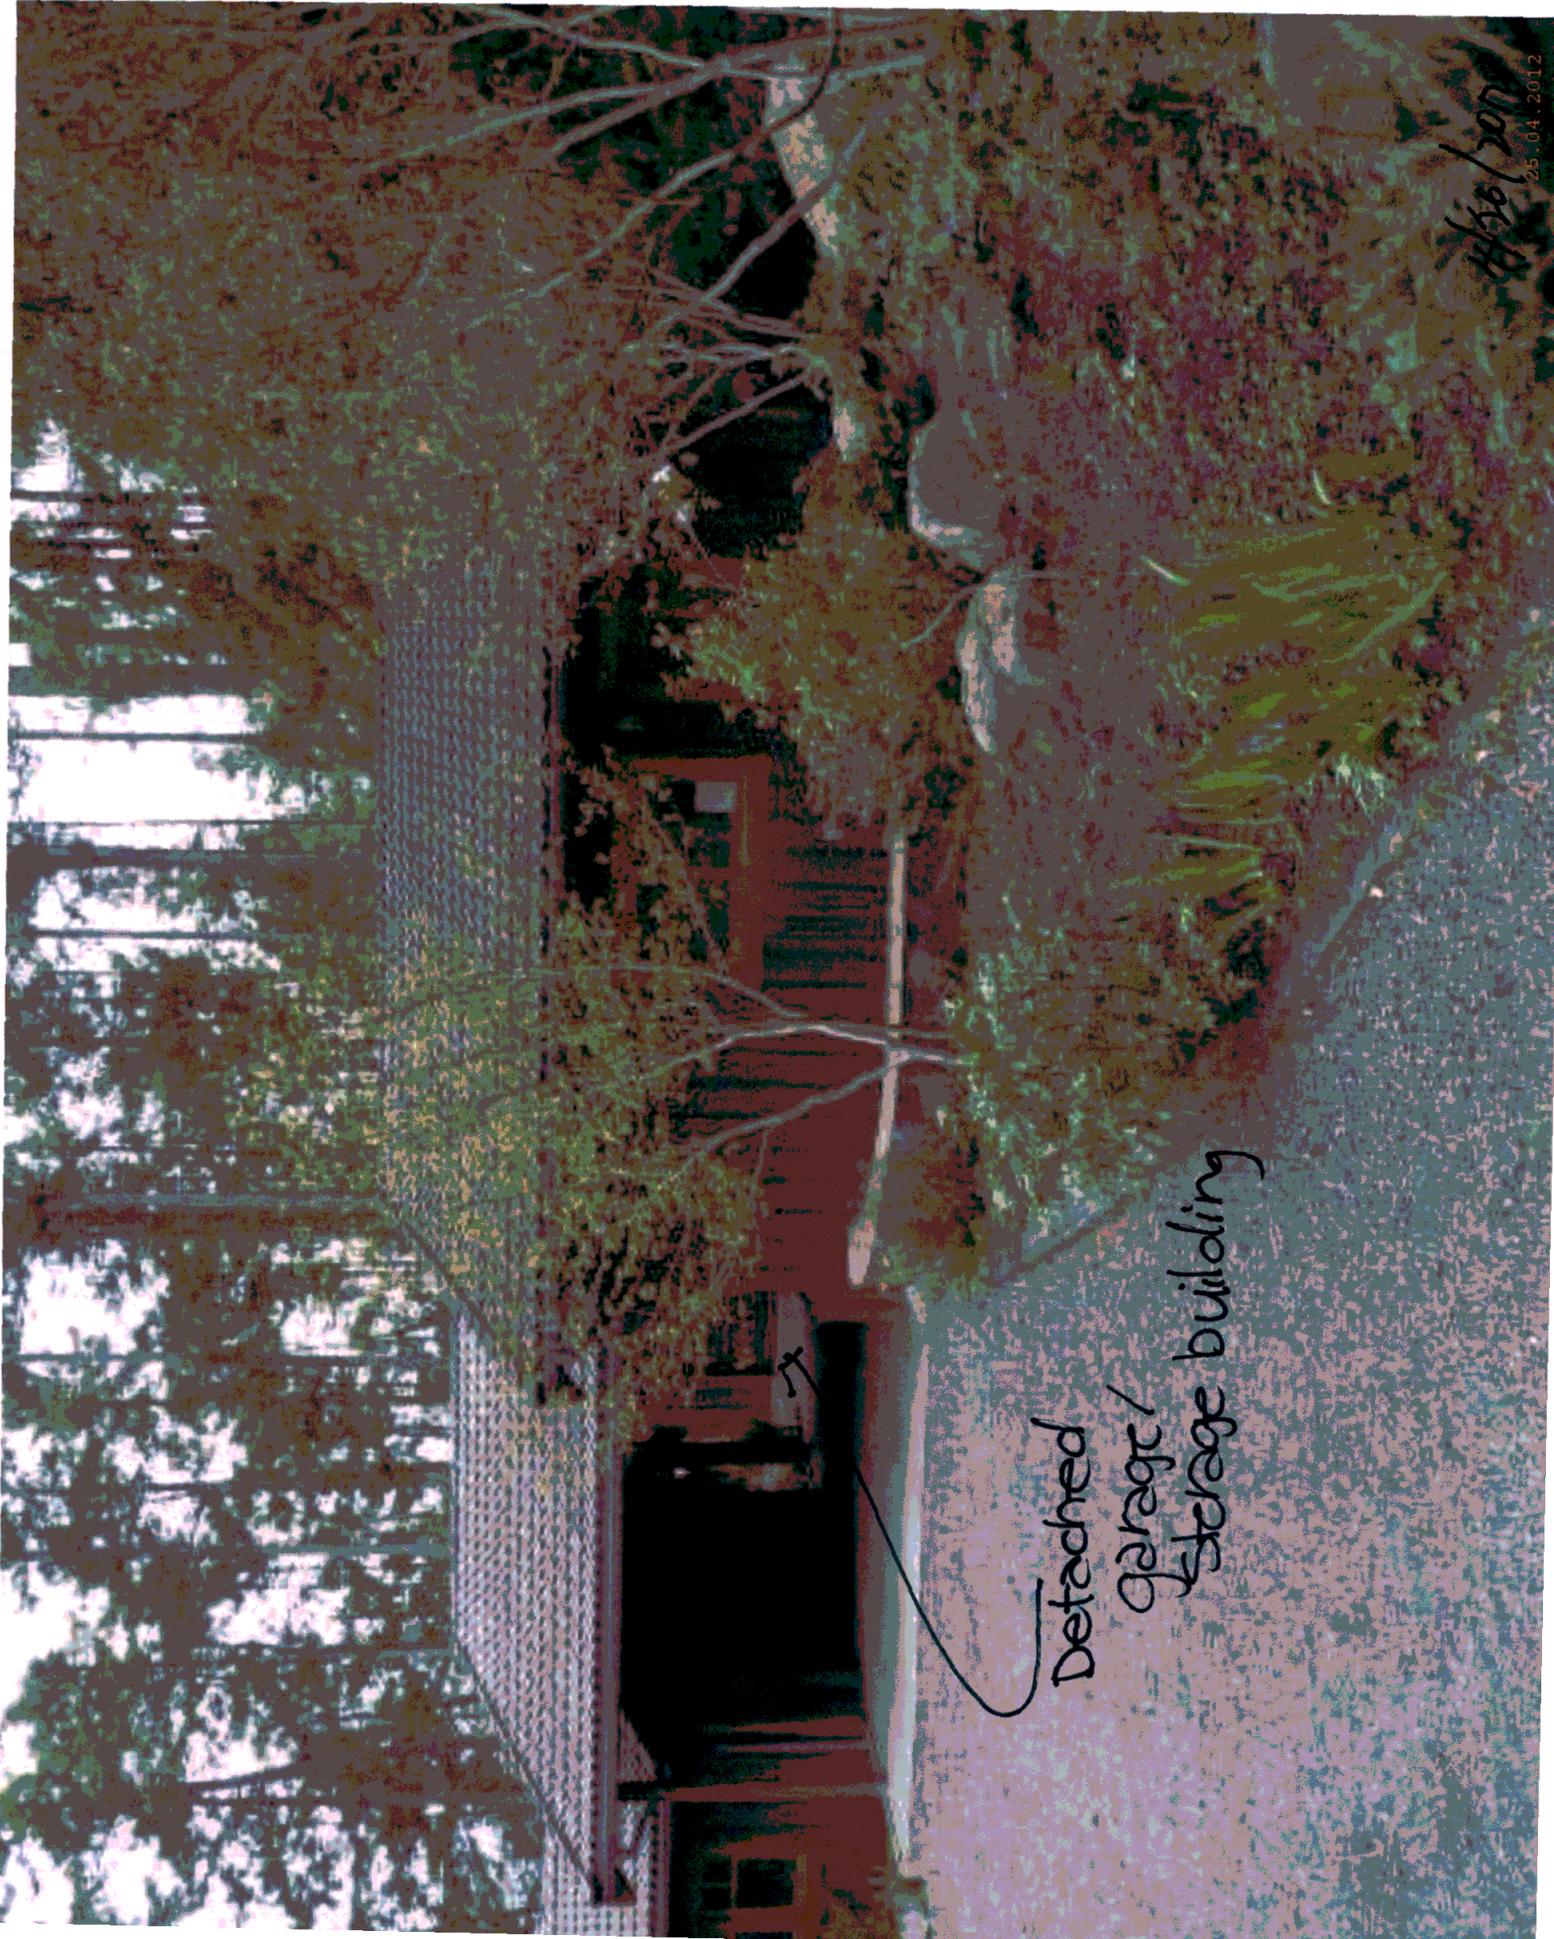
Detached  
Garage /  
Storage building
