SAN JUAN COUNTY  
RESPONSE TO SHORELINE INVENTORY REPORT

PROPERTY OWNERS: John and Jamie Casey

TAX PARCEL NUMBER(S) 462650024 + 462650025 J.C. COMMUNITY

REACH NUMBER 227 (FROM MAP index 37)

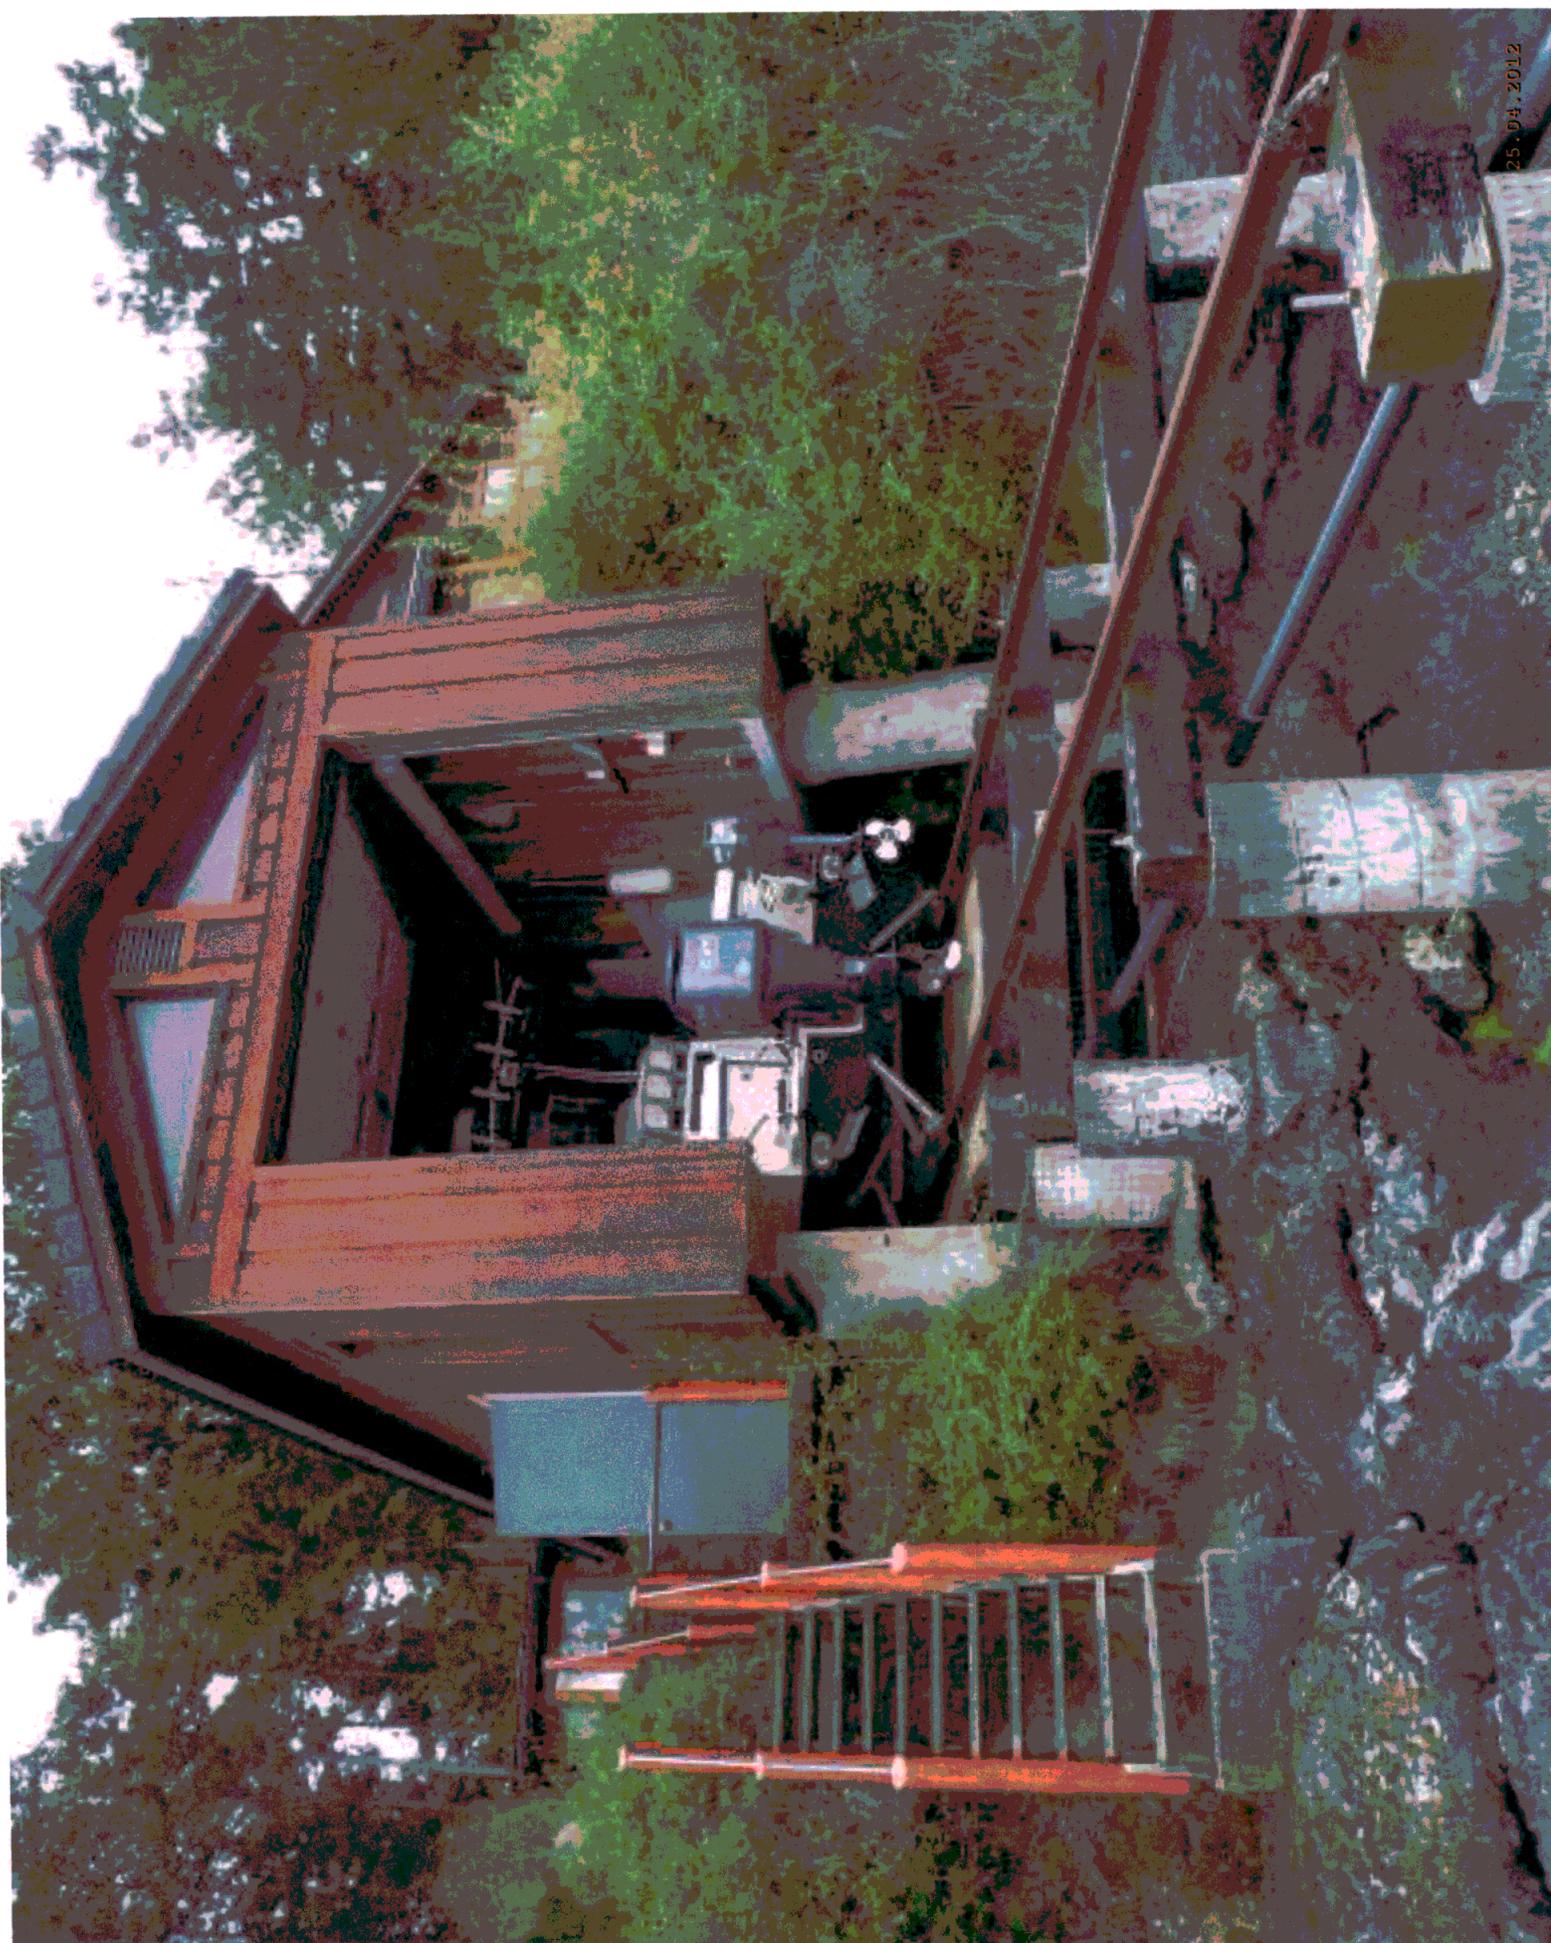
TPN 462650024  
Dated 4-25-12

1. Map 9A does not recognize the existence of a boat house on the property but only the associated marine railway and a mooring buoy. (Please see the attached photographs.)
2. Map 12A indicates the properties are located in a Zone A FEMA Flood Plain. There has been no history or evidence of these properties experiencing flooding. In fact, these properties include a medium to high rocky shoreline bank. (See attached photograph.)

EXISTING Boat House +  
Marine Railway System

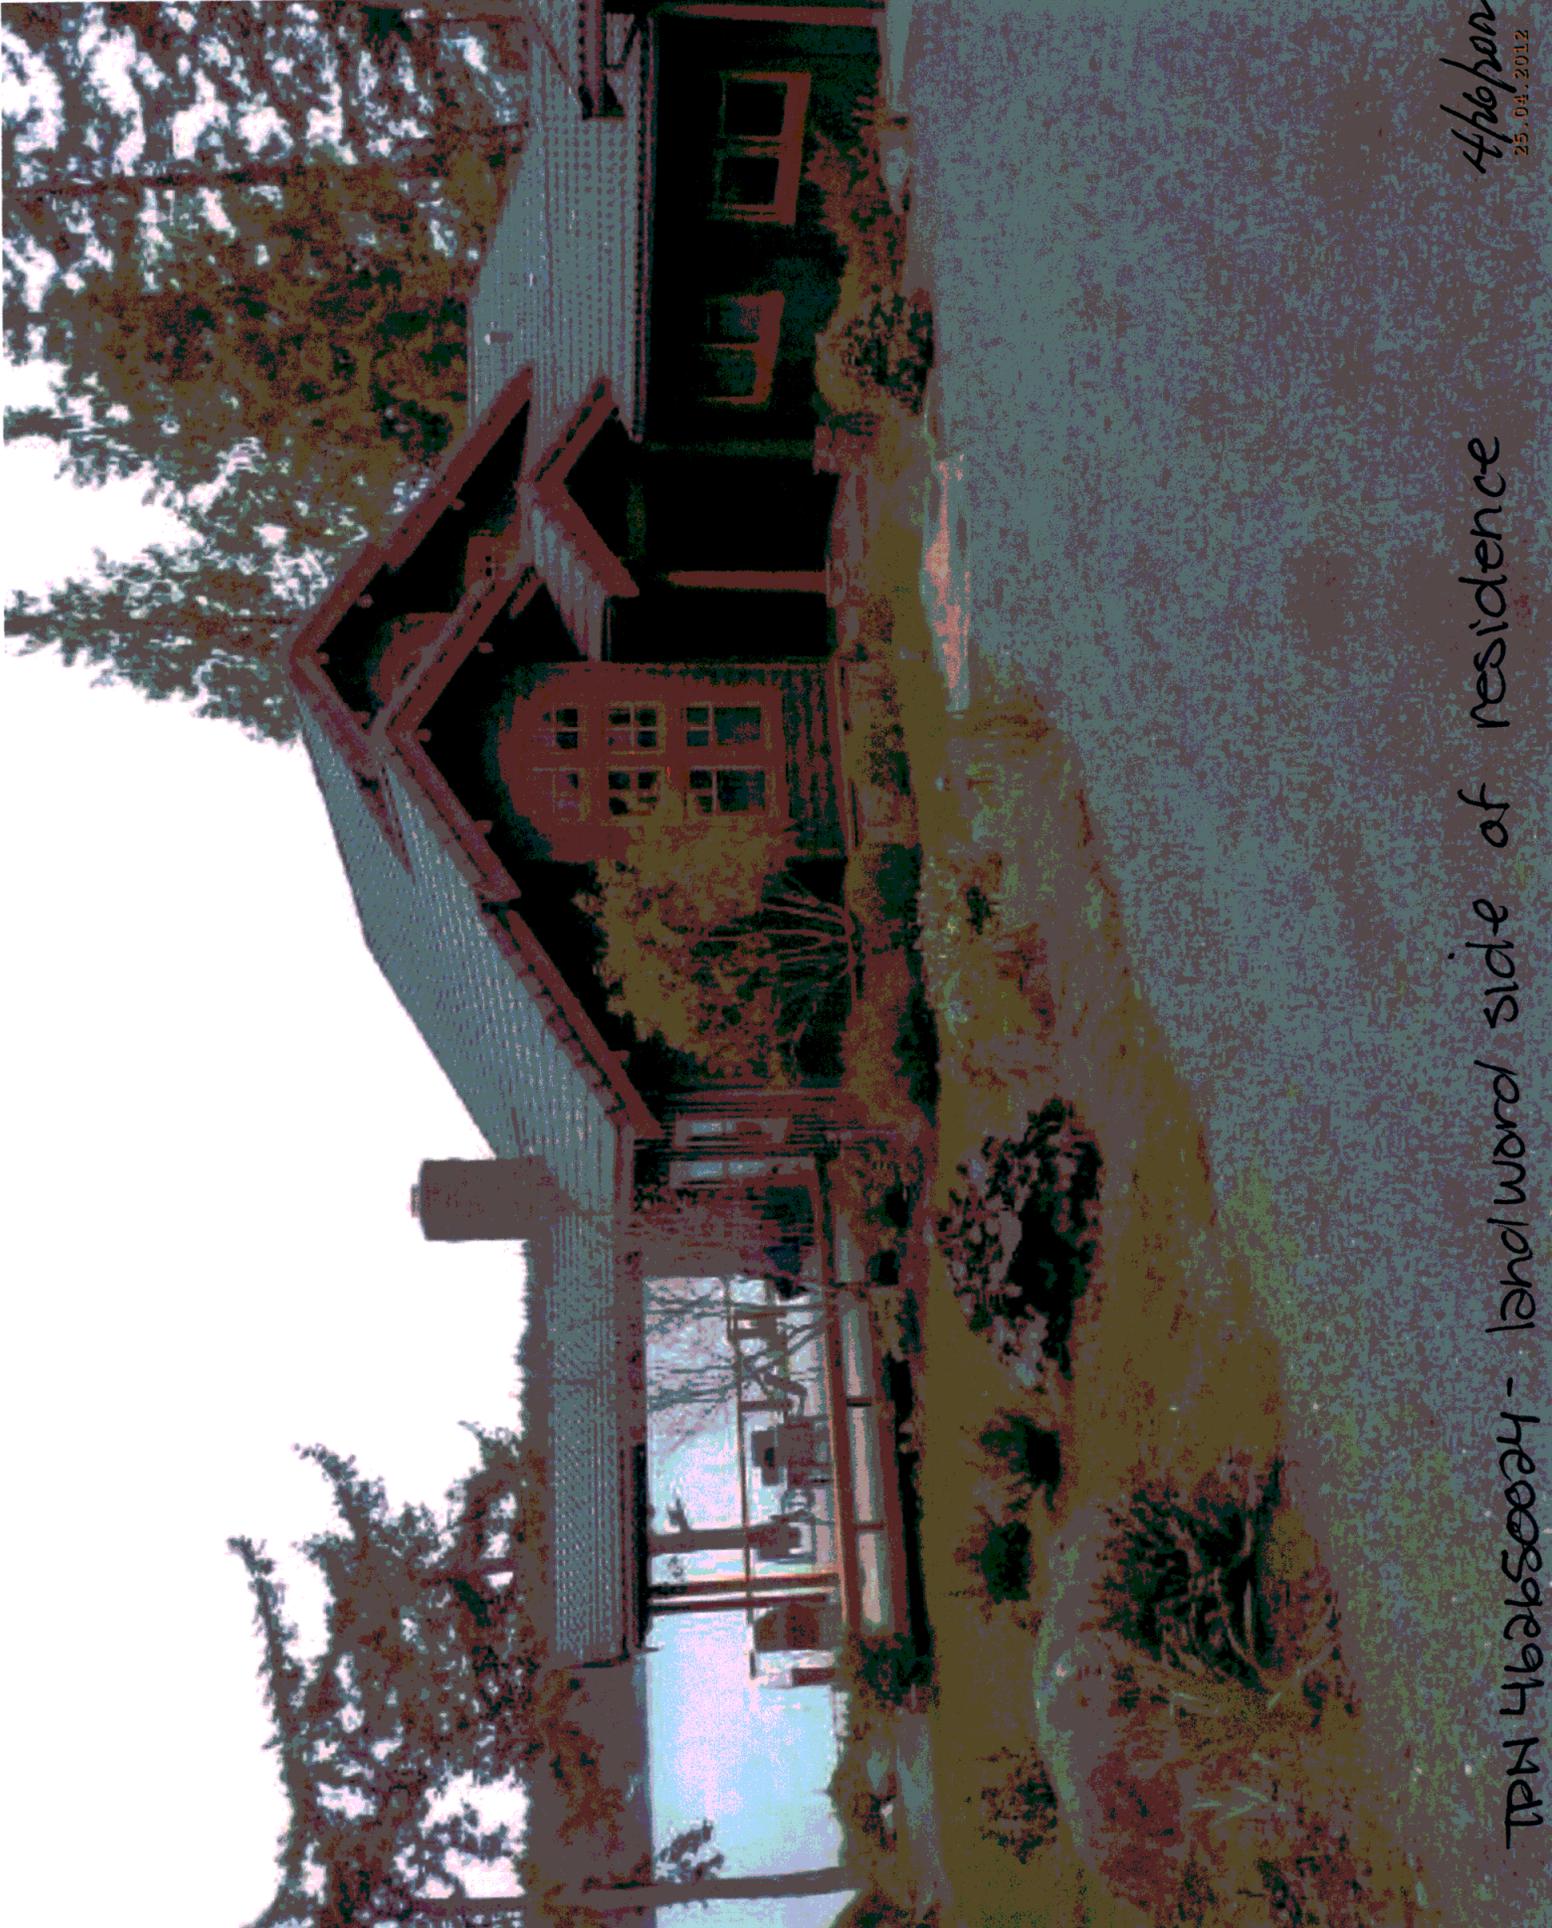
Assessor’s records indicate the house was first constructed in 1954 at a time when no development standards existed for shoreline developments. The existing residence is less than 50-feet from the Top-of-Bank. There is no vegetative screening along the shoreline of this parcel.

TPN 462650024 - landward side of residence

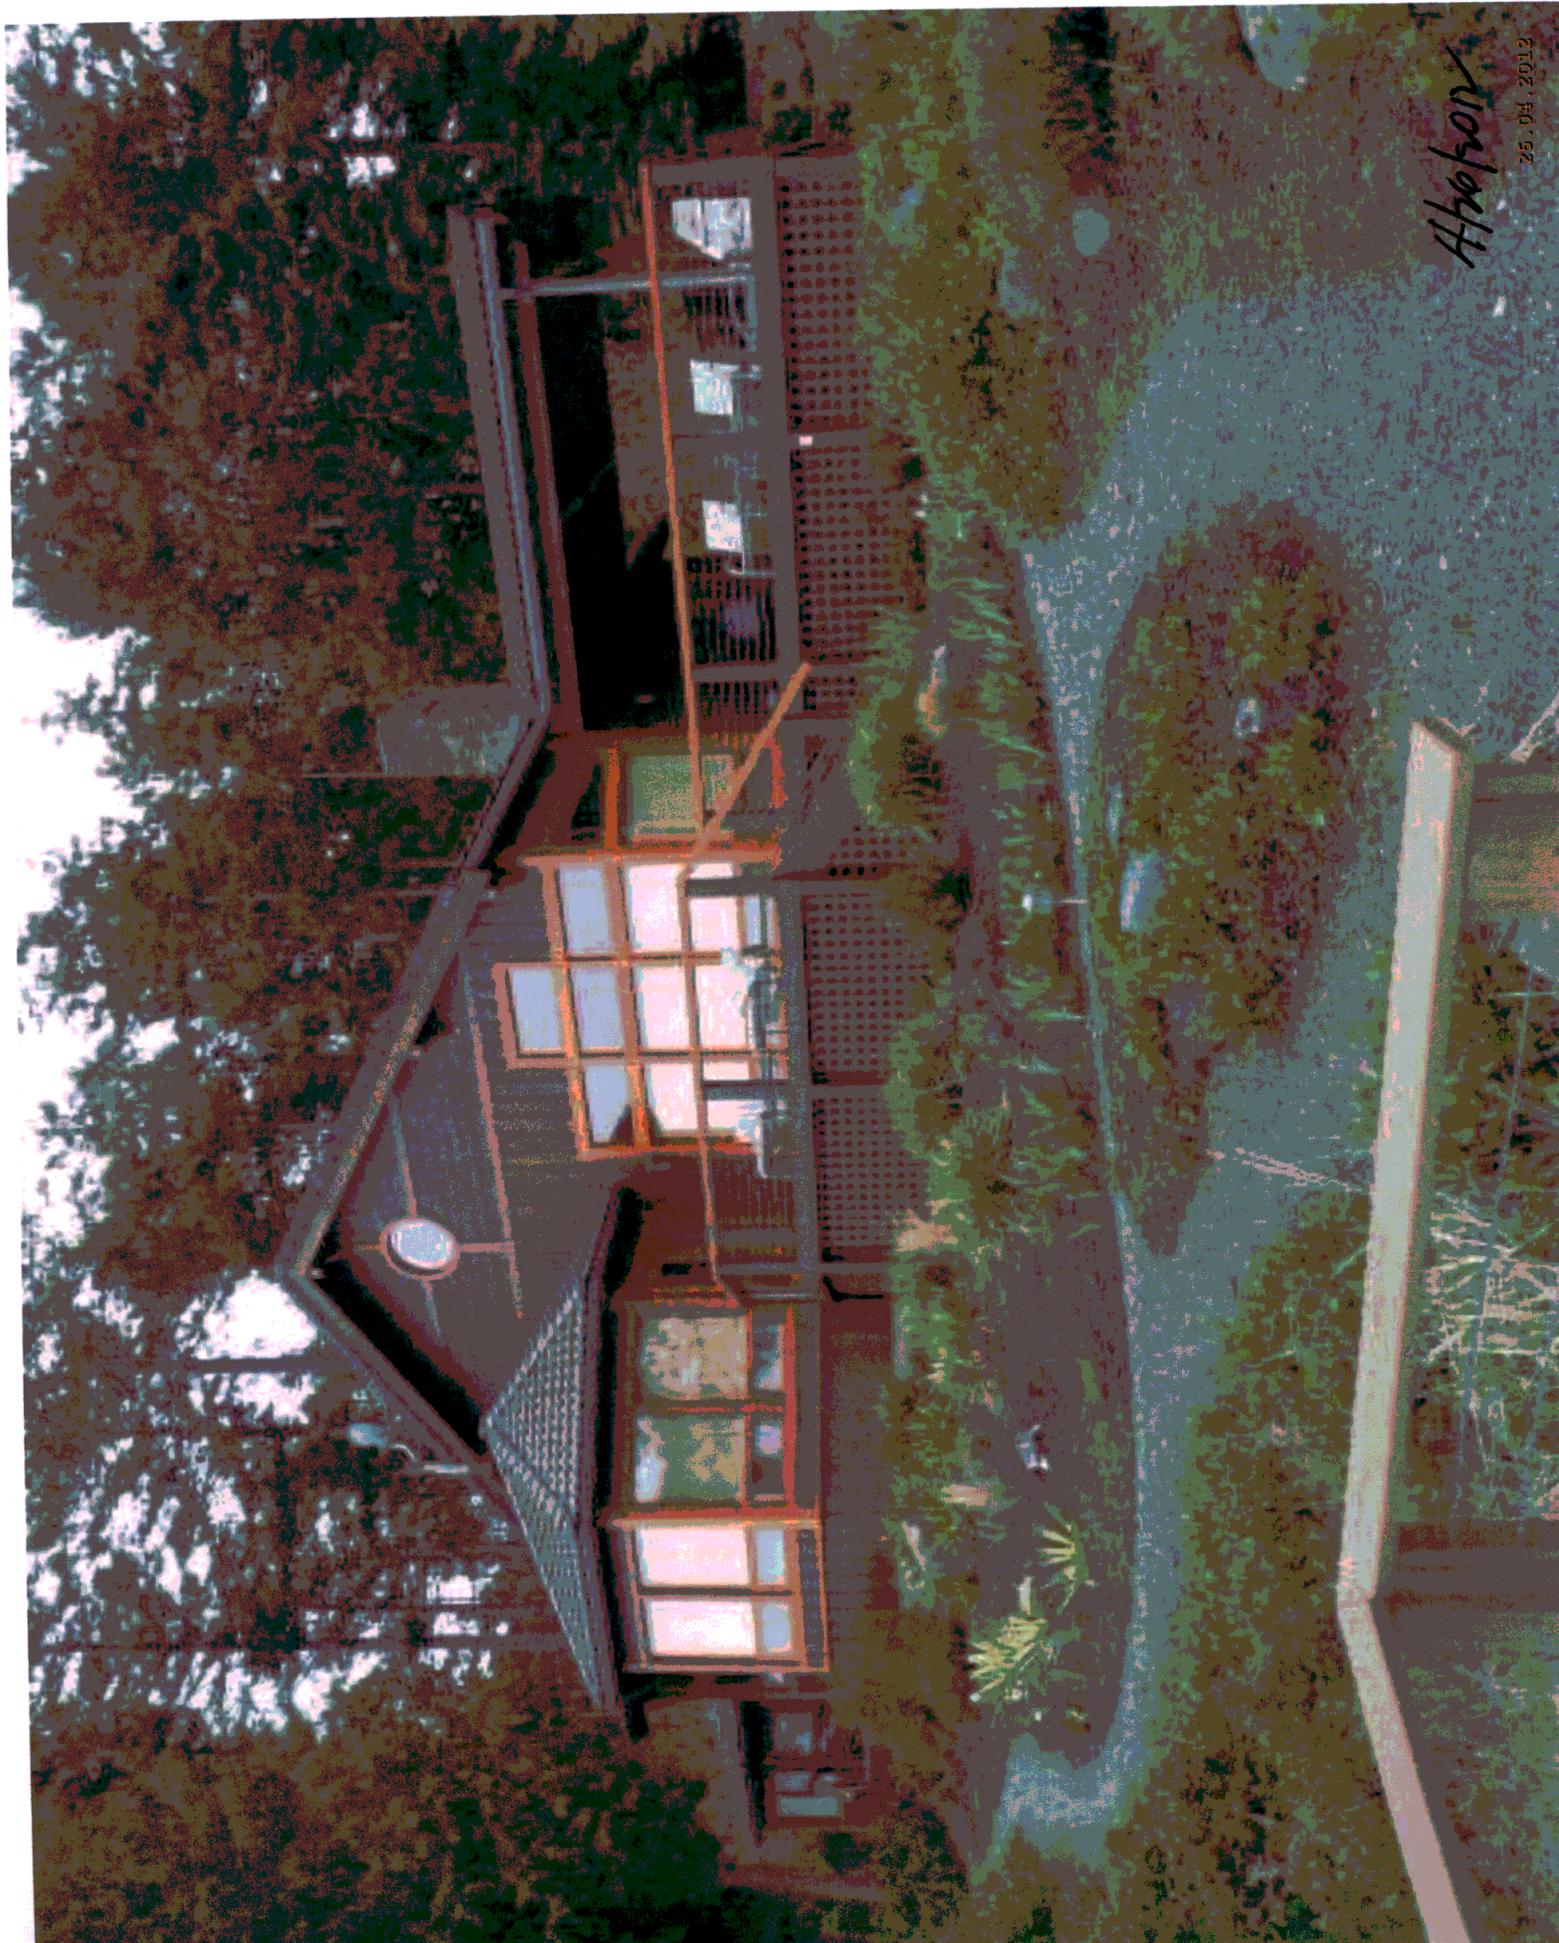
TPN 4650004 - Seaward side of residence 4-26-12

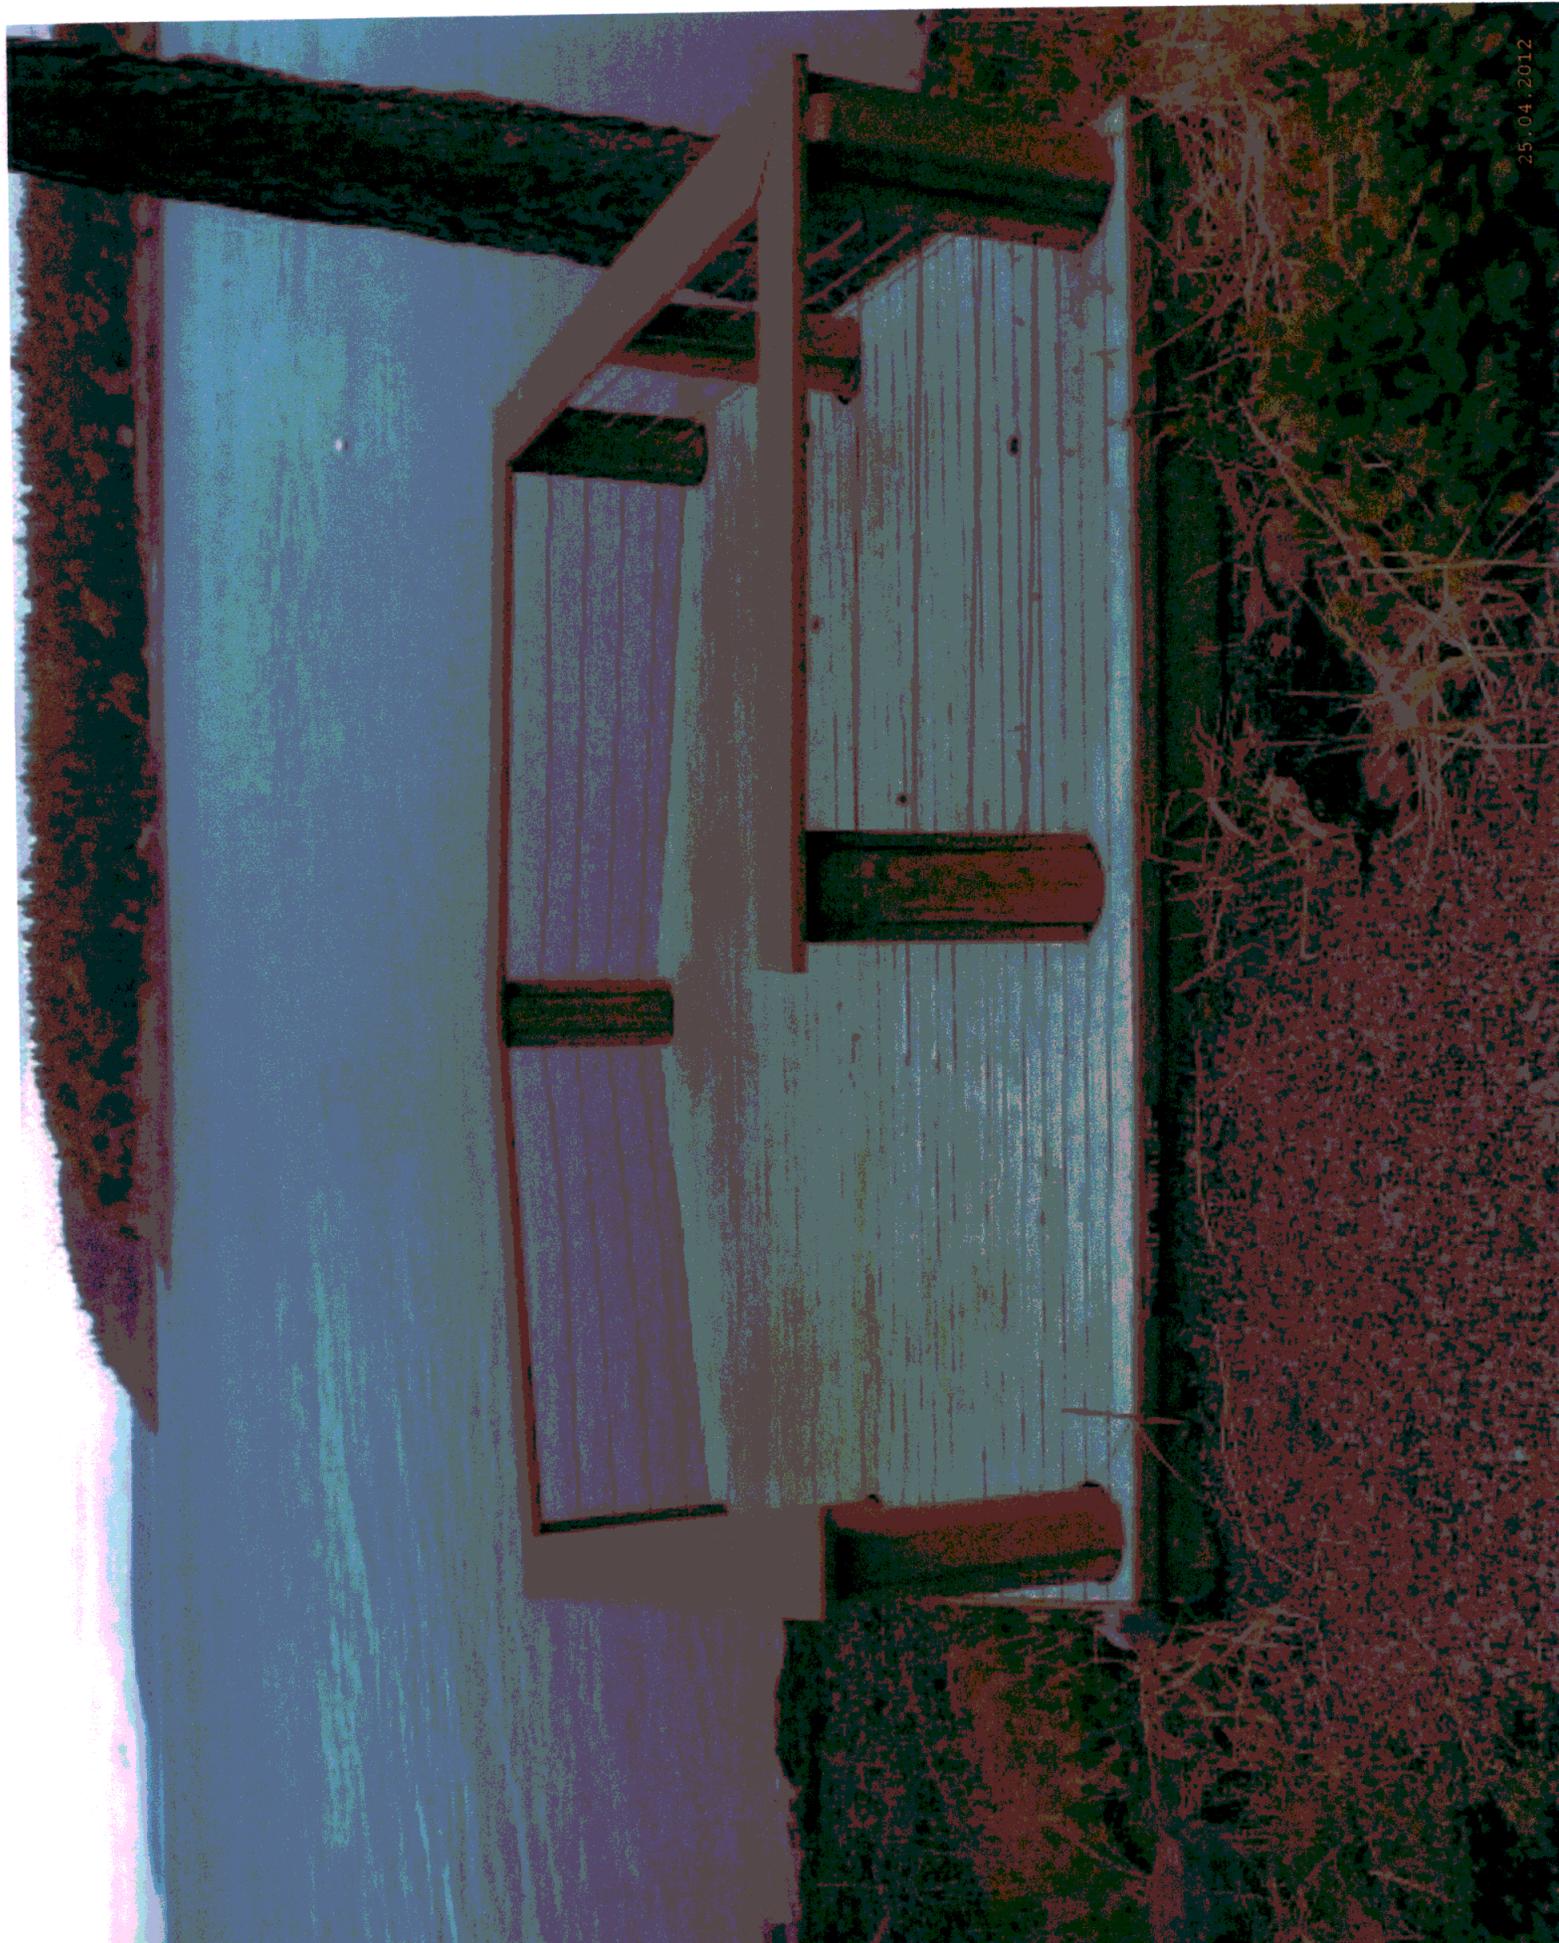
Two other non-conforming structures that exist on site are the wildlife observation deck which is constructed at the Top-of Bank and a detached garage located north of the residence. (See attached photographs.) This deck and garage is considered an accessory structure which would not be allowed to be constructed on the property in these locations today. They would have to be either physically connected to the residence outside the 100-foot shoreline setback or placed landward of the most landward point of the residence. The location of these structures makes them non-conforming.

TPN 469650034 Wildlife observation deck 4-25-12

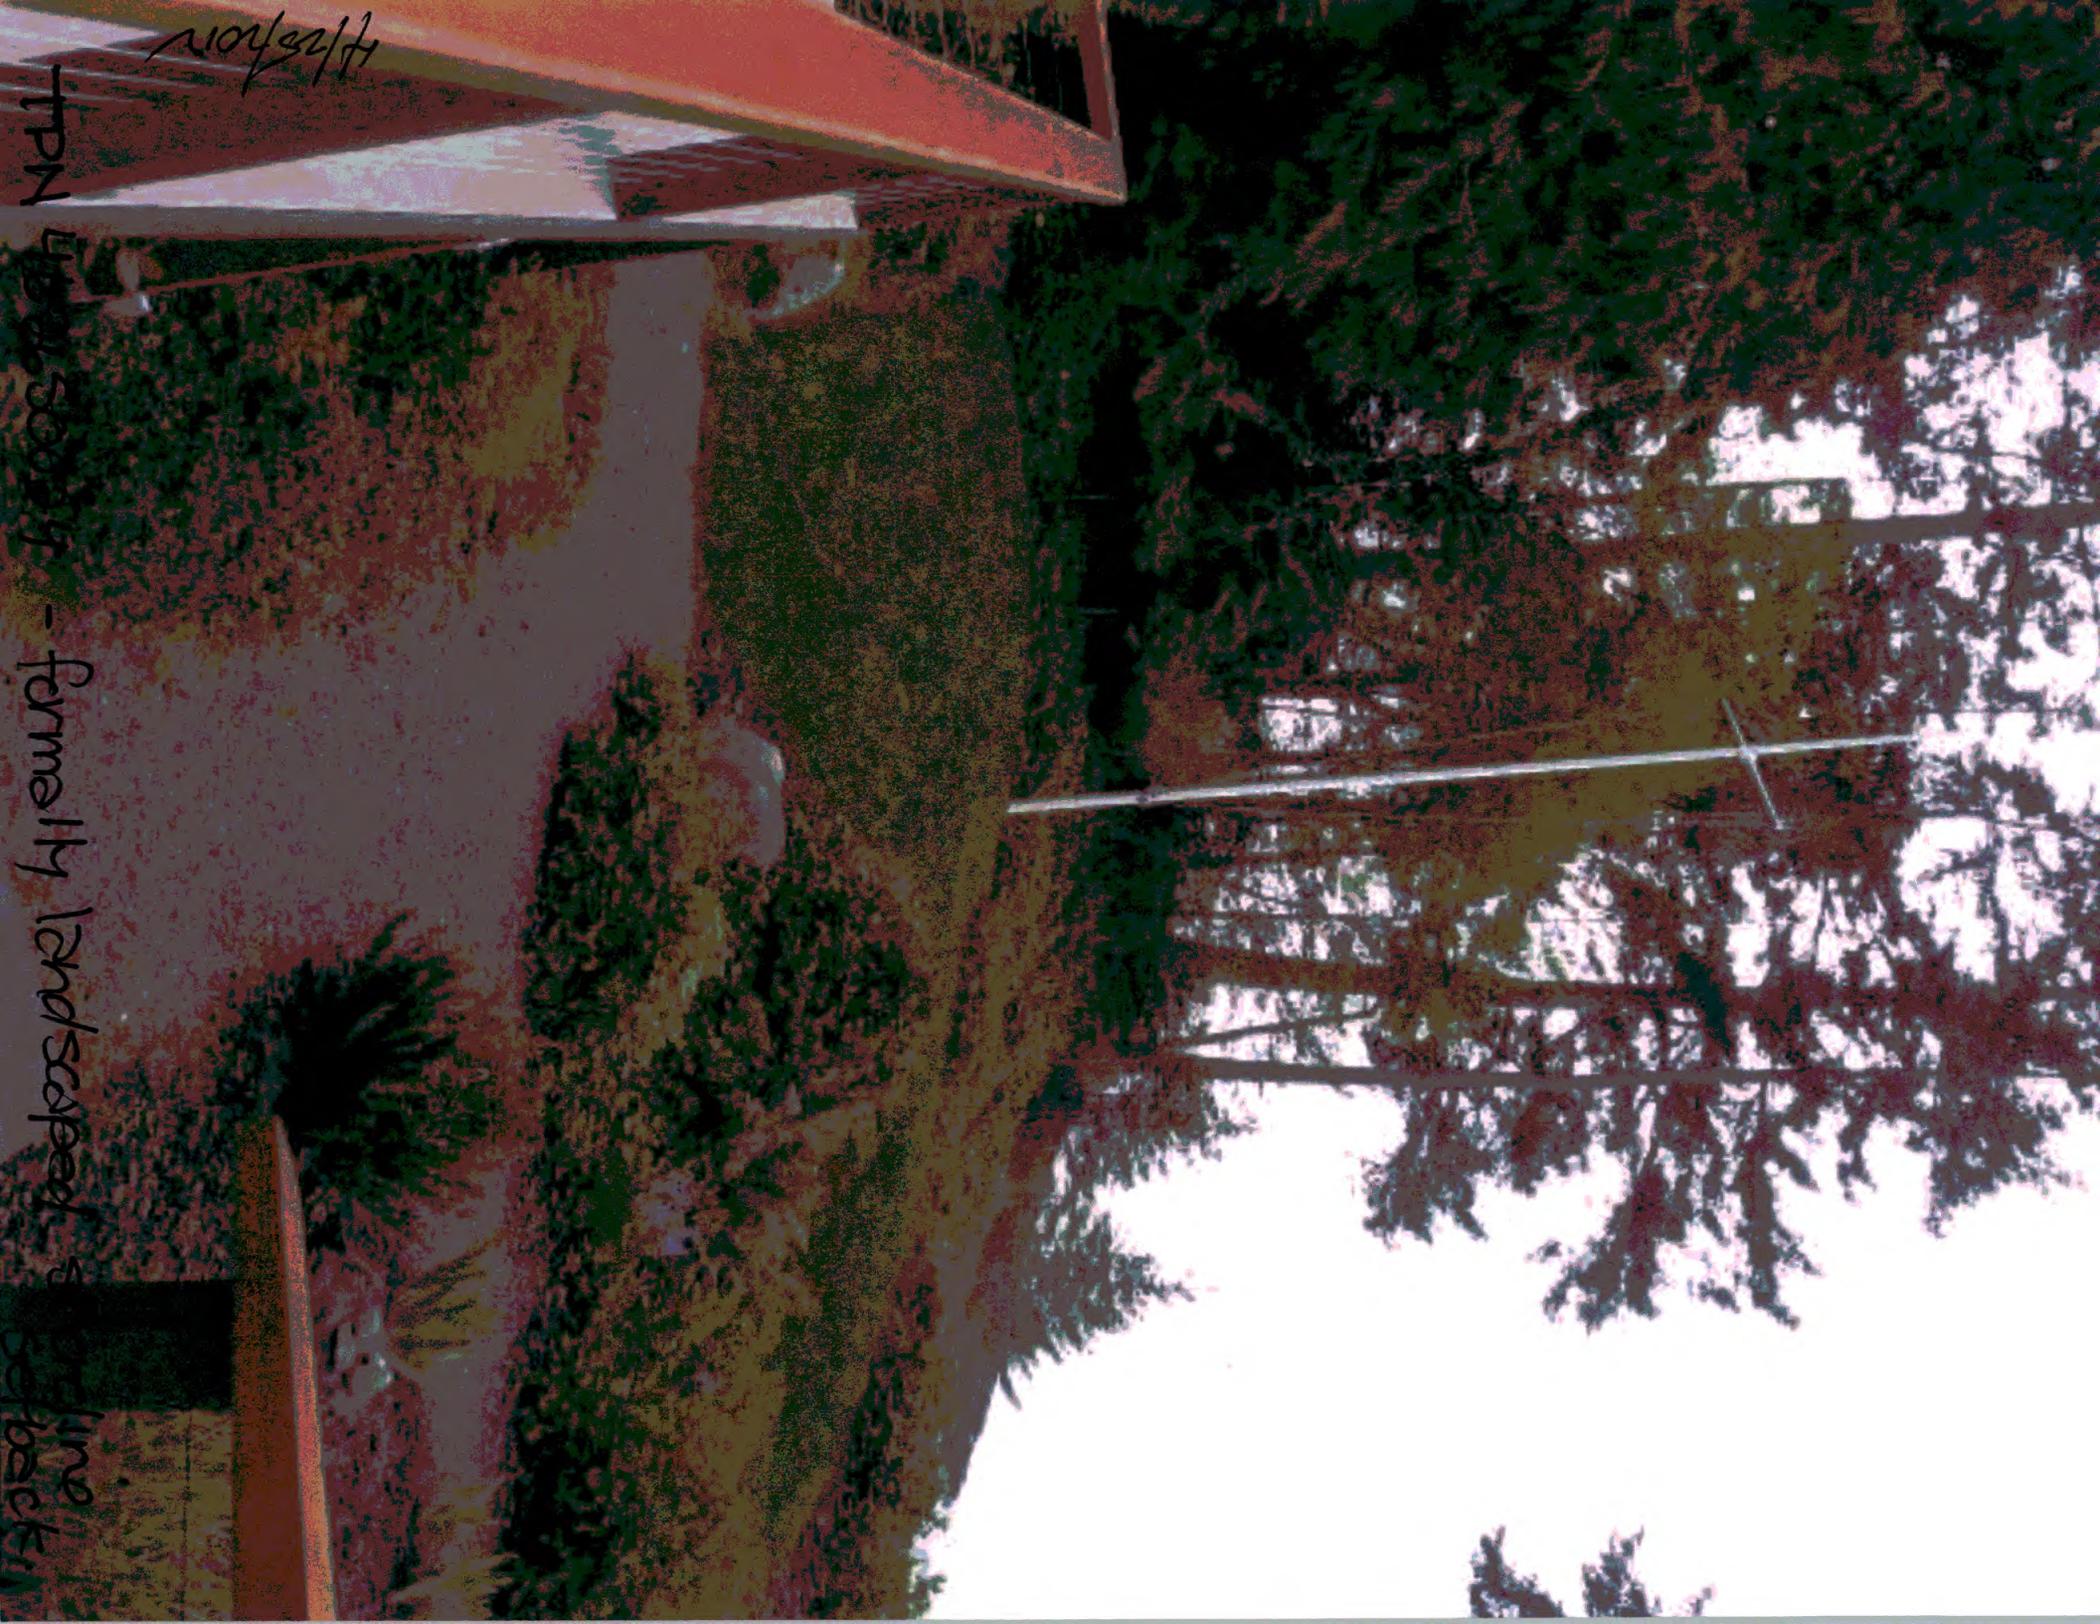
Finally, under the current SMP, no native vegetation removal is allowed seaward of the shoreline setback. The attached photographs clearly show a well maintained formally landscaped yard located between the residence and the Top-of-Bank. This formally landscaped yard is considered non-conforming.

TPN 4/20/2007 - formally landscaped & fine  
se/back

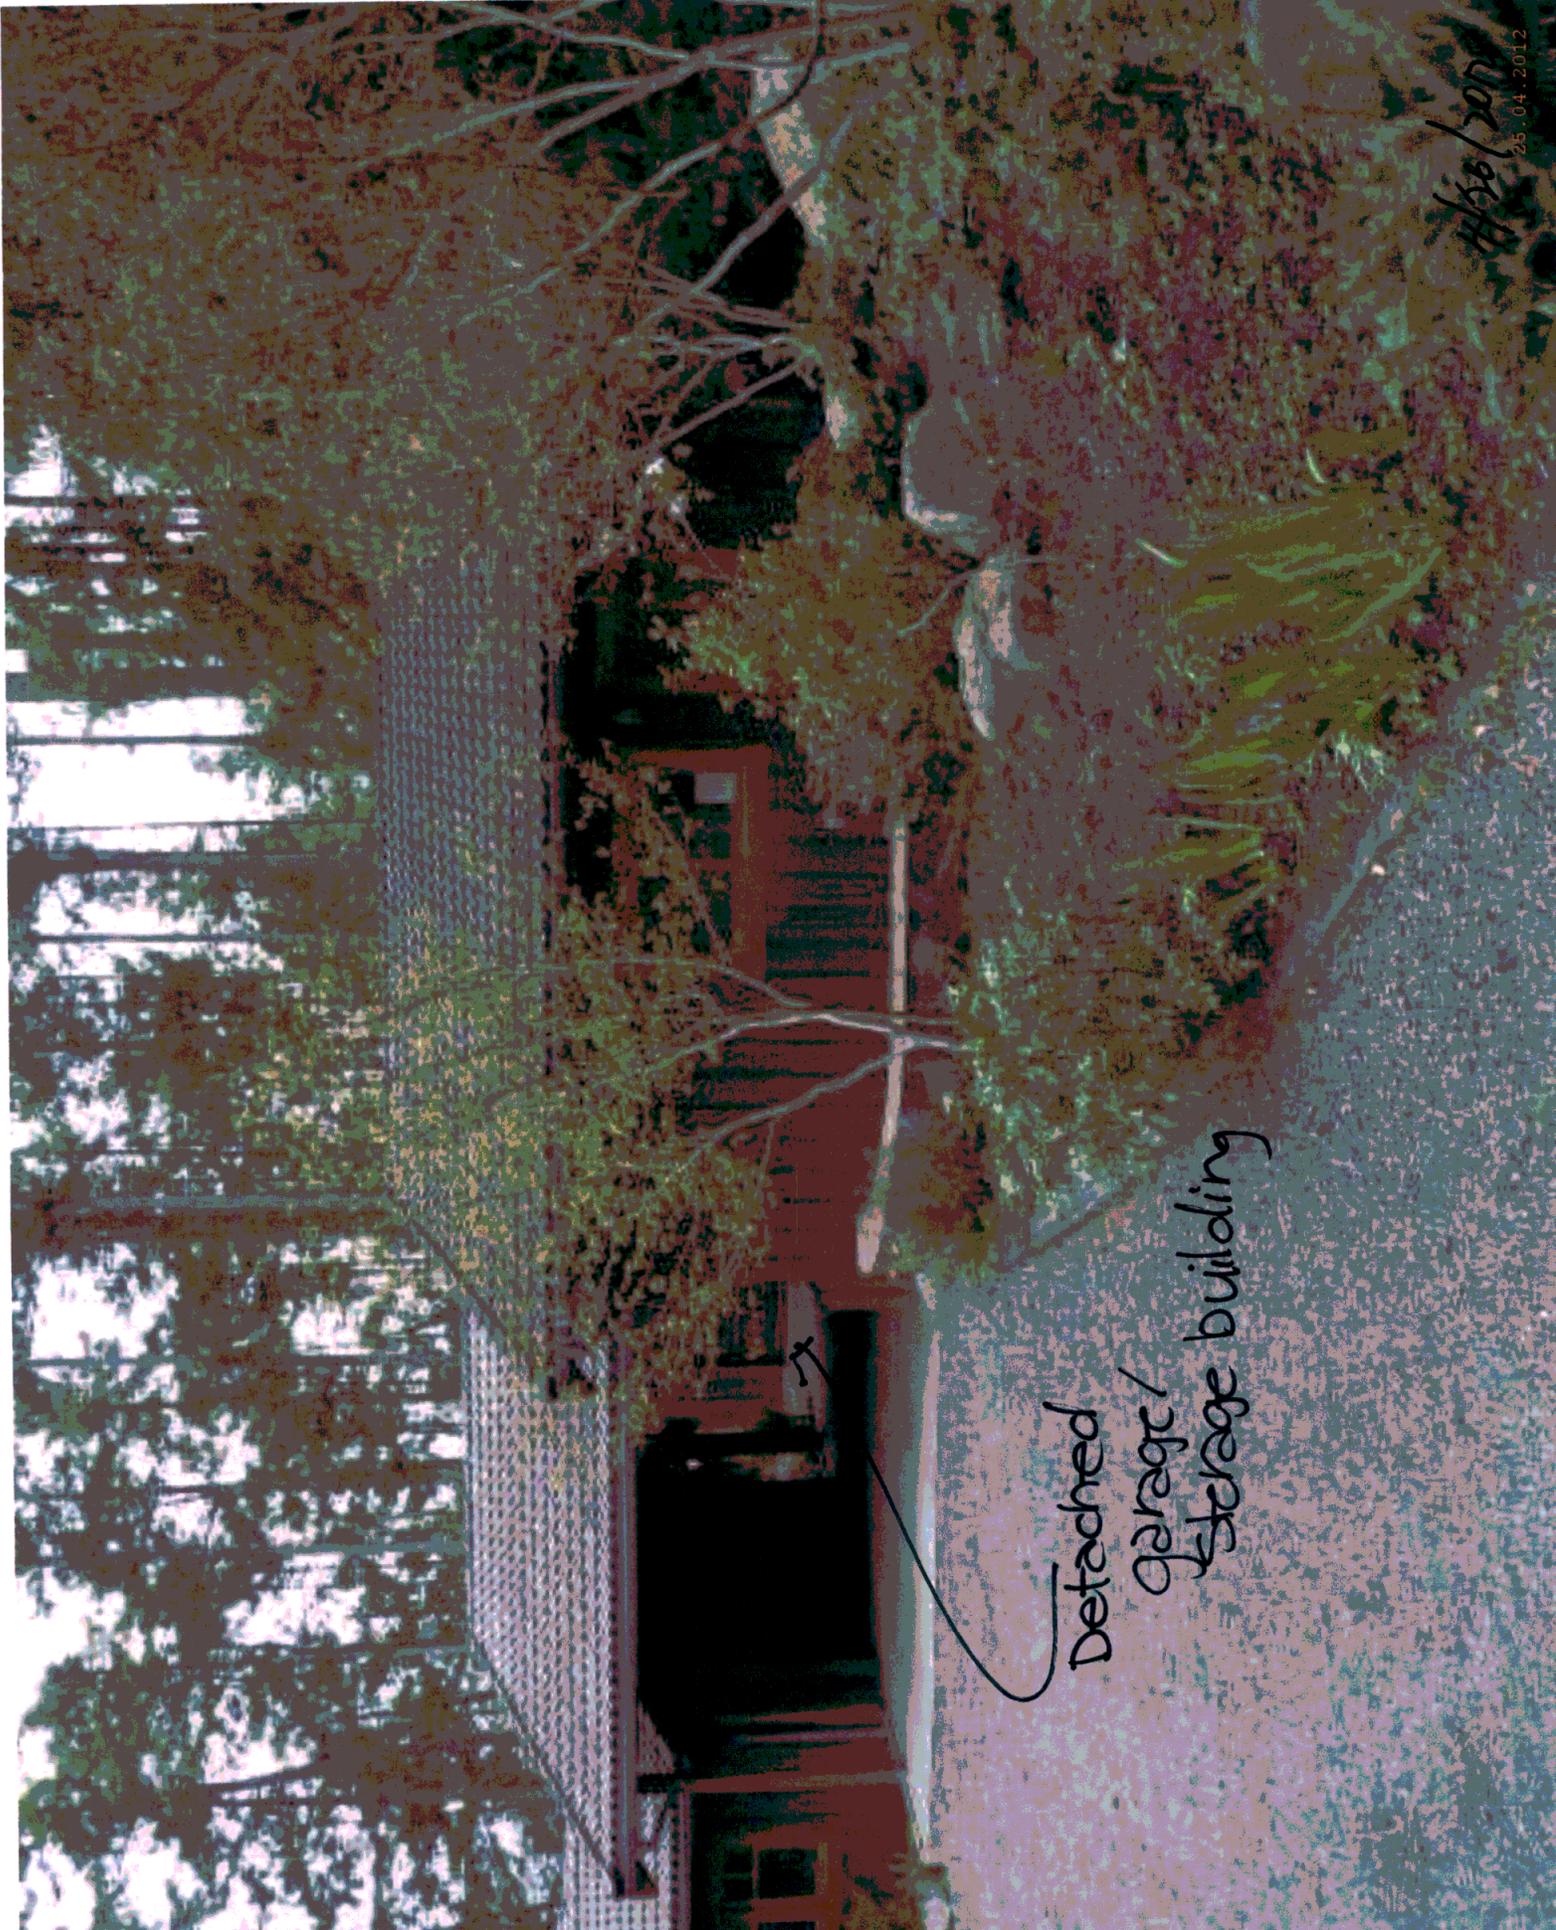
Detached  
garage/  
Storage building
