WDFW CASE # WA-11-001018

RUNSTAD HYDRAULIC (HPA) VIOLATION
TABLE OF CONTENTS

WASHINGTON STATE
DEPARTMENT OF FISH AND WILDLIFE
INCIDENT REPORT

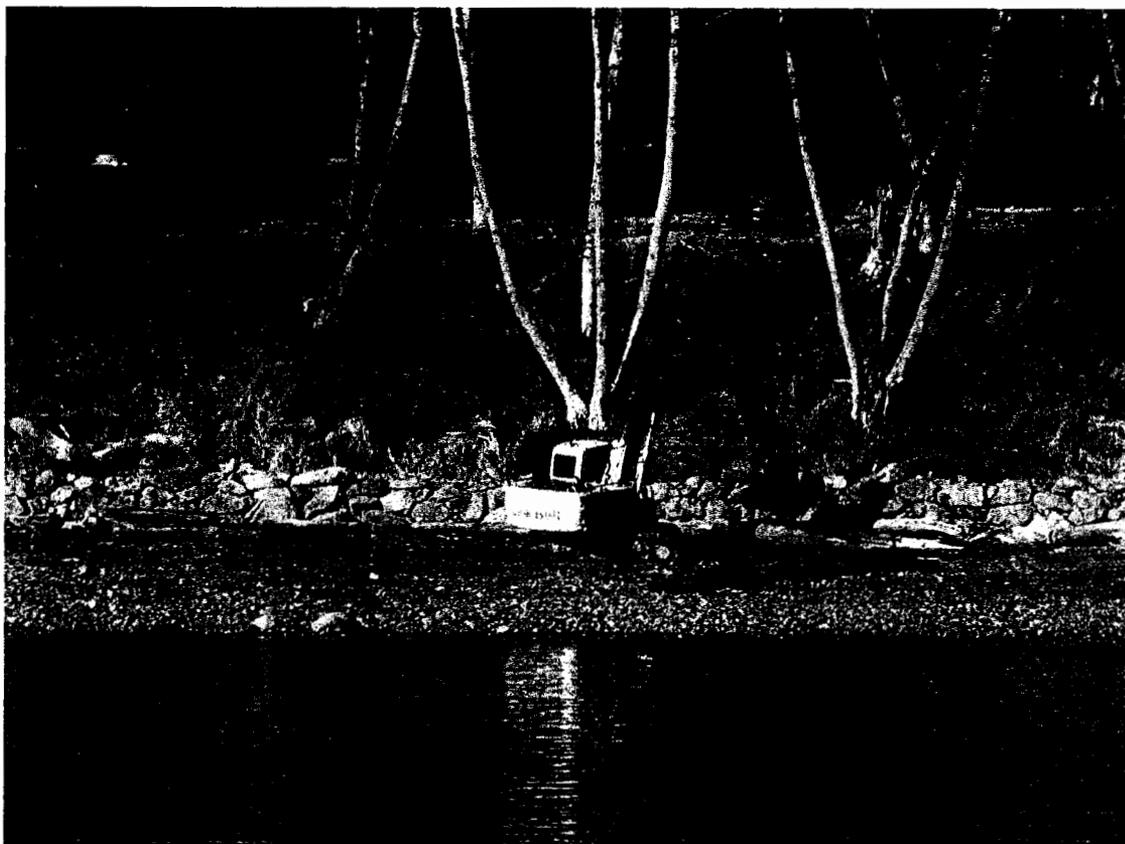
(Photograph of Excavator Working on Beach taken by Officer Rosenberger)

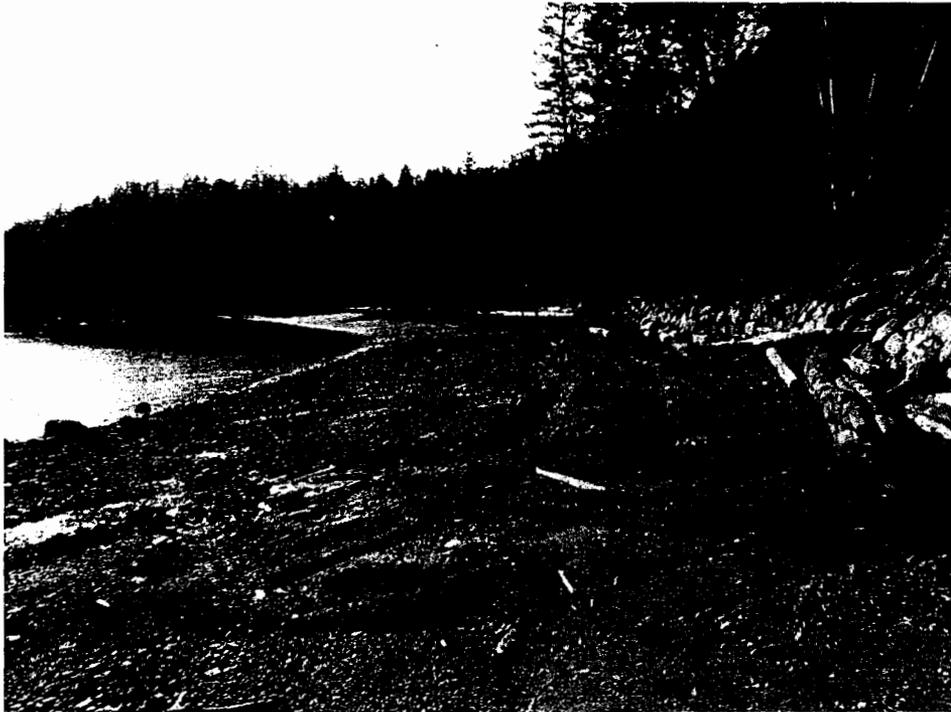
(Photograph of Beach Scaring taken by Officer Rosenberger)

There were areas where the natural substrate appeared to have been scrapped from the shore and others where it was evident that the natural material had been scooped away leaving large depressions on the beach.

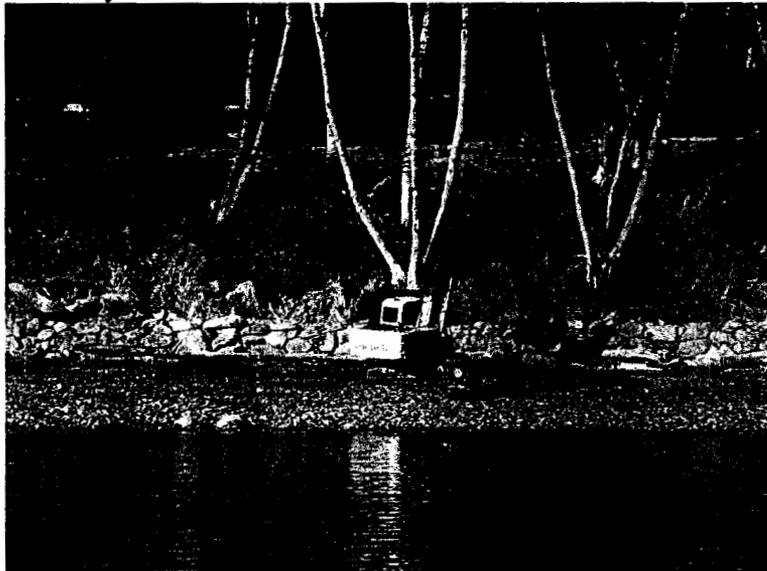
along the beach on the southern end of Blakely Island. (*The MHHW is the tidal elevation obtained by averaging each days highest tide at a particular location for a period of 19 years.*) From my observations it appeared as though the excavator was being used to smooth out the beach. A large log was grasped in the bucket as the operator moved the bucket back and forth. The log was then placed next to the rock wall. I photographed the excavator at work from my patrol vessel within the bay.

Photo taken by Officer Rosenberger 2-10-11 at approximately 1400 hours.

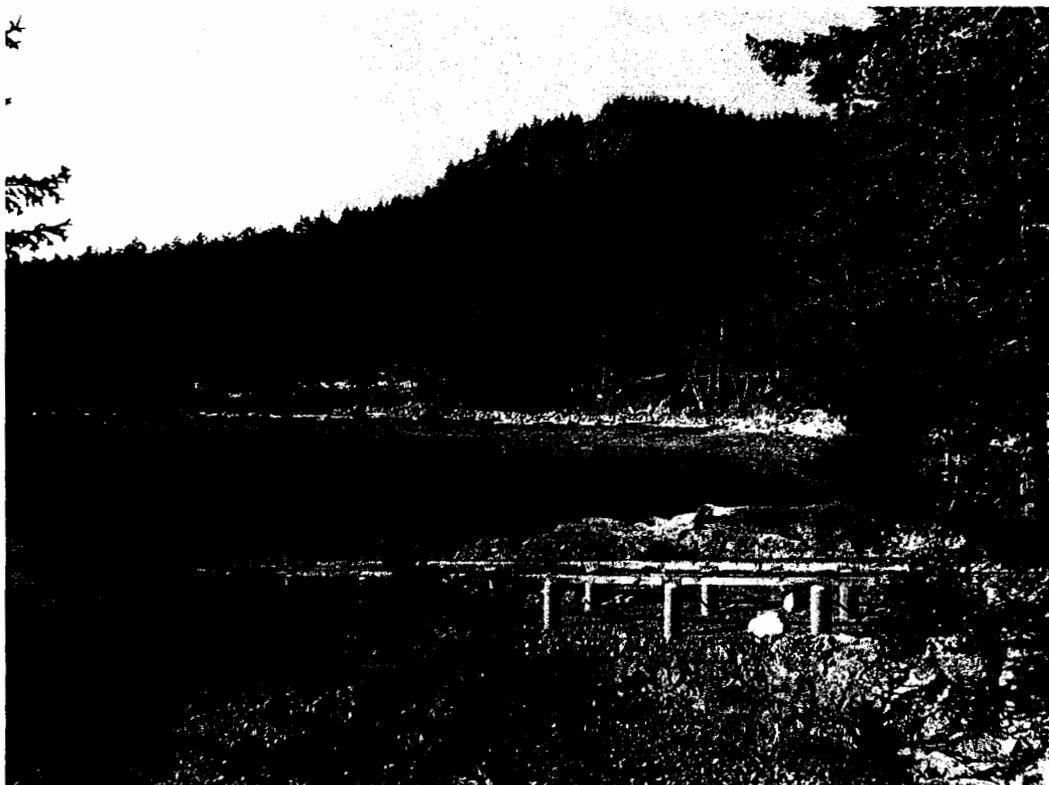
Photo taken on 2-10-11 by Officer Rosenberger

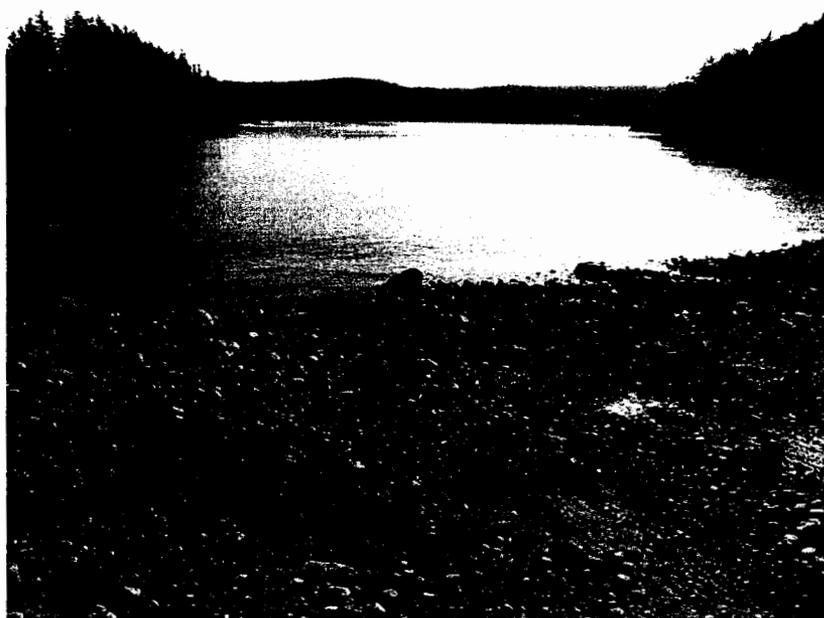
Photo taken by Officer Rosenberger 2-10-11. Construction activity evident on beach bed.

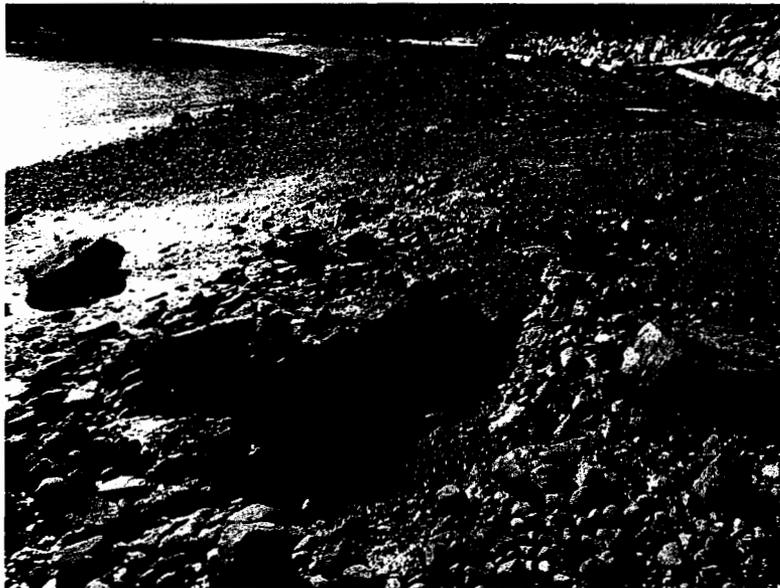
Photo taken by Officer Rosenberger 02-10-11. Hole dug in beach bed.

As Officer Capelli and I inspected the holes and scrape marks along the beach we believed that beach material have been used to construct the bulkhead. Officer Capelli again asked NEEDHAM if material from the beach had been used to construct the bulkhead. NEEDHAM stated that it was not. I then walked over to the rock bulkhead and inspected it. I observed that much of the large boulders making the wall itself appeared to have come from a quarry and had not been subjected to a marine environment for long. However smaller rocks fit between the larger rocks as well as gravel used to fill in on top of the bulkhead appeared to be from the beach, as evident by the barnacles and algae attached to many of the rocks. I informed NEEDHAM of my discovery. NEEDHAM conceded that it appeared as though some material from the beach was used after all. I asked if he had used a sub contractor to do the construction on the bulkhead. NEEDHAM stated that his sub contractor for the rock work was Orcas Excavators. I continued to photograph the bulkhead as we conversed.

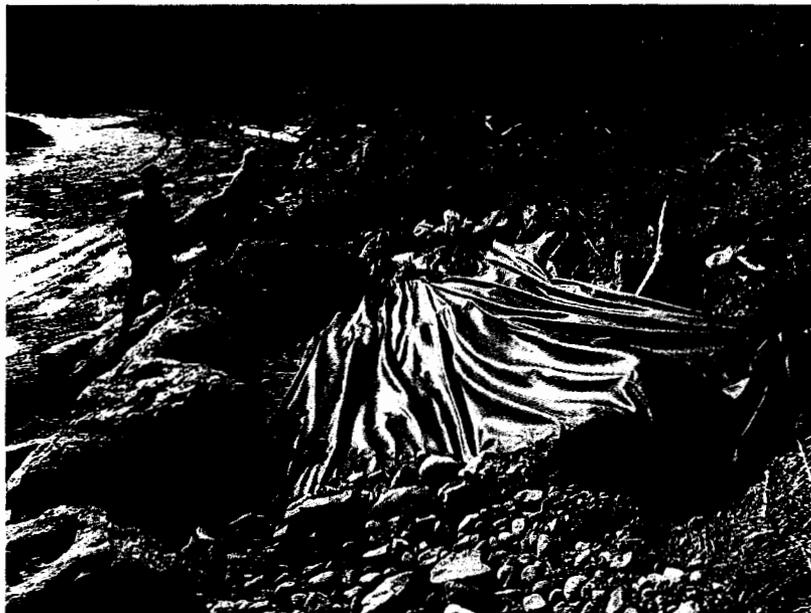
Photo taken by Officer Rosenberger. Officer Downes and Capelli inspect rock bulkhead. Gravel and rocks on top of plastic contained barnacles and algae.

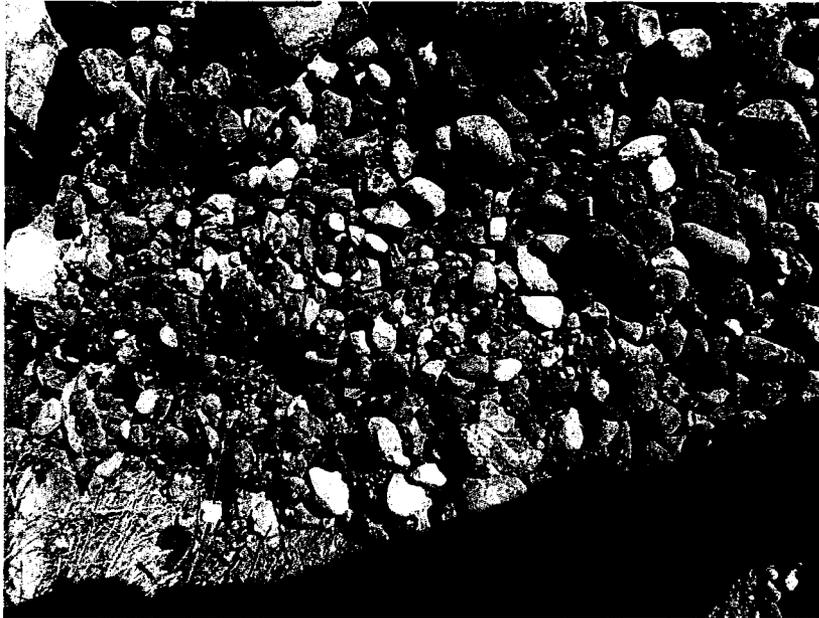
Photo taken by Officer Rosenberger. Close up of beach material on top of bulkhead. Multiple rocks containing barnacles and algae.

As I continued to inspect to bulkhead I observed that where NEEDHAM stated the wash out had occurred dirt was spread over the gravel and small rock atop the bulkhead. A ramp of drift wood and beach material had been constructed on the waterside base of the rock bulkhead allowing machinery to work on the uphill side of the bulkhead. All along the beach where the excavator had been operating large ruts from the machines tracts had torn up the beach well below the high water mark.

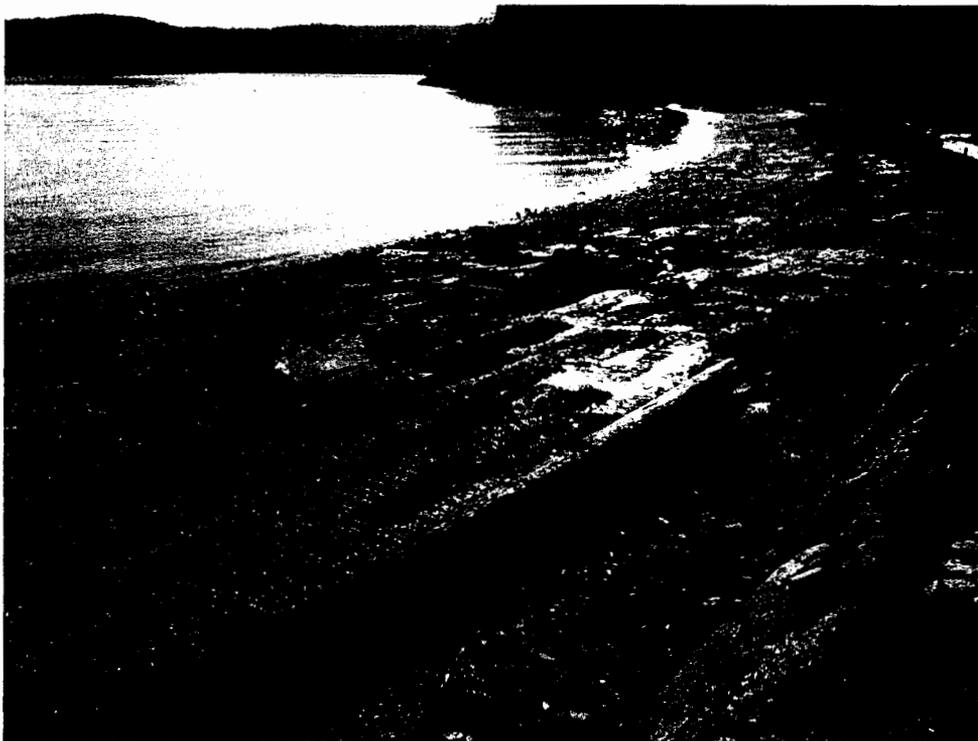
Photo taken by Officer Rosenberger on 02-10-11. Ramp visible at base of rock bulkhead. Large ruts from excavator visible along the beach.

Continuing toward the boat ramp we inspected another section of bulkhead where NEEDHAM initially stated that rock from excavating one of the residences foundation was used. I observed that a relatively small amount of rock appeared to have been excavated from the ground, the majority appeared to have been removed from the beach. Many of the rocks contained a significant number of barnacles attached to them. The barnacles must have been attached to the rocks prior to them being put in place because they were placed well above the high tide mark. Rock used to build up the boat ramp adjacent to this bulkhead appeared to have been introduced to the beach area recently due to its color and lack of barnacles or algae.

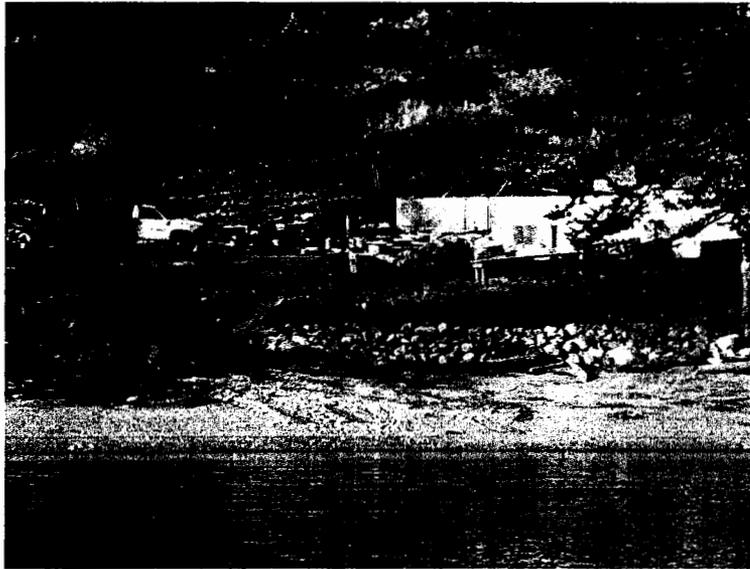
Photo taken by Officer Rosenberger from his patrol vessel on 2-10-11. Boat ramp and bulkhead visible.

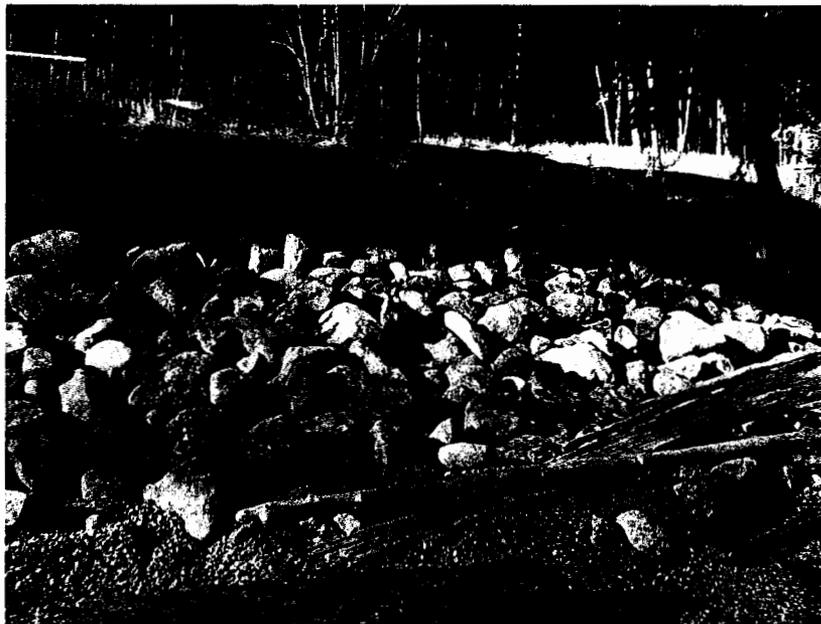
Photo taken by Officer Rosenberger 2-10-11. Closer view of bulkhead next to boat ramp containing several rocks with barnacles attached.

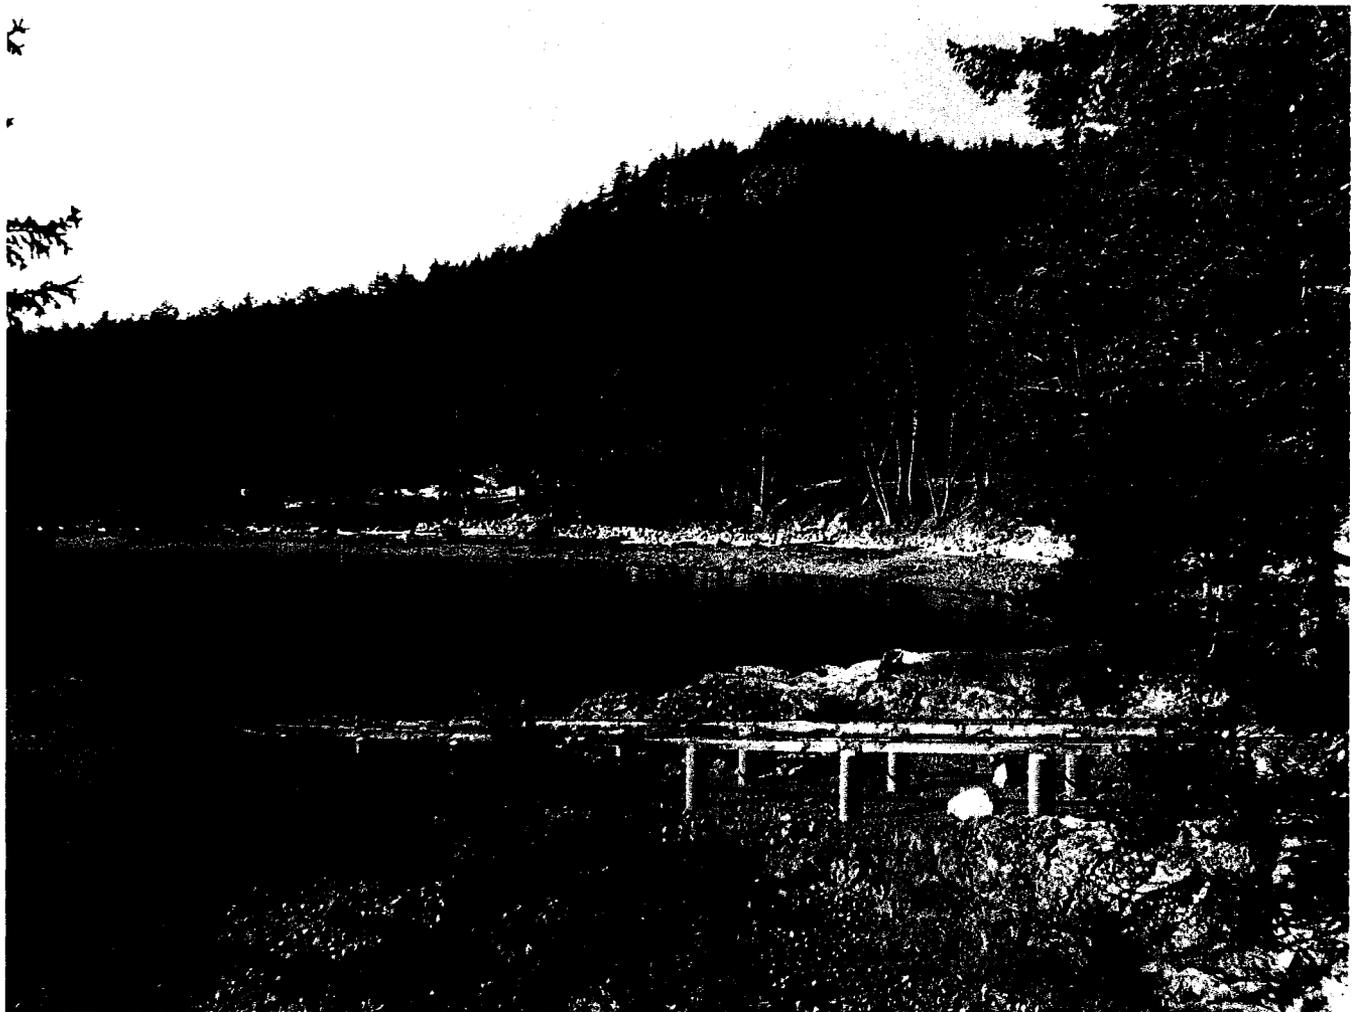
(W175 PHOTO 3)

(See Attached Officer Rosenberger PHOTO 3)

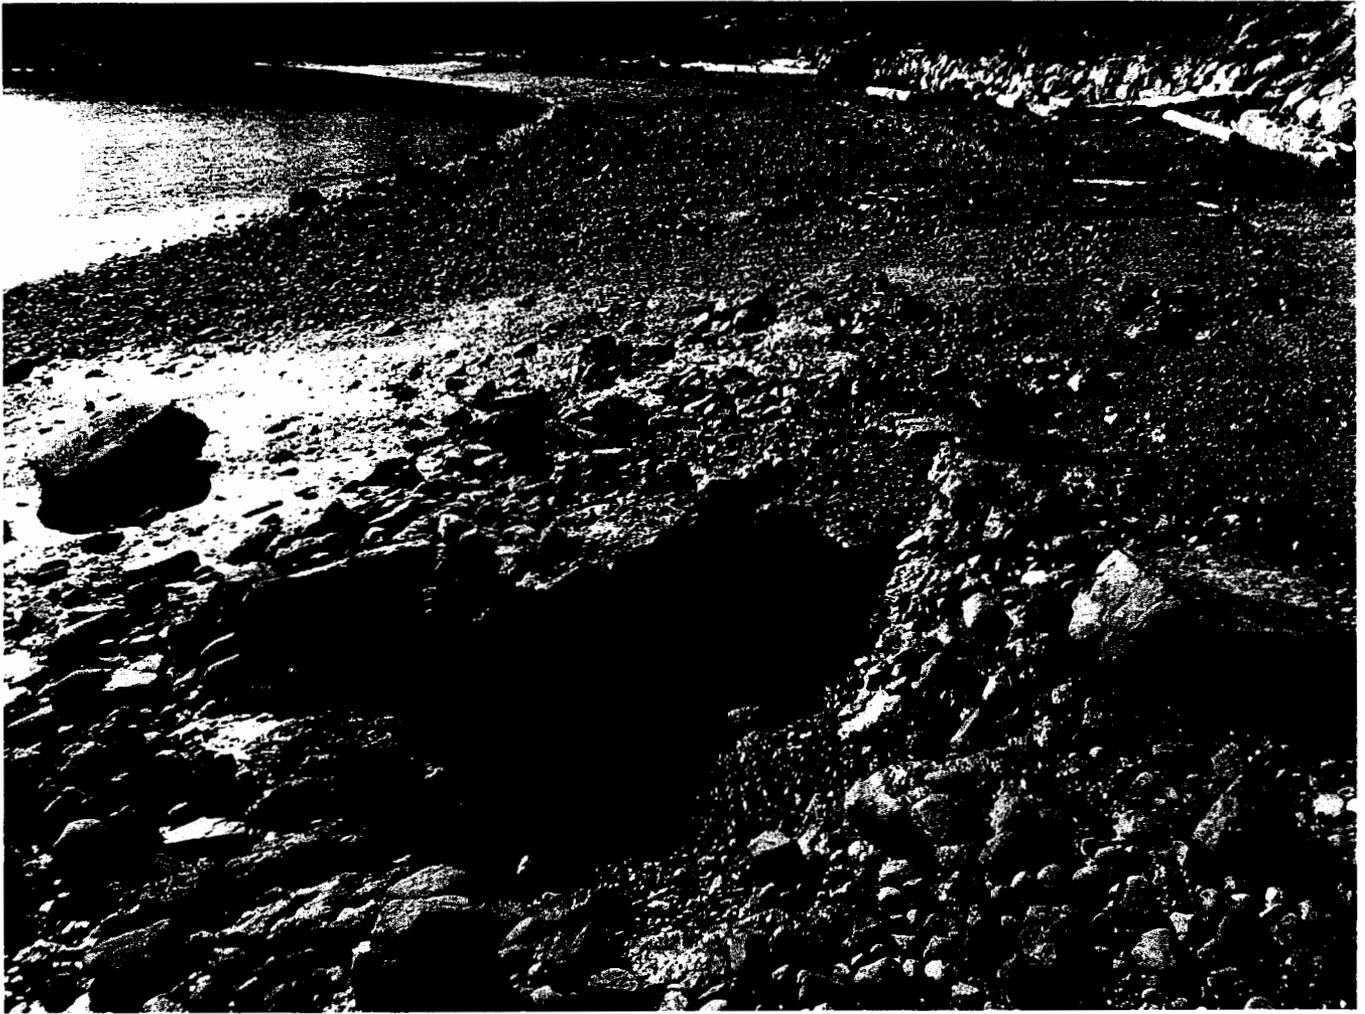
(W175 PHOTO 4)

(See Attached Officer Rosenberger PHOTO 4, 5, 6, 8 and 10)

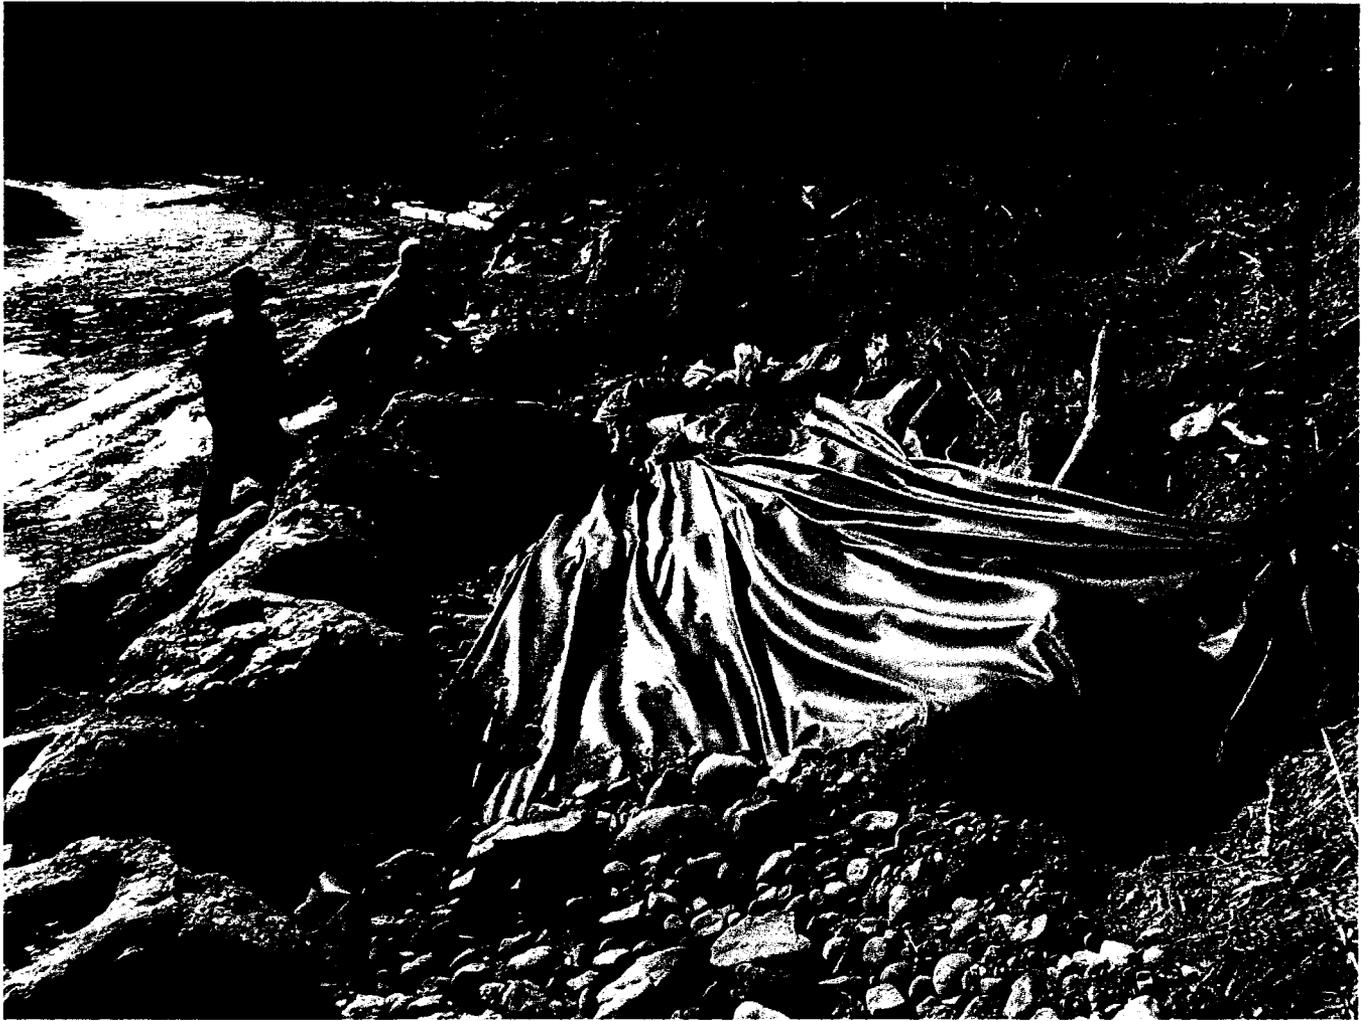
(W175 PHOTO 7)

Our inspection also found that, contrary to NEEDHAM's claims, beach materials had been used during the construction of the face of the wall as well as backfill behind the wall. This fact was evident by the presence of attached barnacles and visible marine algae.

(See Attached Officer Rosenberger PHOTO 7 and 12)

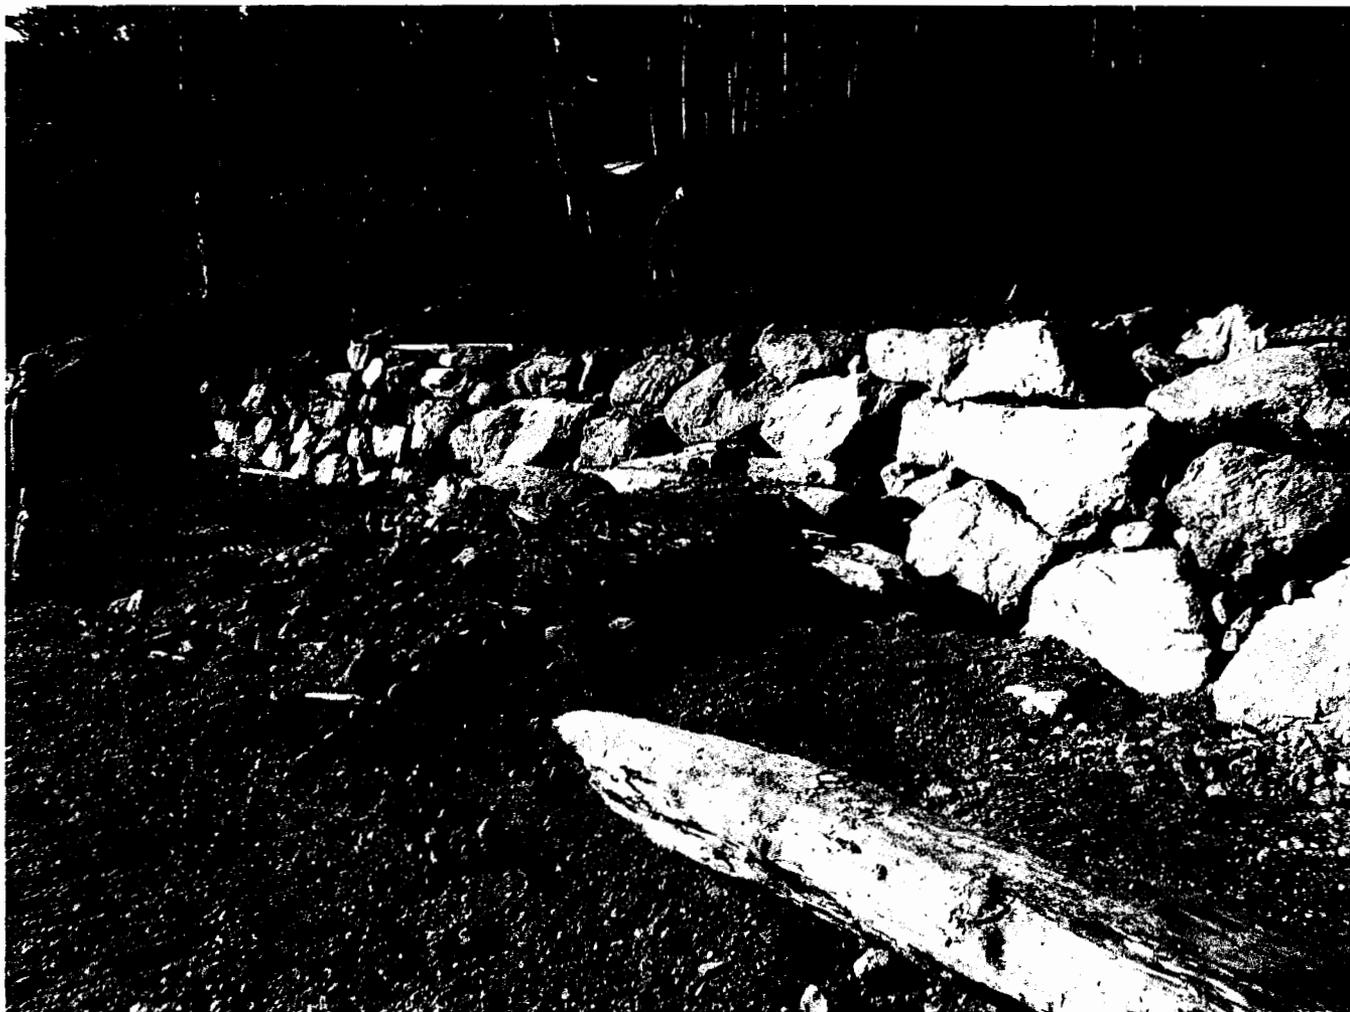
(W175 PHOTO 9)

We observed other areas of the beach where it was clear that natural substrate and woody debris had been removed and deposited at the base of the wall.

(See Attached Officer Rosenberger PHOTO 9 and 11)

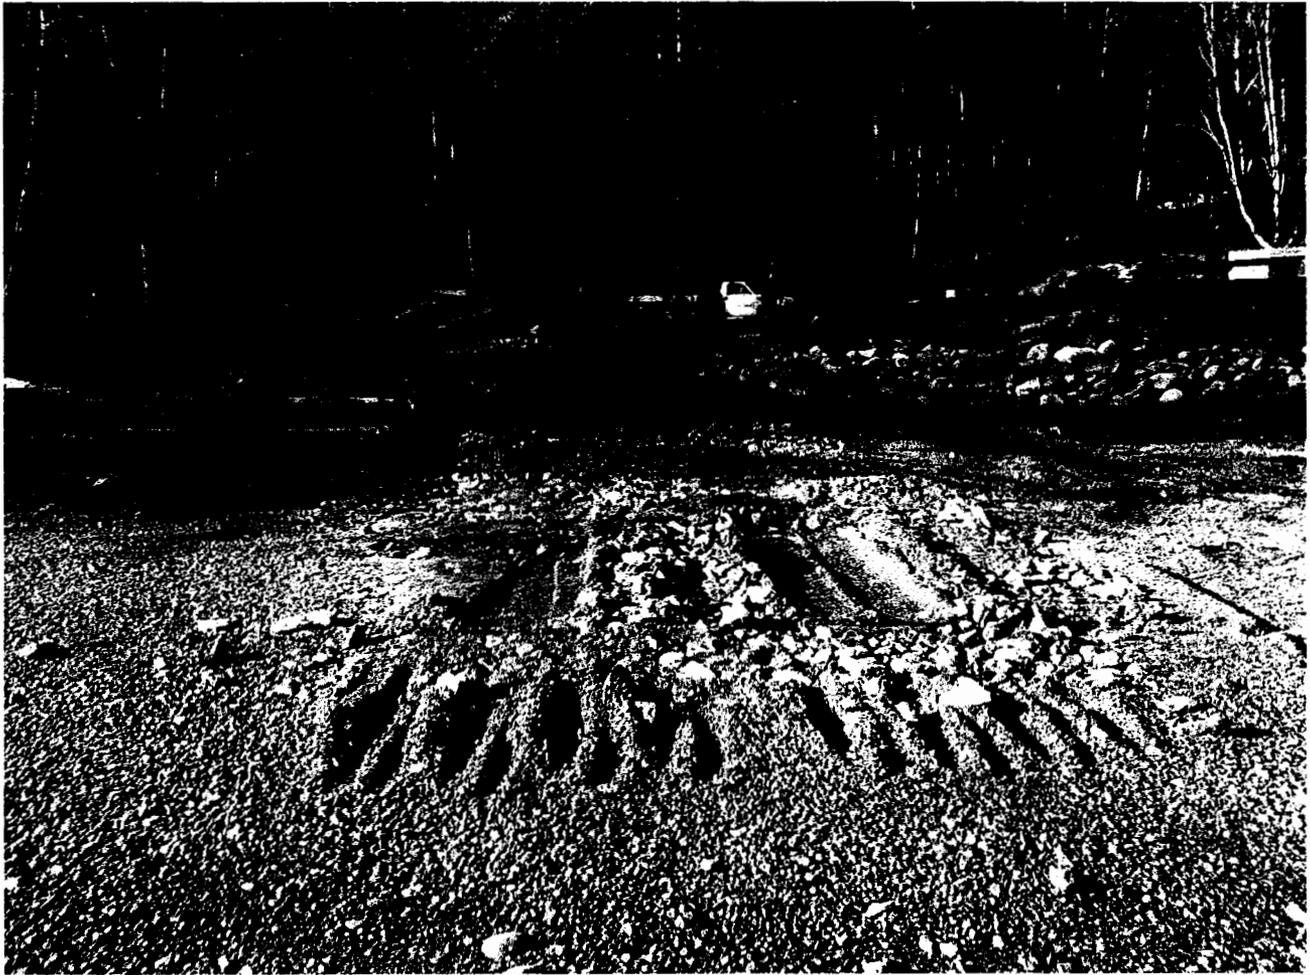
(W175 PHOTO 13)

NEEDHAM stated that he had been told that the landing area or ramp had been in use for years. When asked regarding the obvious addition of materials to the area, he said that rock had been added to help with the landing of the vessel and movement of equipment up and down the beach. (See Attached Officer Rosenberger PHOTO 13)

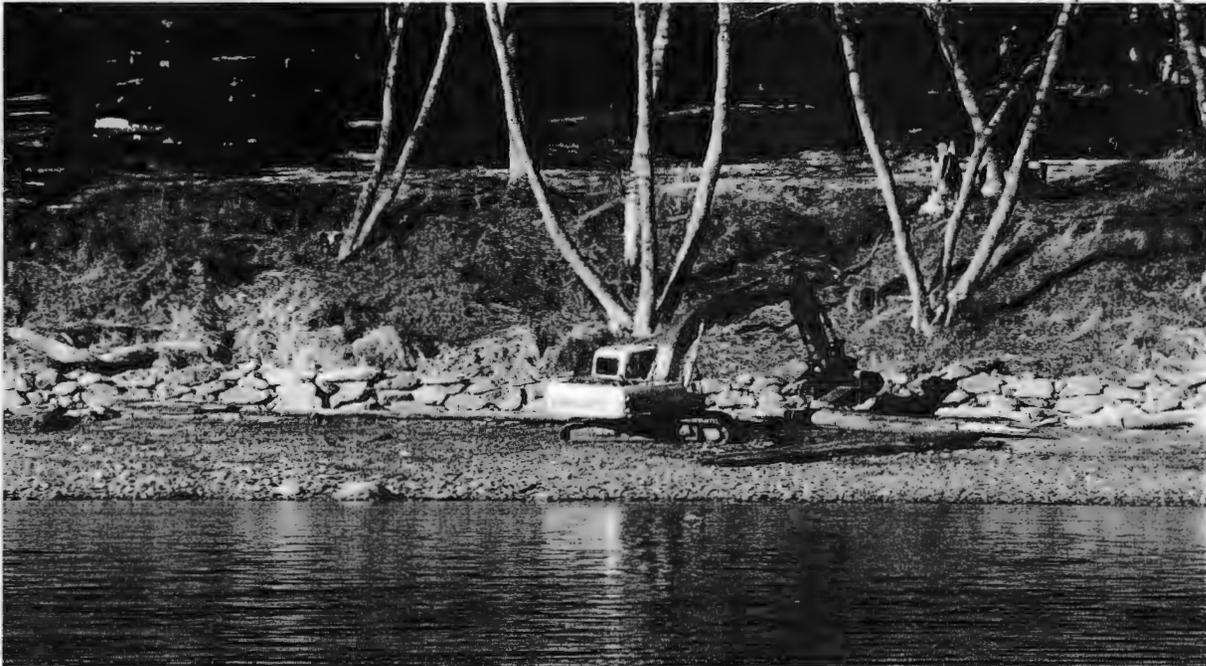
PHOTO 1: Enforcement photo of equipment operating on beach and constructing non-permitted bulkhead.

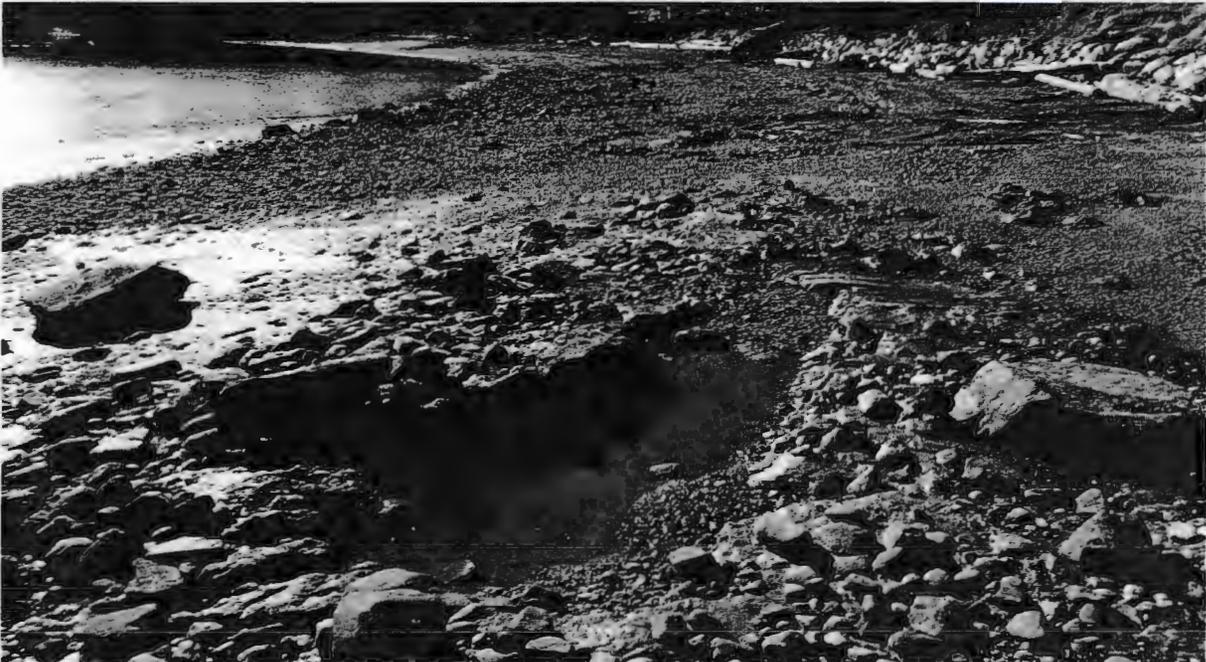
PHOTO 2: Enforcement photo showing large boulder recently removed from beach. May have been used in bulkhead construction.

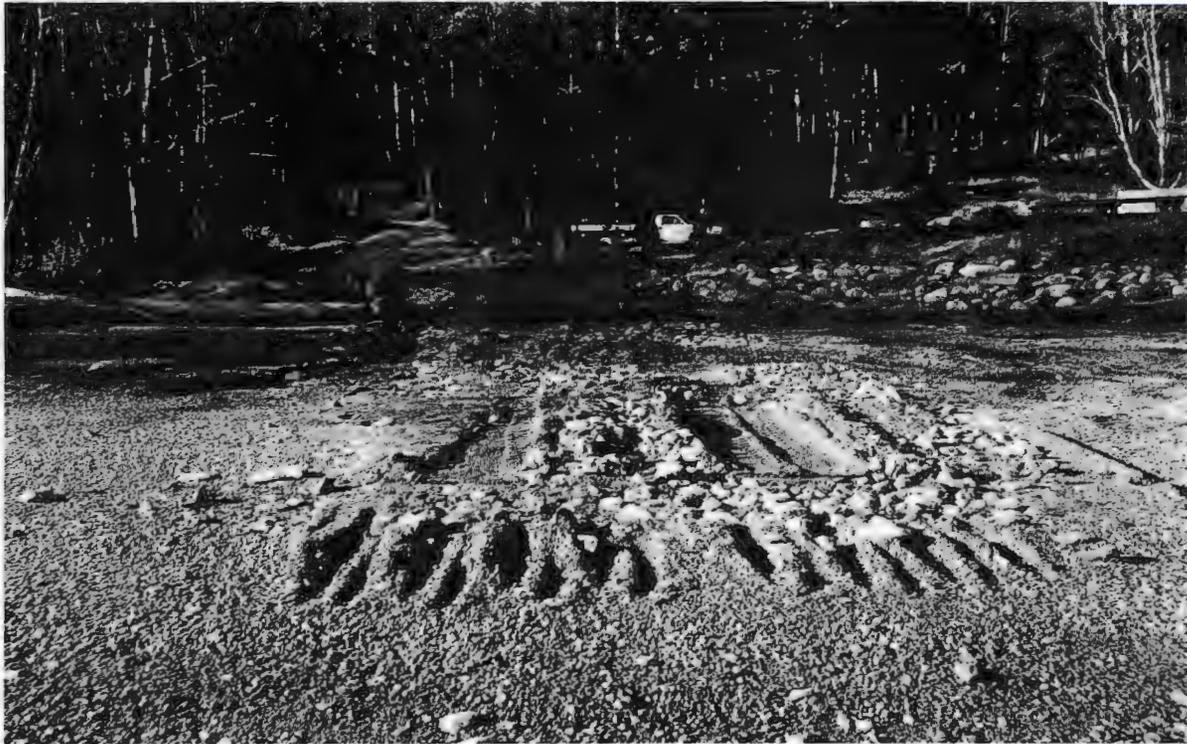
PHOTO 3: Enforcement photo illustrating recent equipment activity on beach at soft boat ramp.

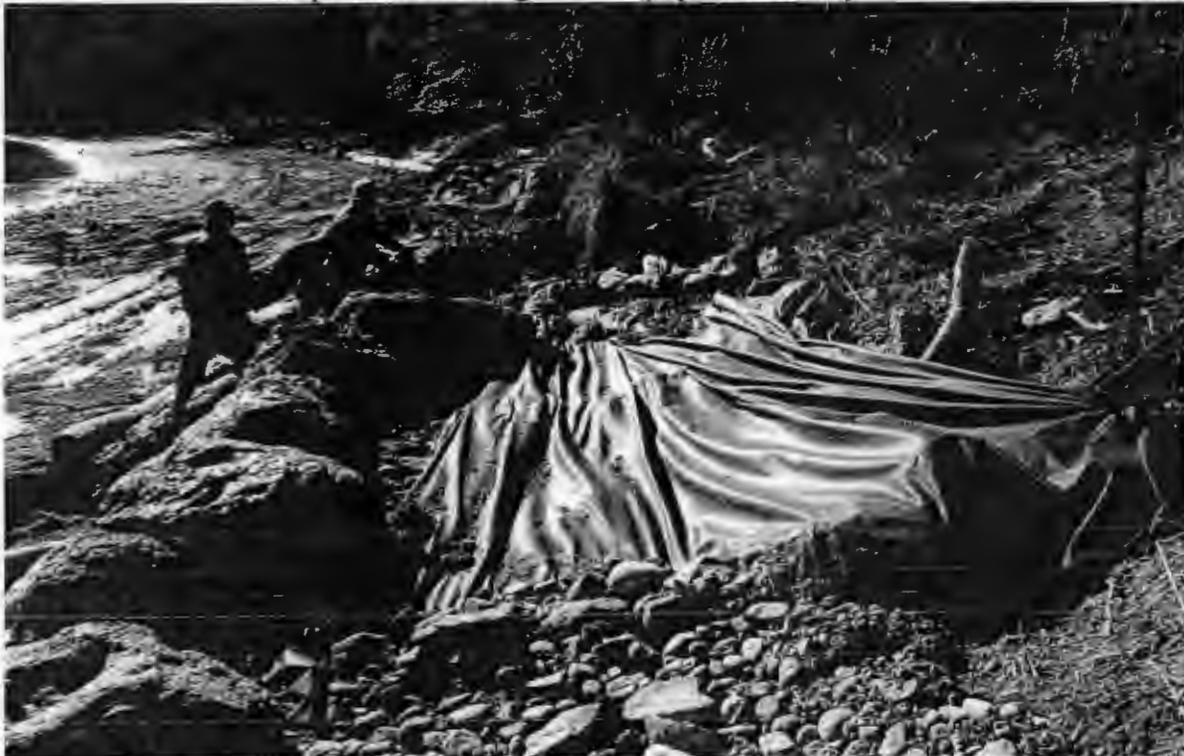
PHOTO 4: Enforcement photo showing construction of bulkhead.

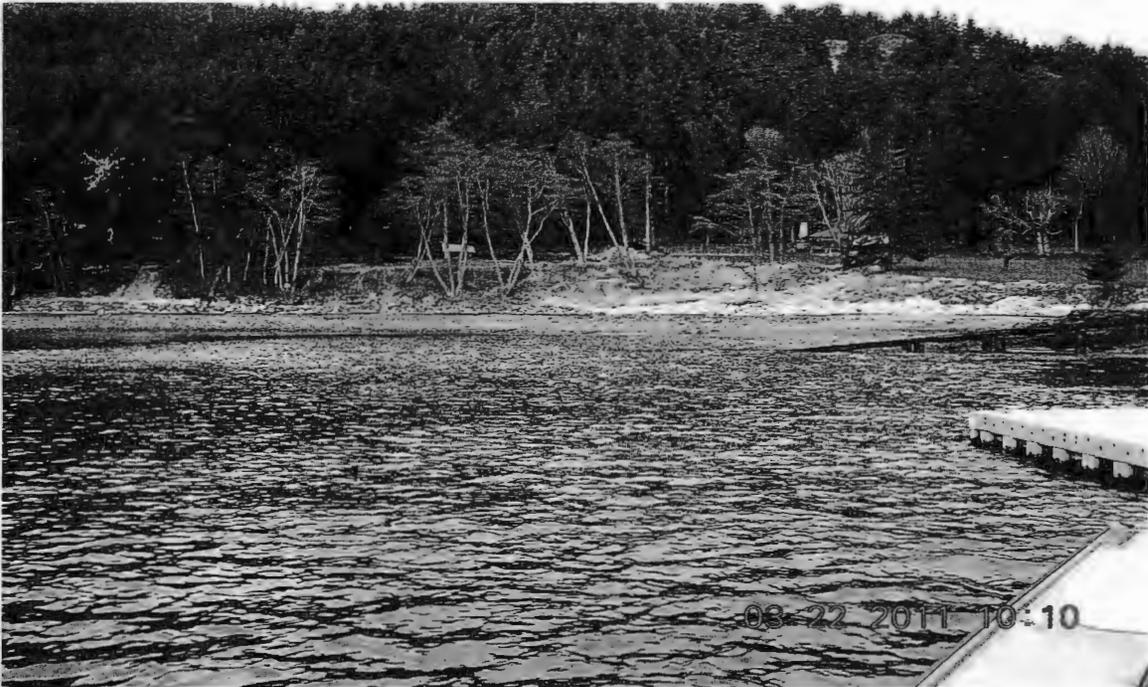
PHOTO 5: View from east (white rock on right) to west (gray rock on left). Older rock bulkhead is white and new bulkhead, which is gray, begins in middle of photo. Taken by Area Habitat Biologist.

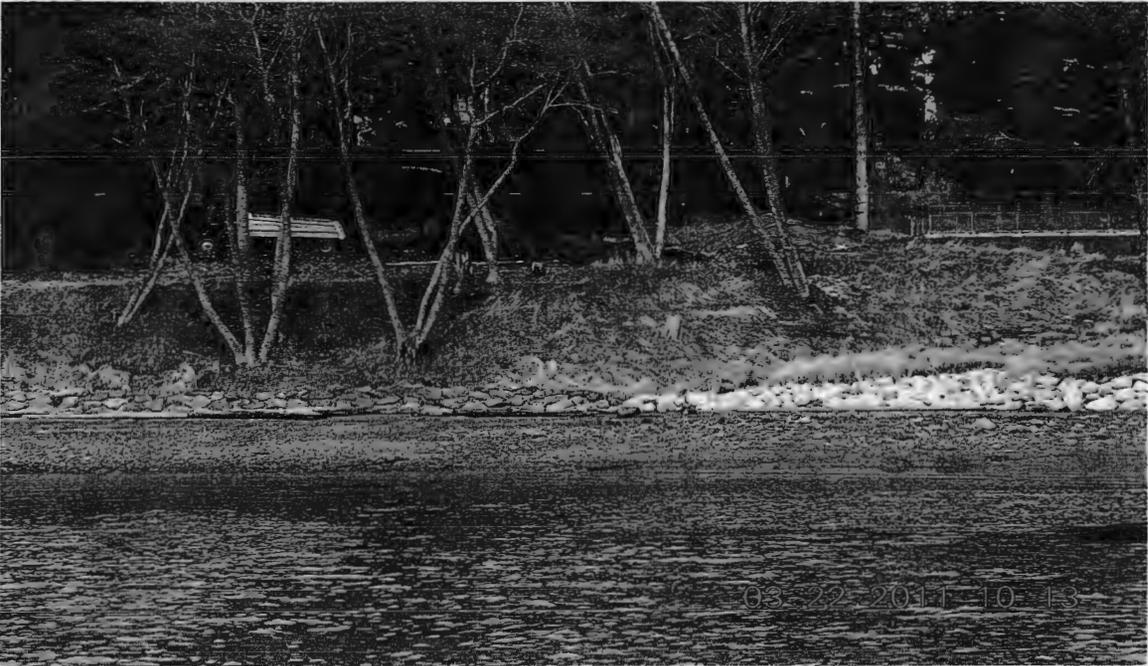
PHOTO 6: Close-up of intersection between new and older bulkhead location. Also illustrates end of Reach 2 (Total reach 218 lineal ft) and beginning of Reach 3 (Total reach 252 lineal ft). Taken by Area Habitat Biologist.

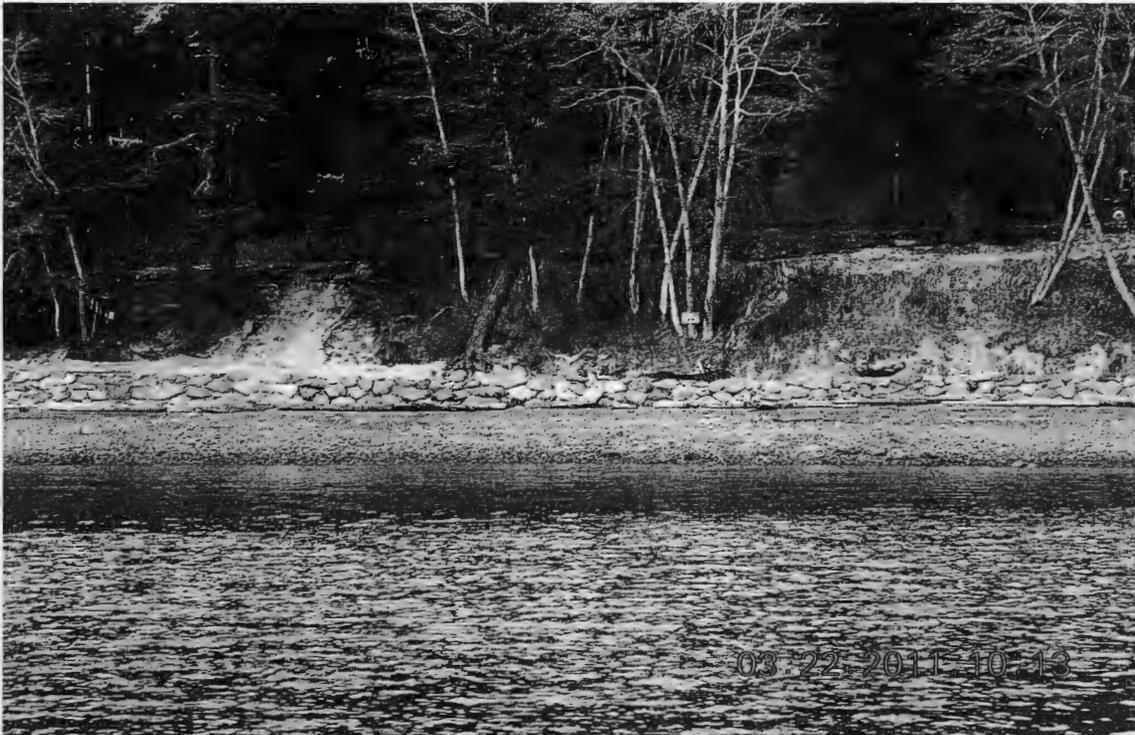
PHOTO 7: Portion of Reach 3 (Total reach 252 lineal ft). Taken by Area Habitat Biologist.

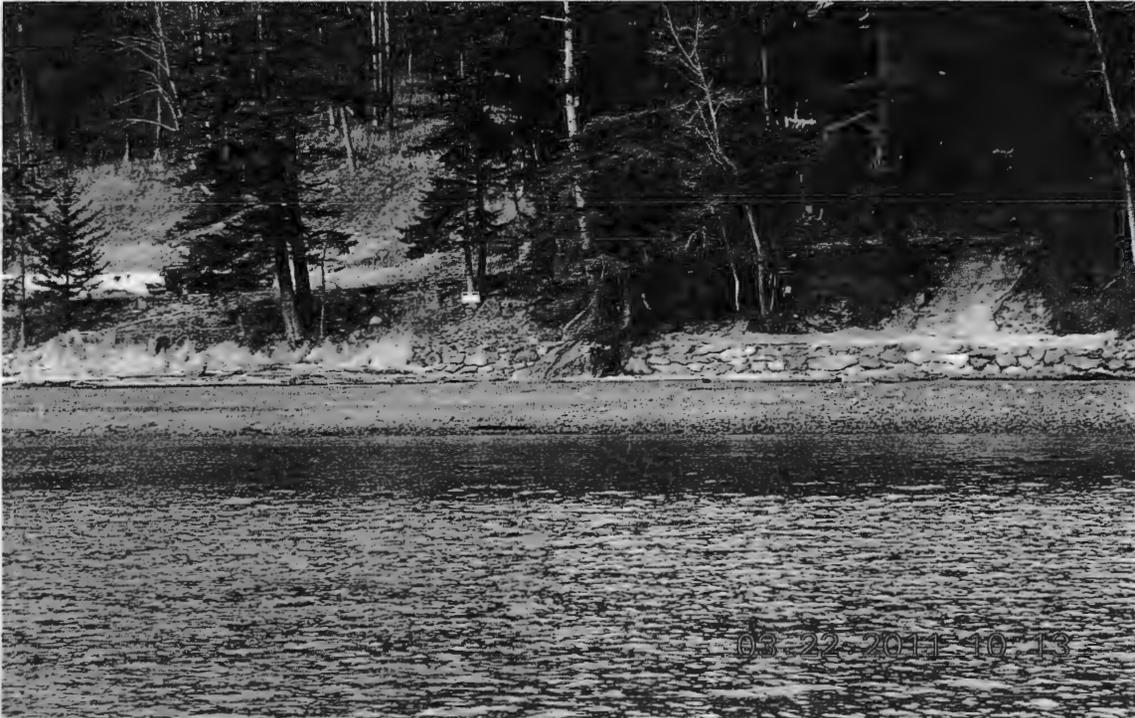
PHOTO 8: Reach 4 (Total reach 39 lineal ft) and Reach 5 (Total reach 82 lineal ft). Taken by Area Habitat Biologist.

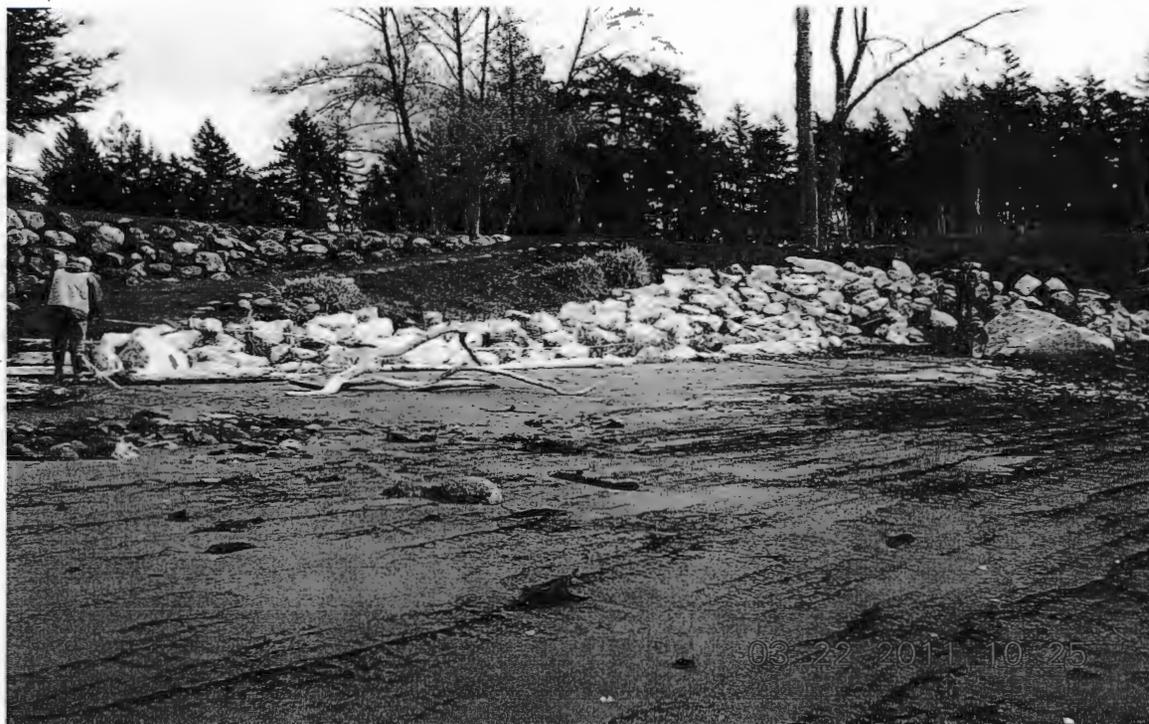
PHOTO 9: Portion of Reach 1 (Total reach 205 lineal ft), with older white bulkhead with established dune grass growing between some rocks. Taken by Area Habitat Biologist.
