WDFW CASE # WA-11-001018

RUNSTAD HYDRAULIC (HPA) VIOLATION
TABLE OF CONTENTS

WASHINGTON STATE
DEPARTMENT OF FISH AND WILDLIFE
INCIDENT REPORT

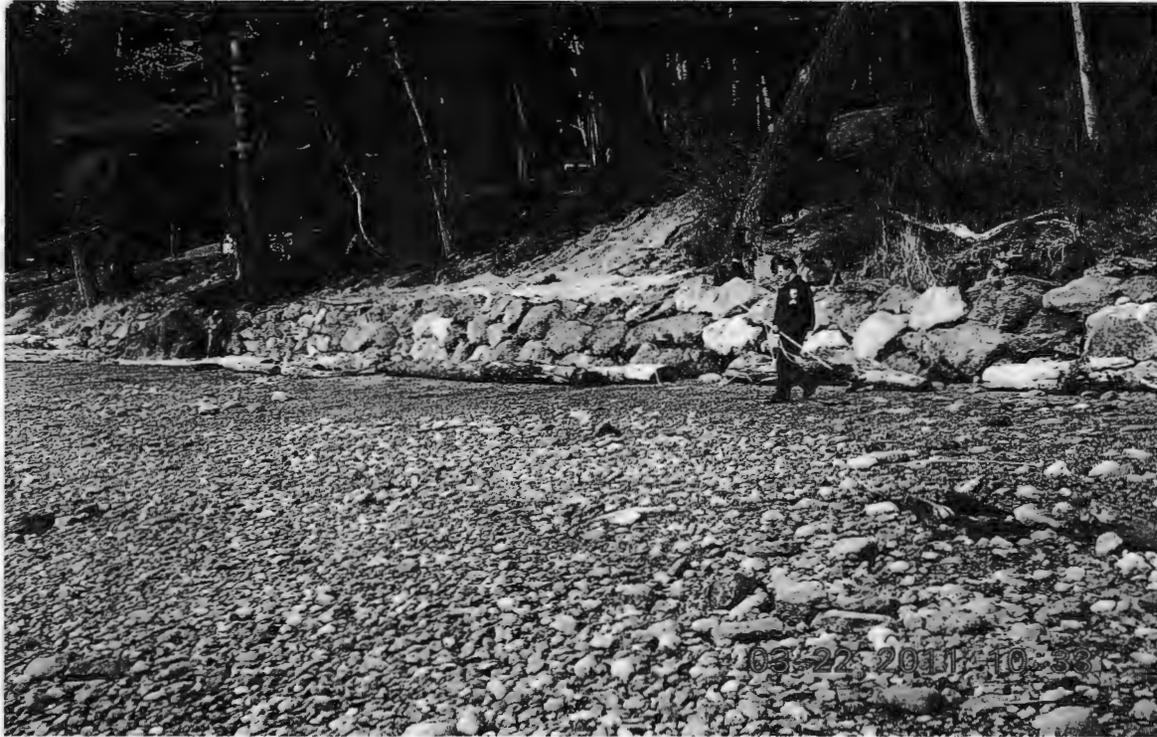
PHOTO 11: Brian Williams and Sgt. Mullins measuring Reach 3 (Total reach 252 lineal ft). Taken by Area Habitat Biologist.

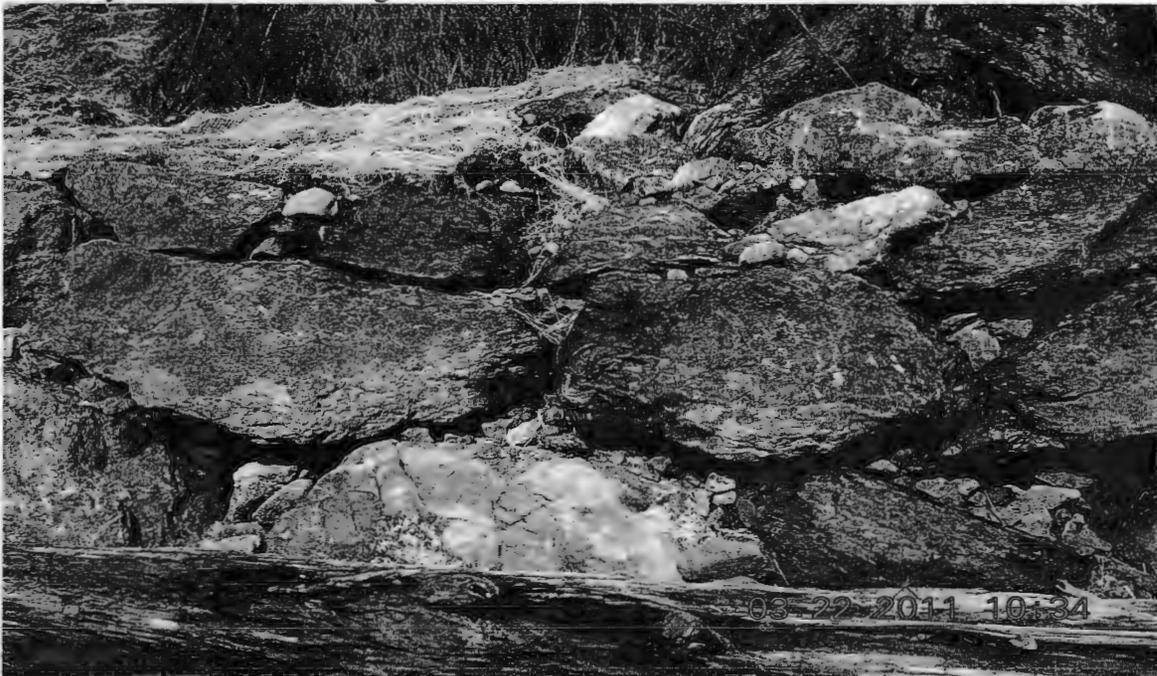
PHOTO 12: New bulkhead includes rocks that have barnacles present on rock face indicating rocks were taken from the beach. Taken by Area Habitat Biologist.

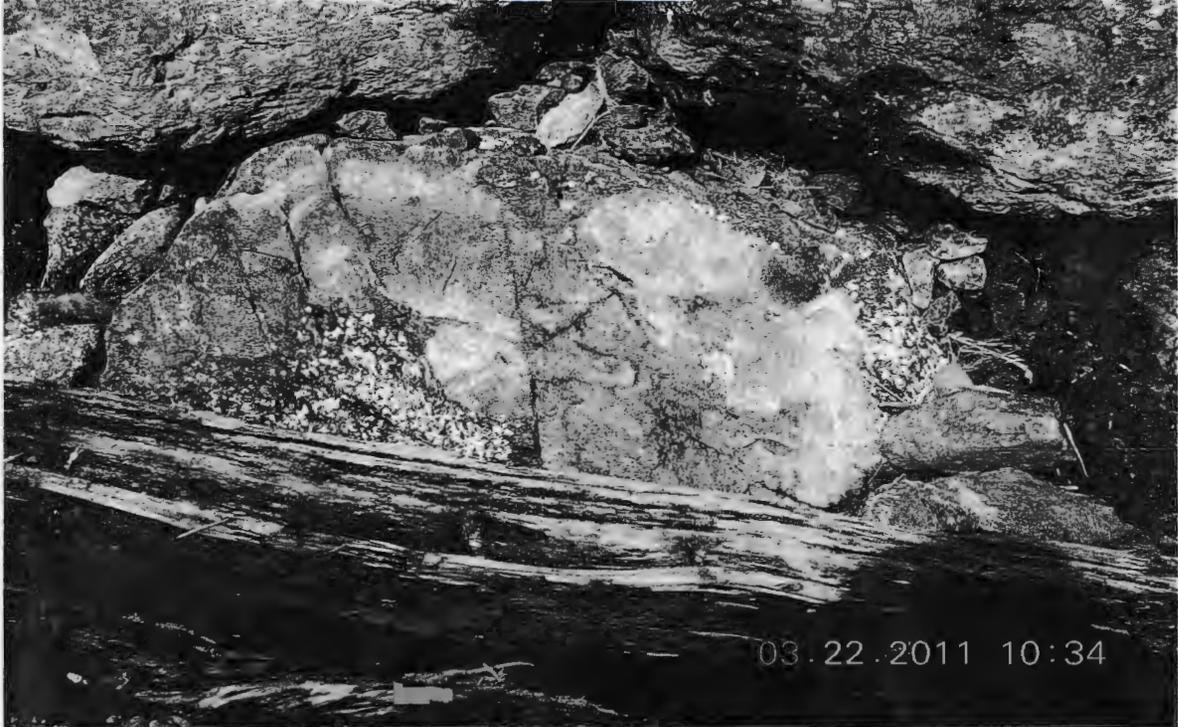
PHOTO 13: Close-up of barnacles on rocks. Taken by Area Habitat Biologist.

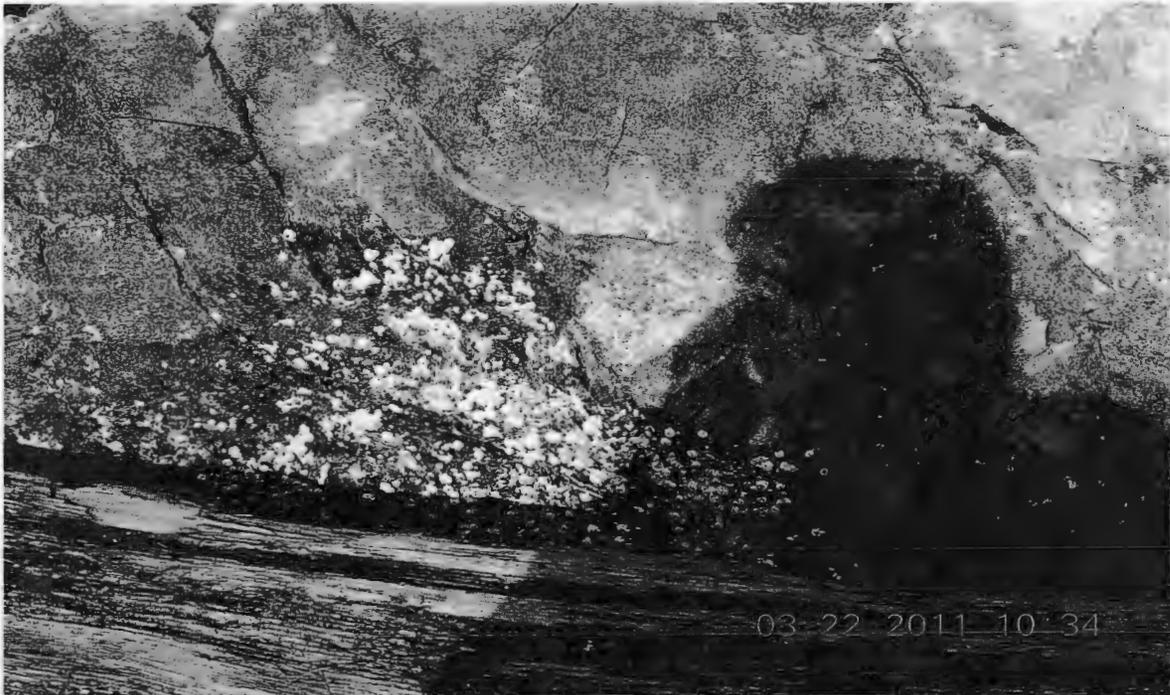
PHOTO 14: Barnacles on rocks. Taken by Area Habitat Biologist.

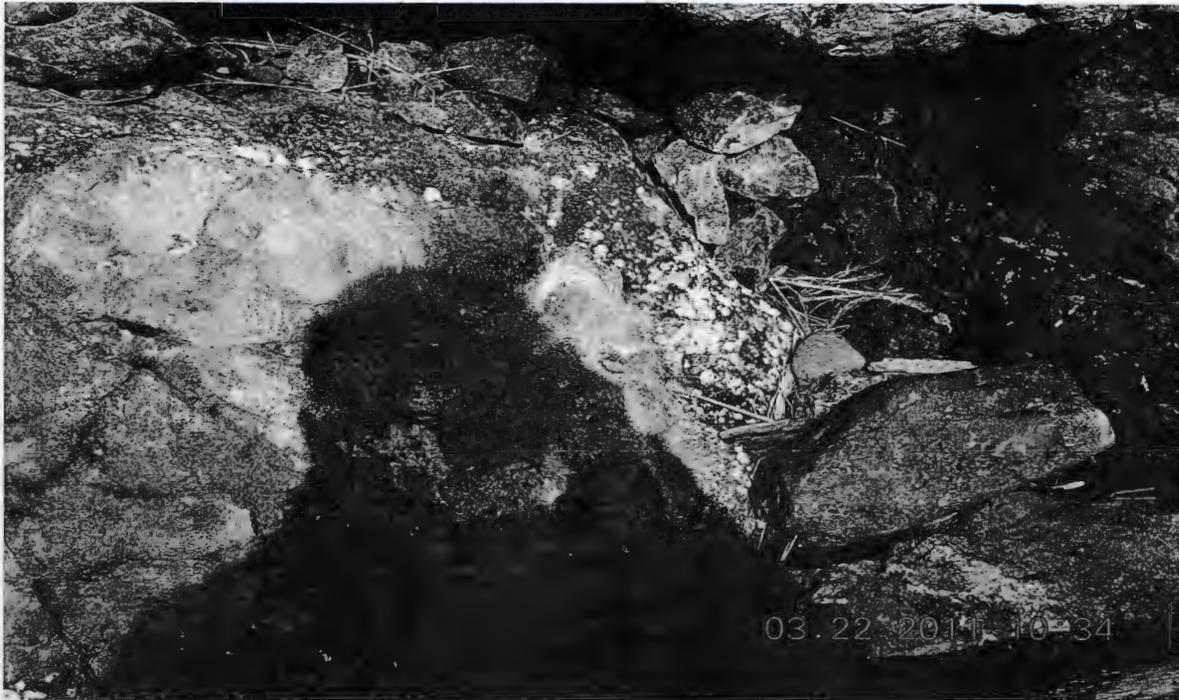
PHOTO 15: More barnacles on rocks. Taken by Area Habitat Biologist.

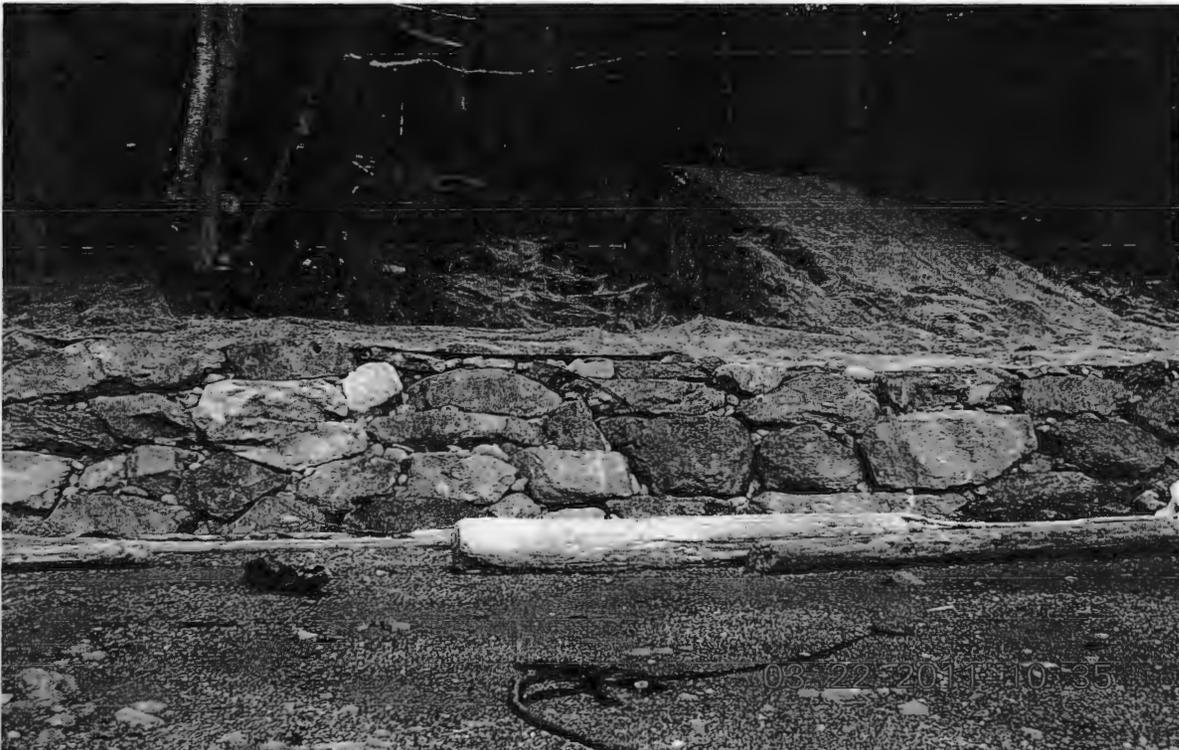
PHOTO 16: Portion of Reach 3 (Total reach 252 lineal ft) showing bankline work to minimize erosion. Taken by Area Habitat Biologist.

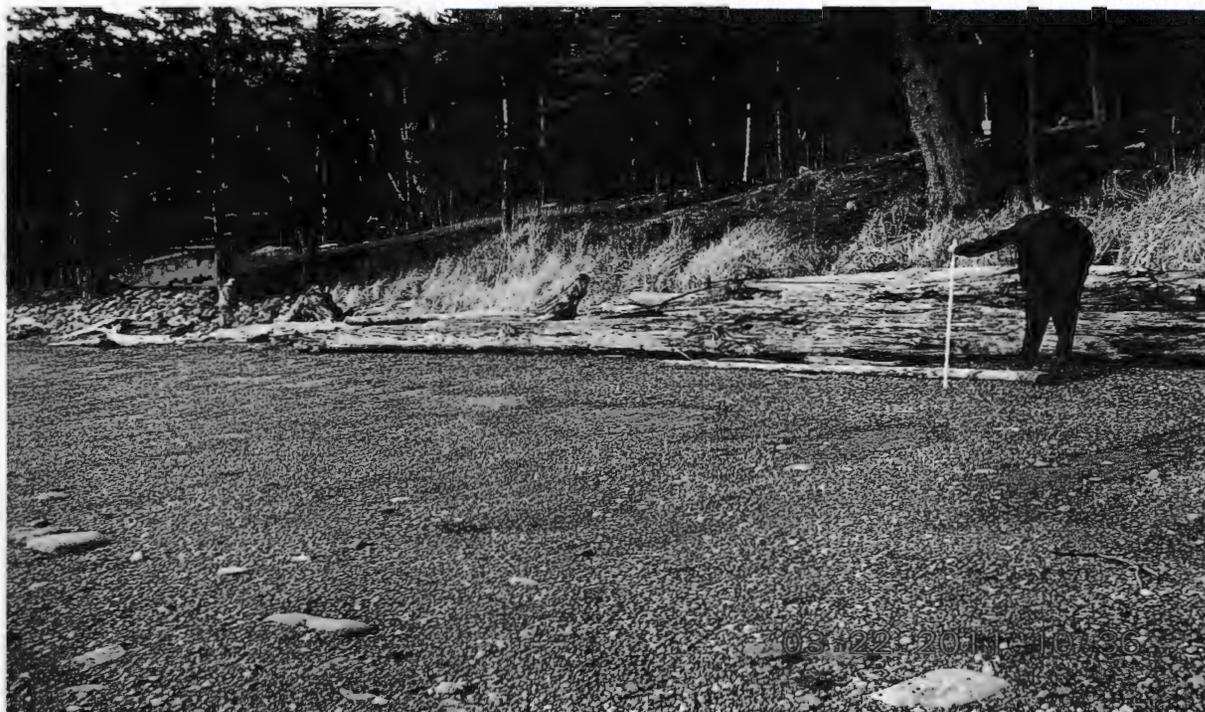
PHOTO 17: Reach 5 (Total 82 lineal ft) with undisturbed shoreline and illustrating what shoreline looked like along this stretch before bulkhead installation. Taken by Area Habitat Biologist.

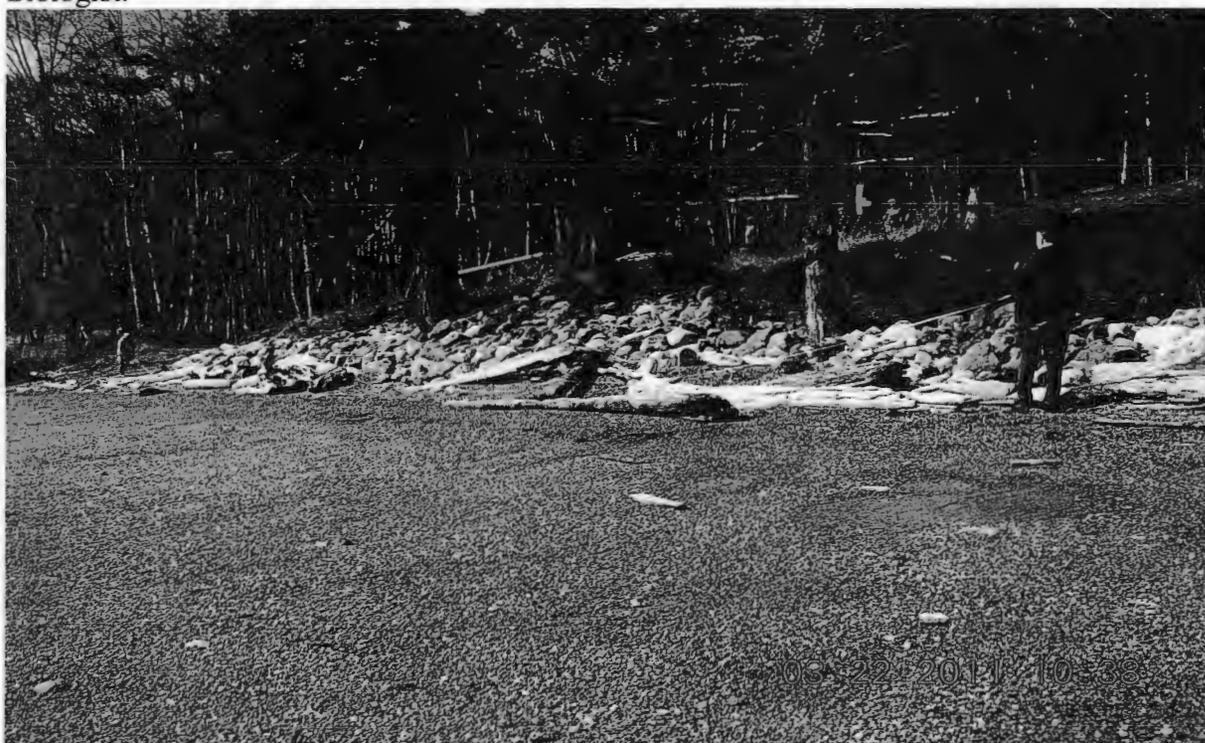
PHOTO 18: Reach 6 (Total reach 125 lineal ft) shows native round rock likely taken from the beach to use in the bulkhead. Taken by Area Habitat Biologist.

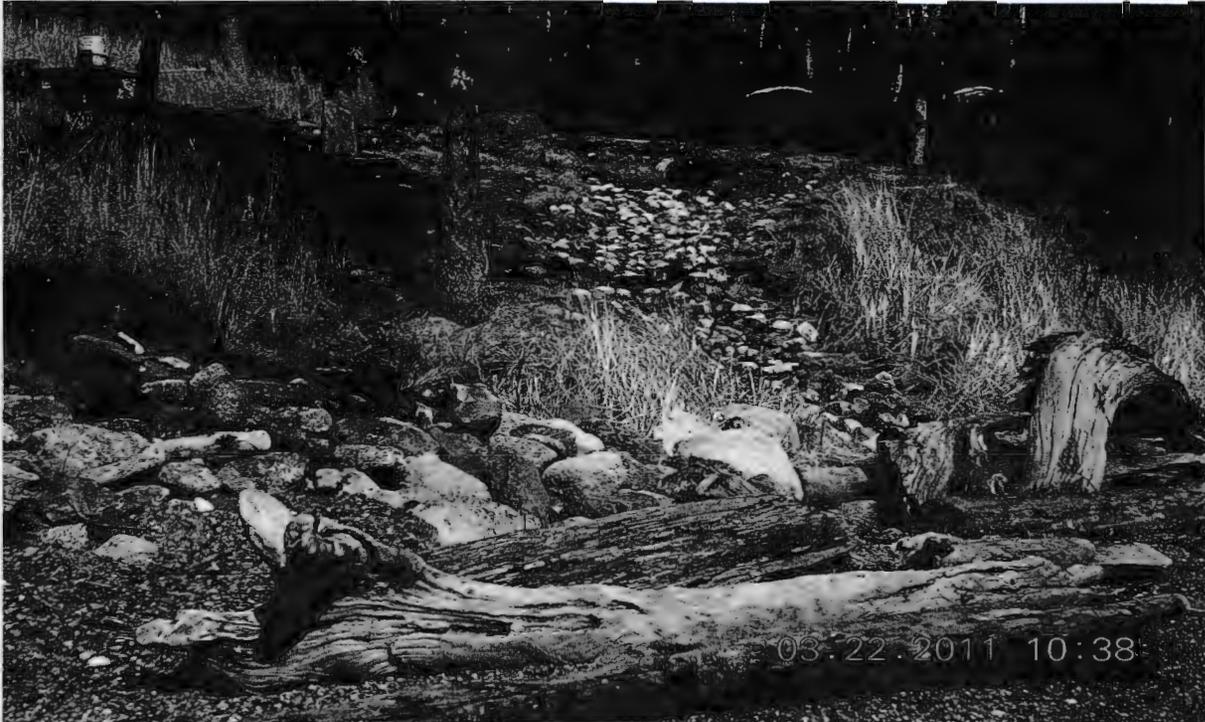
PHOTO 19: New stormwater drainage tightline outfall and quarry spalls for dissipation between Reaches 5 and 6. Taken by Area Habitat Biologist.

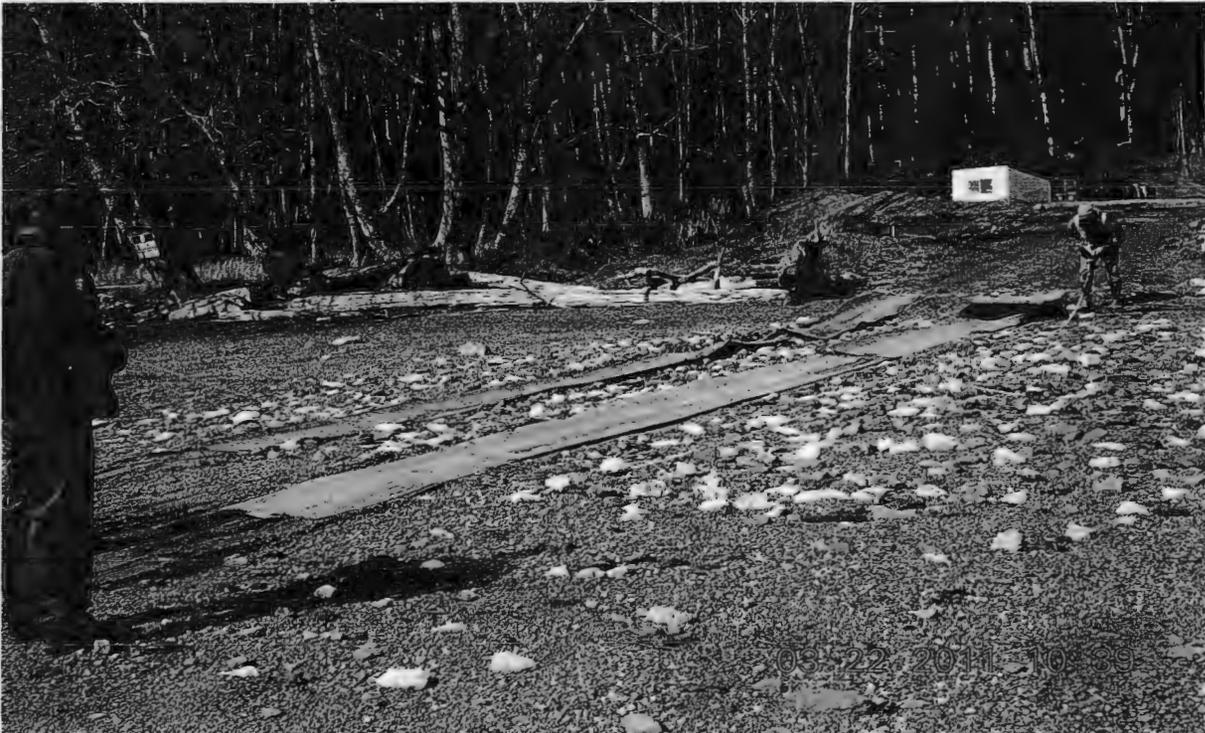
PHOTO 20: Reach 7- Shows barge access ramp constructed with quarry spalls and geo-pads on top of rocks. Boat ramp 30 lineal ft wide by 44 ft long. Taken by Area Habitat Biologist.

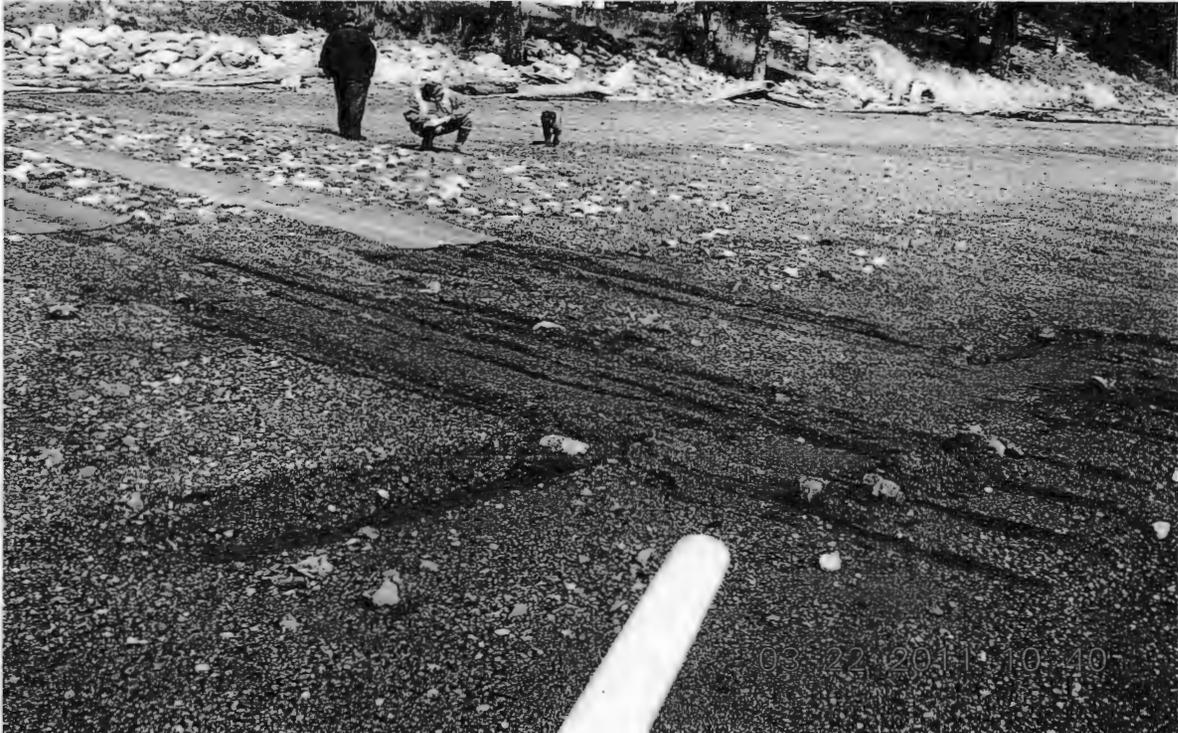
PHOTO 21: Barge access ramp and recent landing activity. Taken by Area Habitat Biologist.

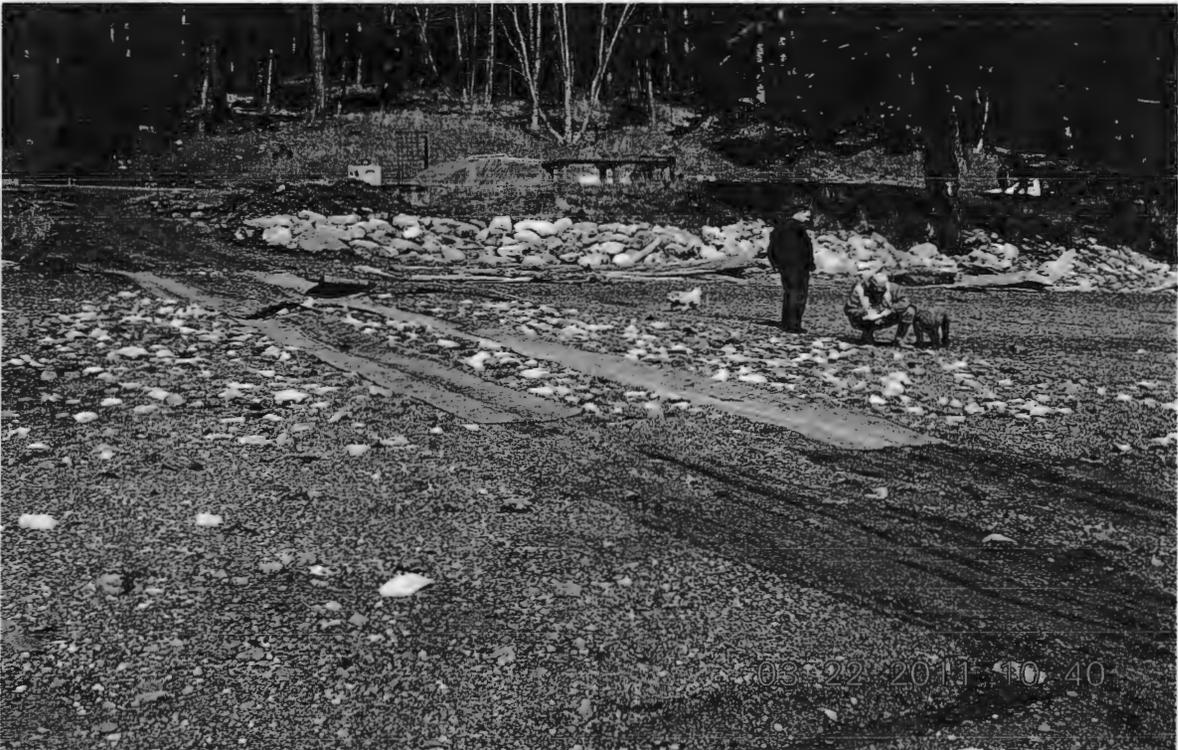
PHOTO 22: Barge access ramp and recent landing activity. Taken by Area Habitat Biologist.

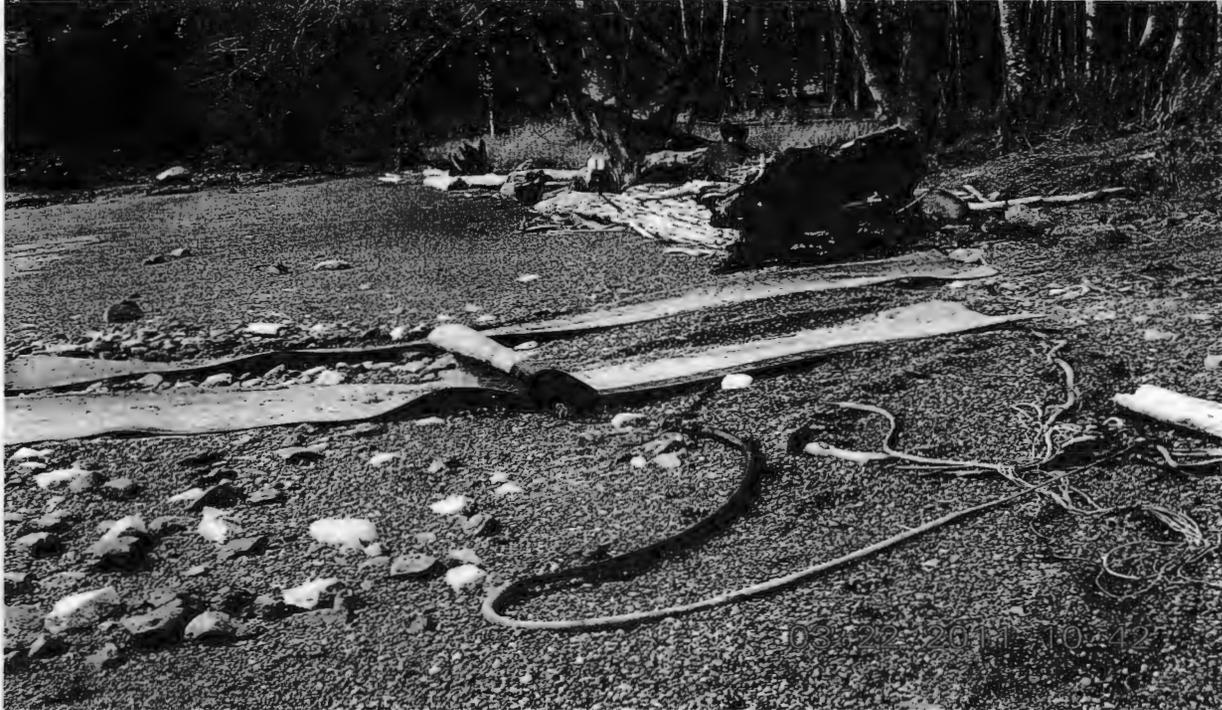
PHOTO 23: Reach 7- Barge access ramp (Total 30 lineal ft) and geo-pads over non-native quarry spalls, and showing native beach substrate (sand and pea gravel), at west end adjacent to the remaining natural shoreline. Taken by Area Habitat Biologist.

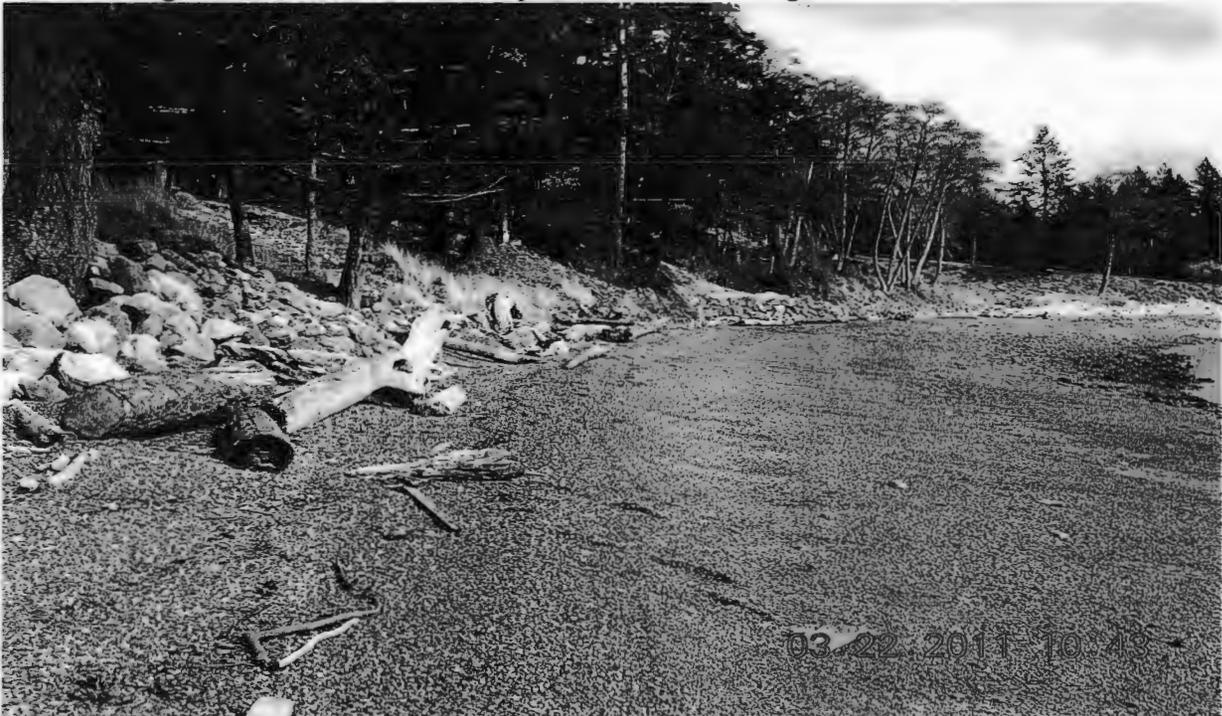
PHOTO 24: View of beach and bulkhead from the west end looking north east. Taken by Area Habitat Biologist.

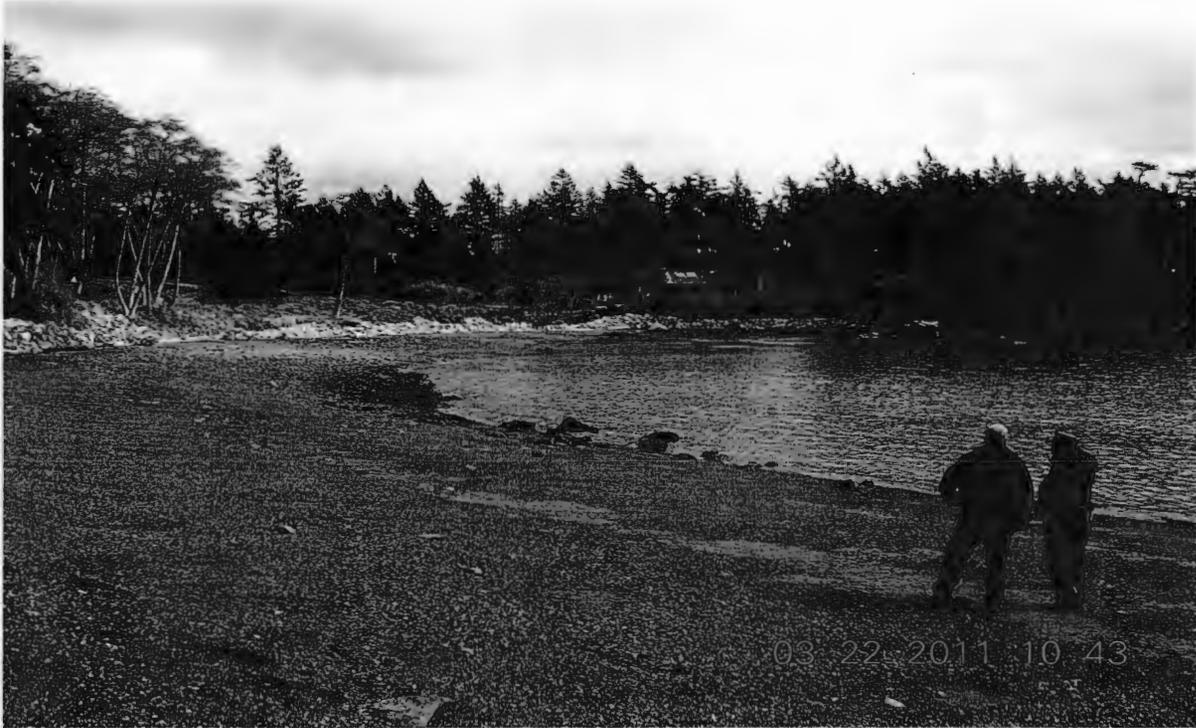
PHOTO 25: View of bulkhead and beach (largely pea gravel and sand) from west end looking east.

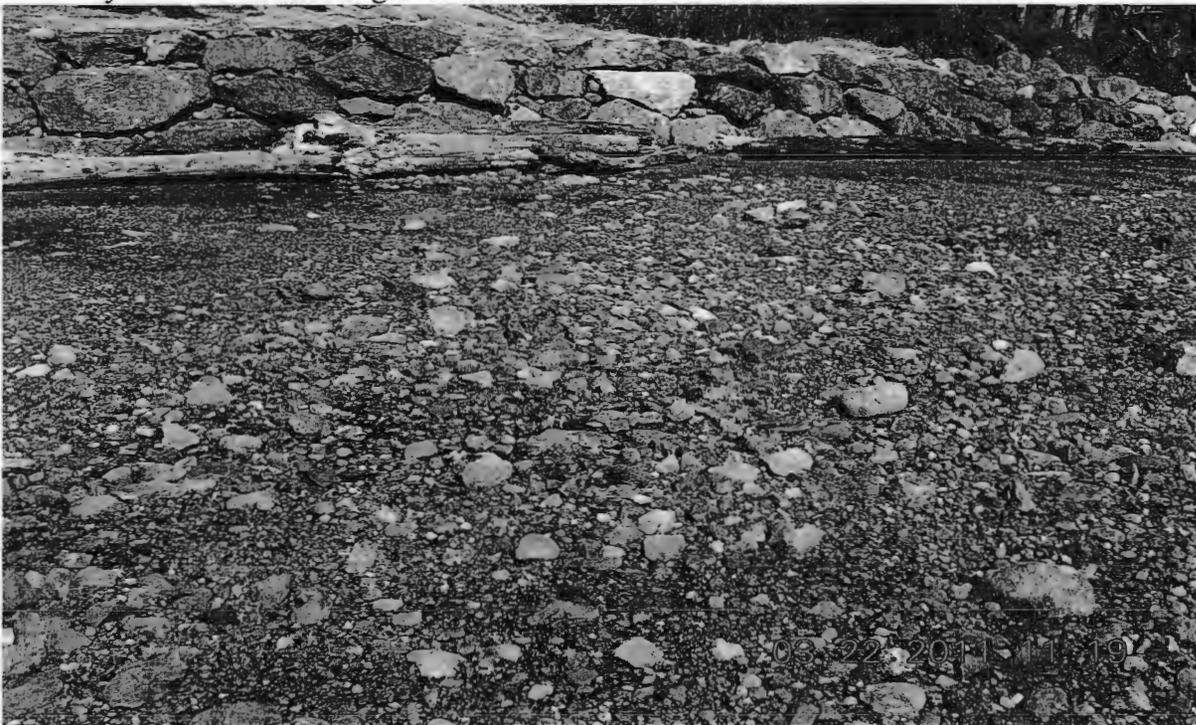
PHOTO 26: Non-native quarry spalls on beach left by barge (do not belong on beach). Taken by Area Habitat Biologist.

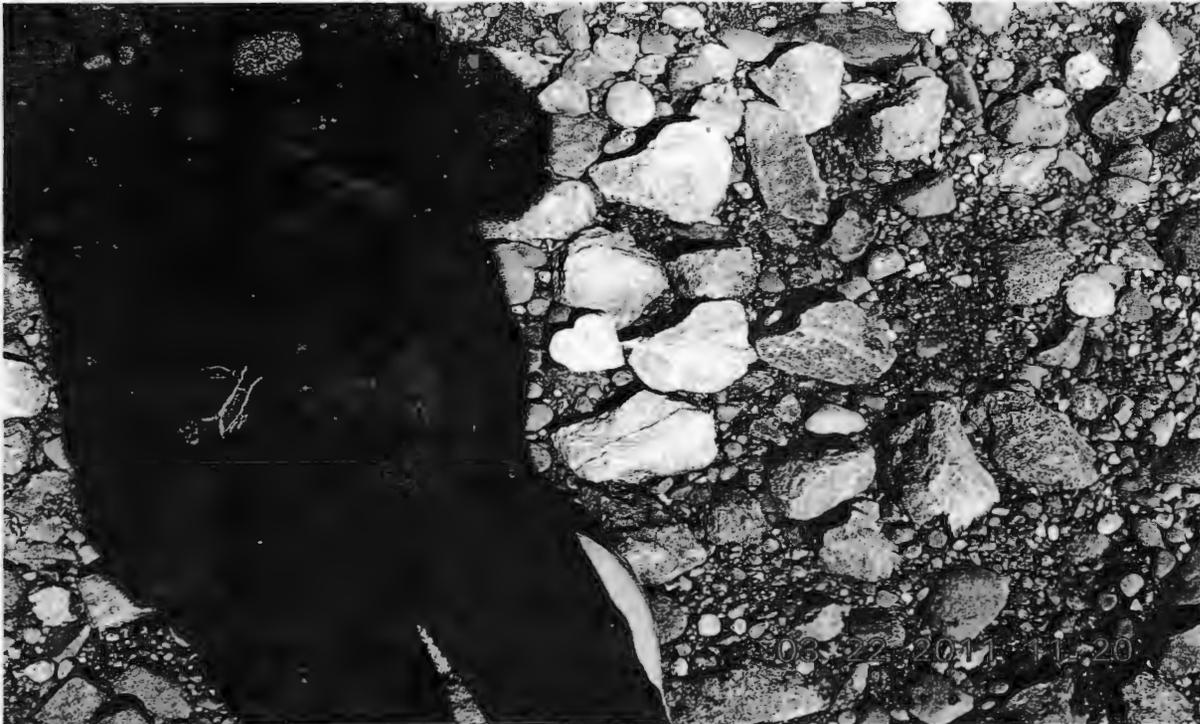
PHOTO 27: Size of quarry spalls relative to native material (sand and pea gravel) beneath. Taken by Area Habitat Biologist.

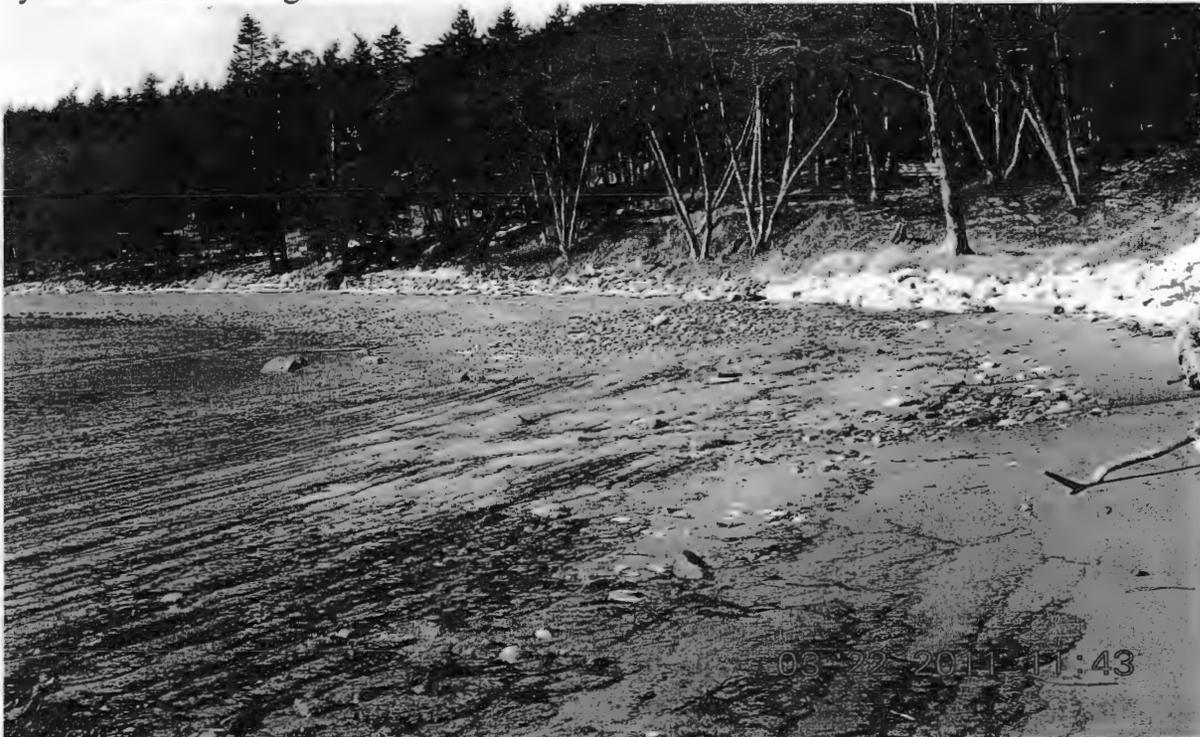
PHOTO 28: View of bulkhead and beach (largely sand and fine grain sediments with some native round rock) from east end looking west. Taken by Area Habitat Biologist.
