RUNSTAD PROPERTY

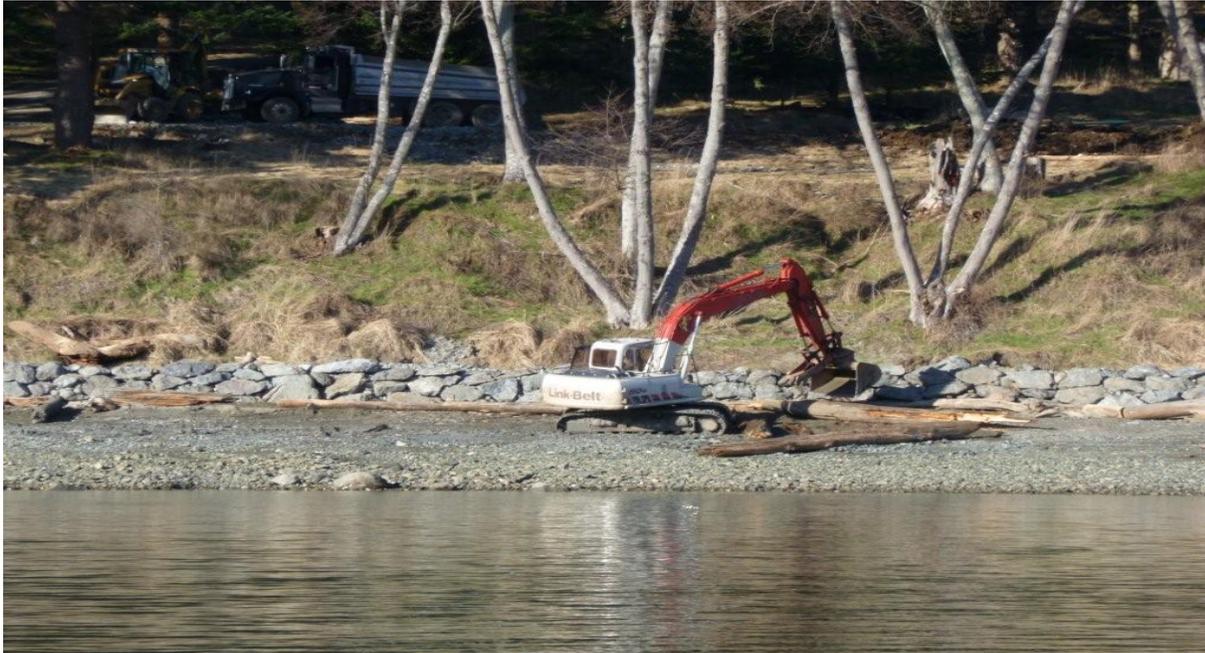
PHOTO 1: Enforcement photo of equipment operating on beach and constructing non-permitted bulkhead.

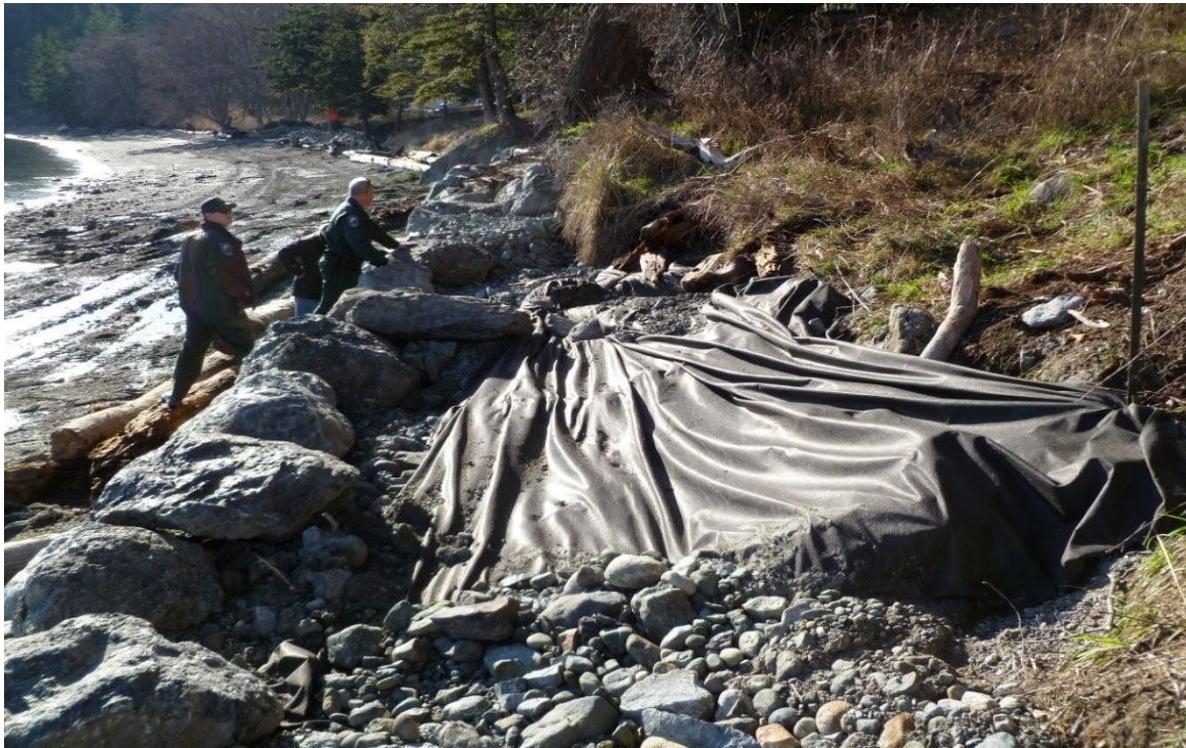
PHOTO 3: Enforcement photo illustrating recent equipment activity on beach at soft boat ramp.

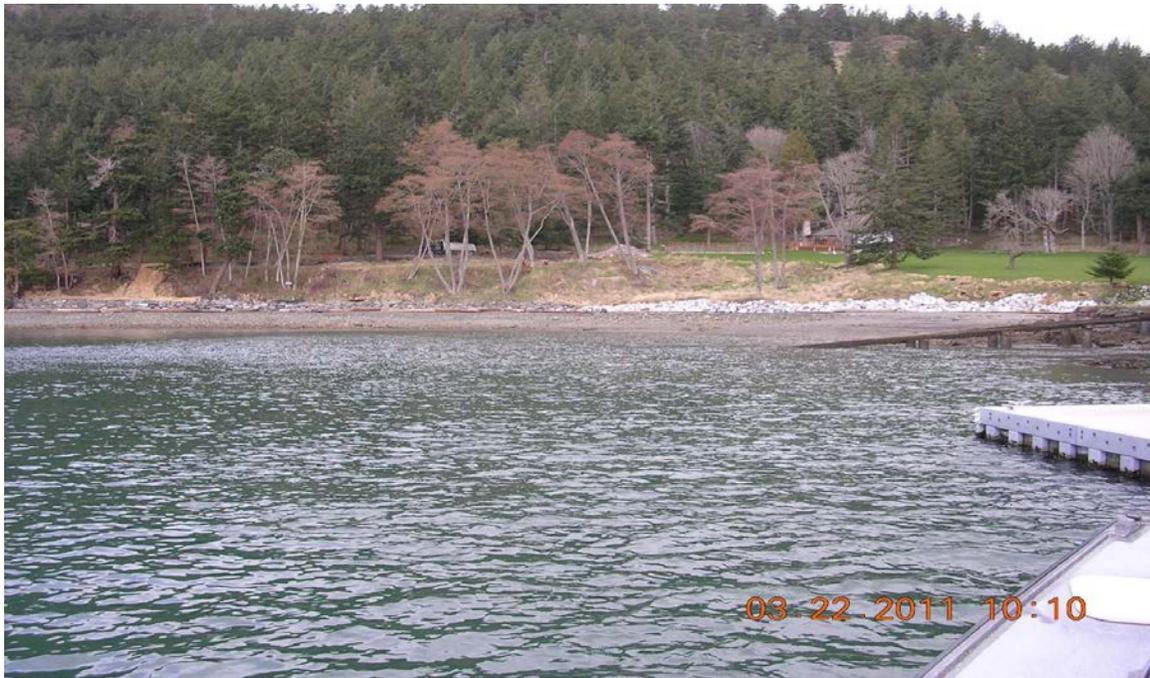
PHOTO 4: Enforcement photo showing construction of bulkhead.

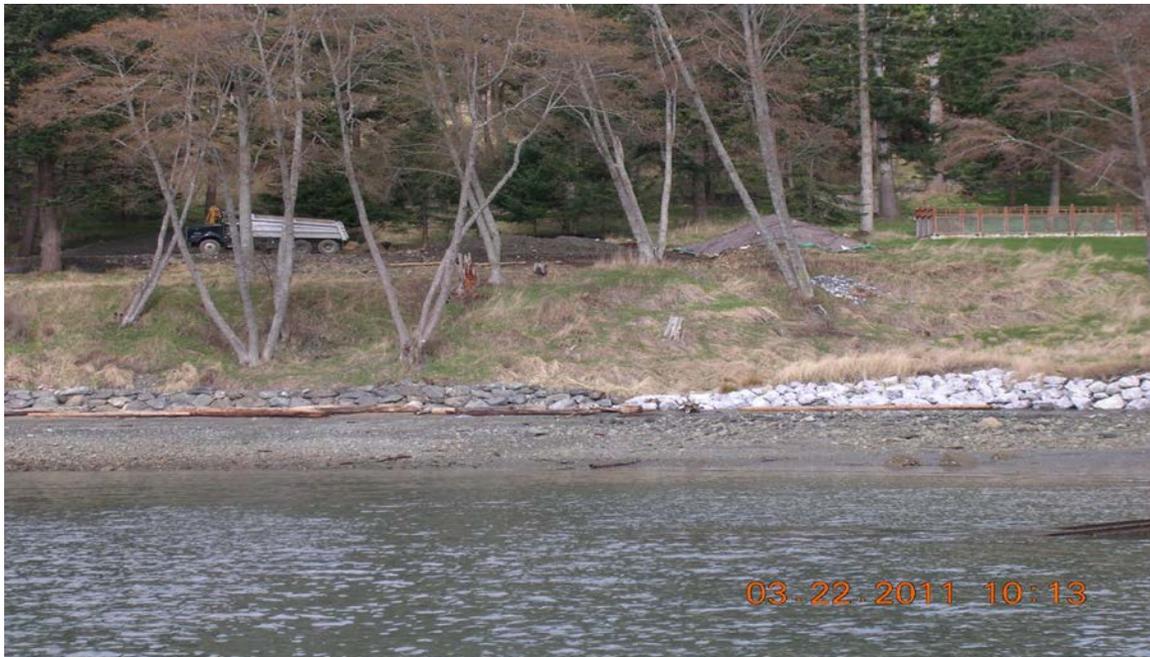
PHOTO 5: View from east (white rock on right) to west (gray rock on left). Older rock bulkhead is white and new bulkhead, which is gray, begins in middle of photo. Taken by Area Habitat Biologist.

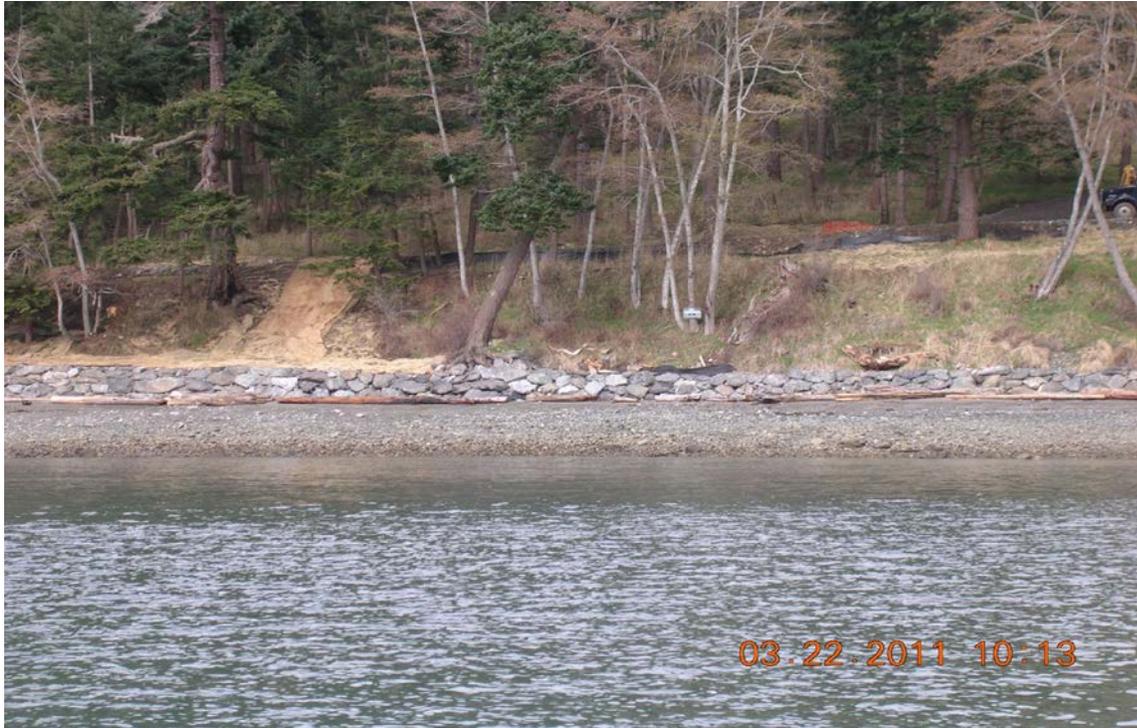
PHOTO 6: Close-up of intersection between new and older bulkhead location. Also illustrates end of Reach 2 (Total reach 218 lineal ft) and beginning of Reach 3 (Total reach 252 lineal ft). Taken by Area Habitat Biologist.

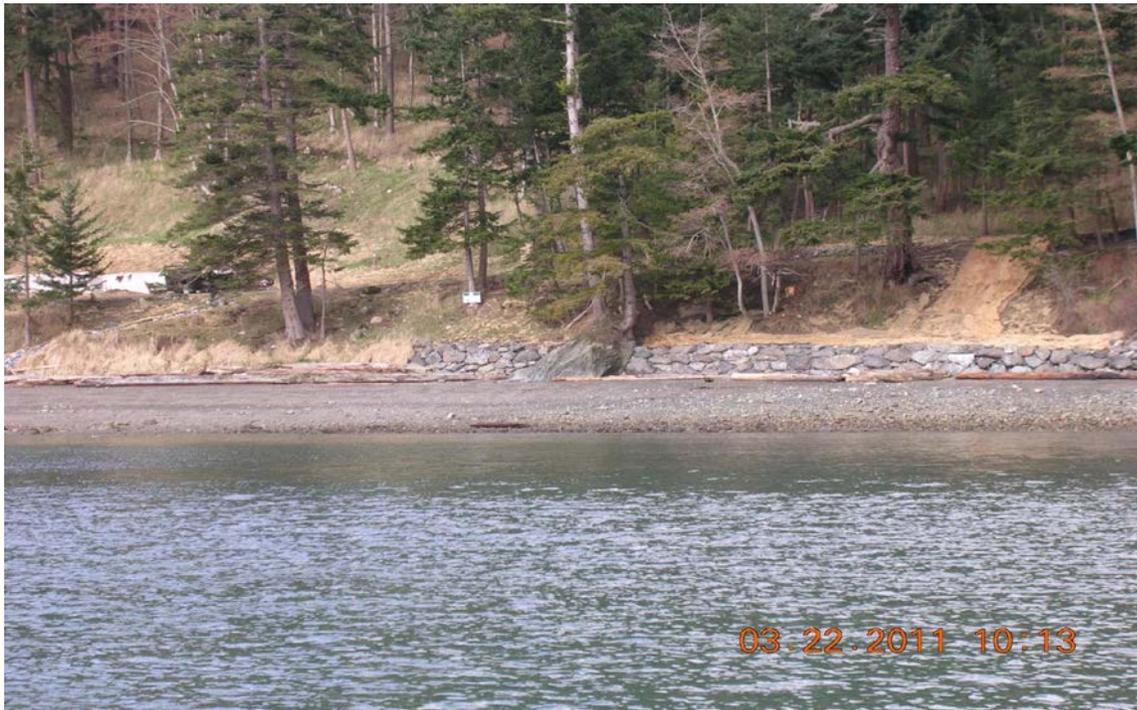
PHOTO 7: Portion of Reach 3 (Total reach 252 lineal ft). Taken by Area Habitat Biologist.

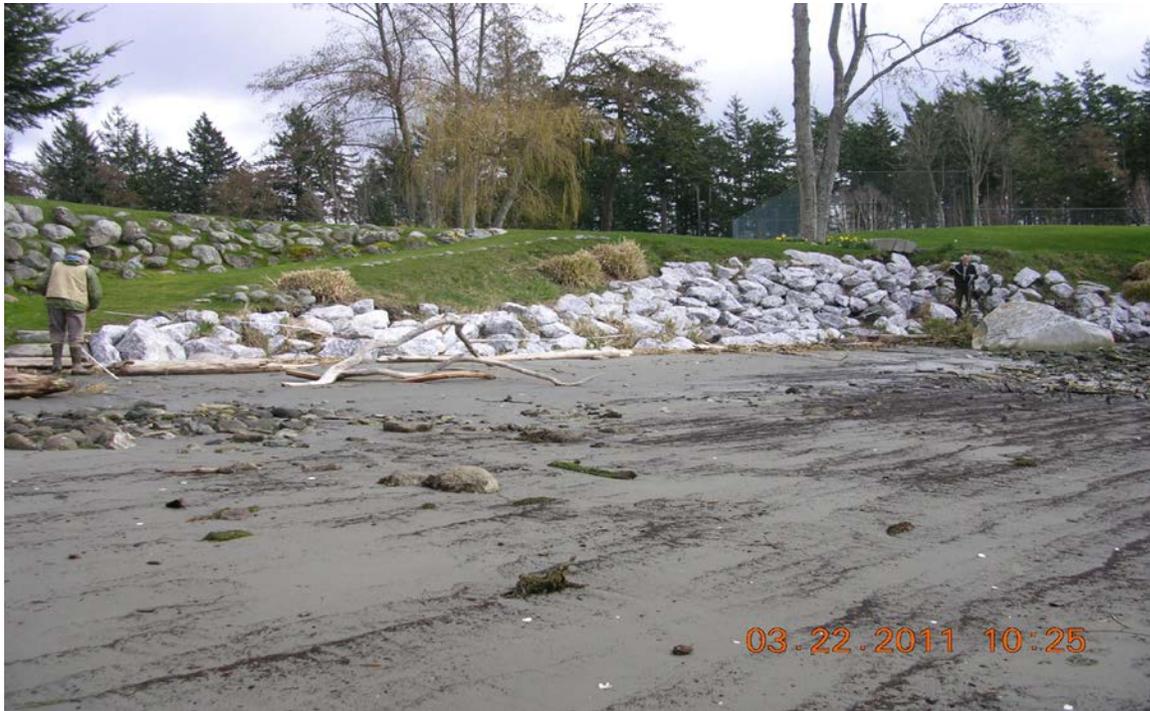
PHOTO 8: Reach 4 (Total reach 39 lineal ft) and Reach 5 (Total reach 82 lineal ft). Taken by Area Habitat Biologist.

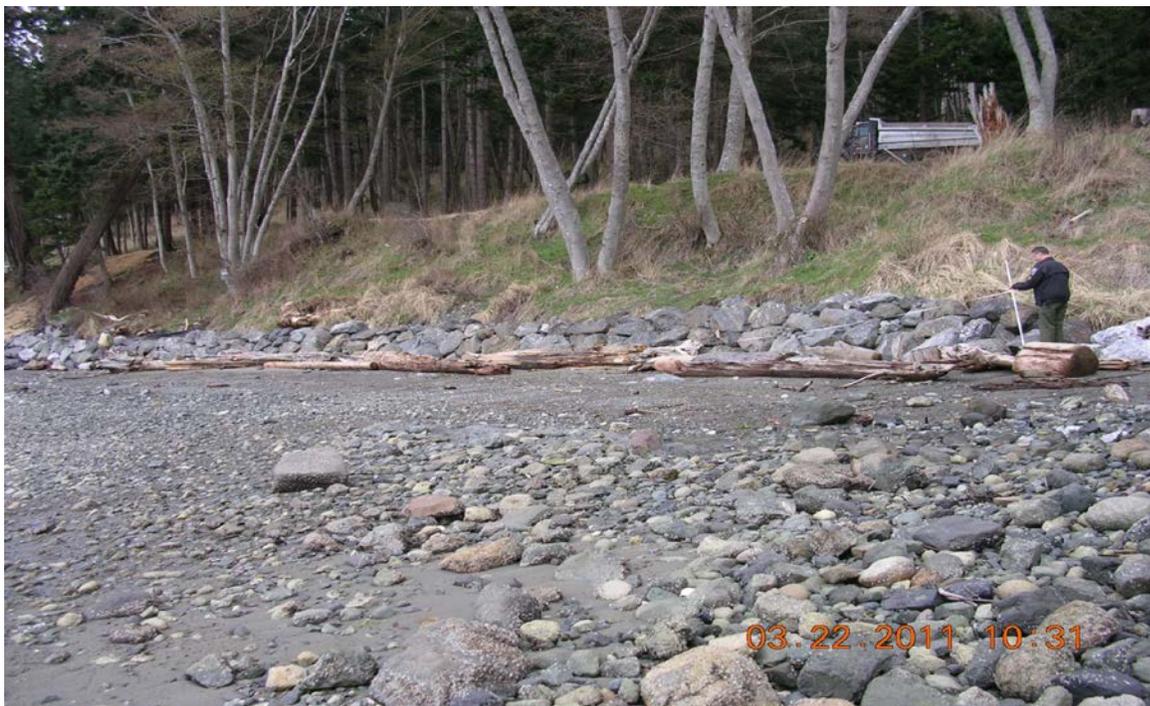
PHOTO 9: Portion of Reach 1 (Total reach 205 lineal ft), with older white bulkhead with established dune grass growing between some rocks. Taken by Area Habitat Biologist.

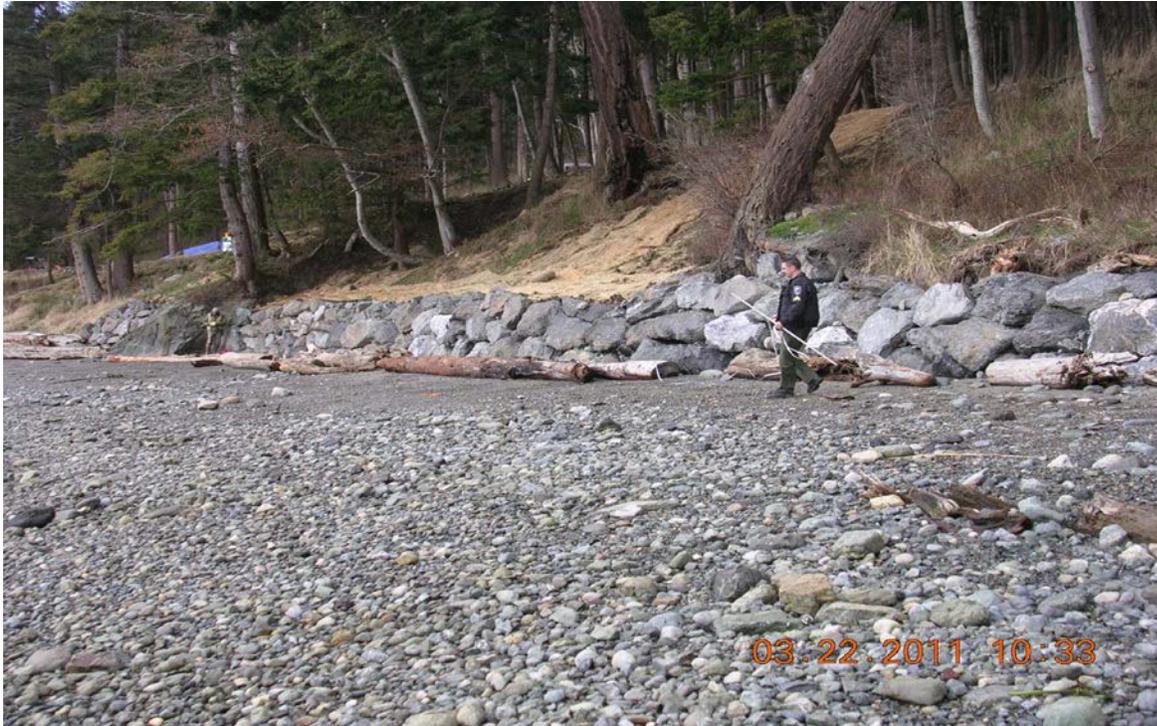
PHOTO 11: Brian Williams and Sgt. Mullins measuring Reach 3 (Total reach 252 lineal ft). Taken by Area Habitat Biologist.

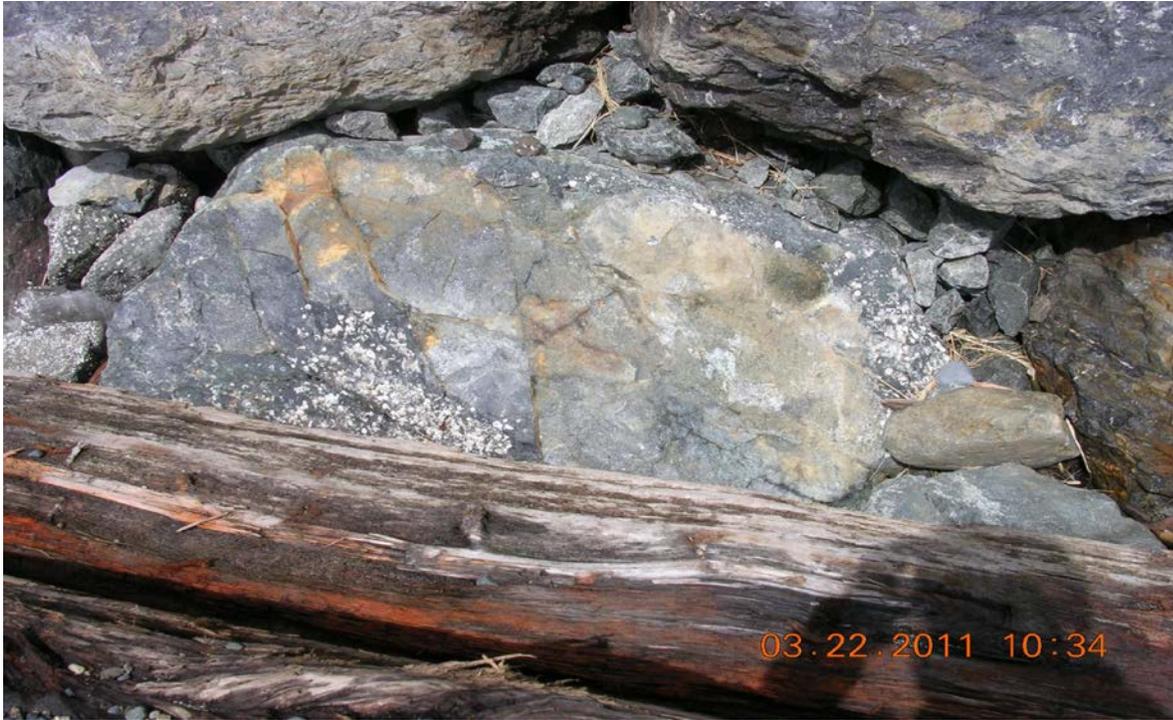
PHOTO 12: New bulkhead includes rocks that have barnacles present on rock face indicating rocks were taken from the beach. Taken by Area Habitat Biologist.

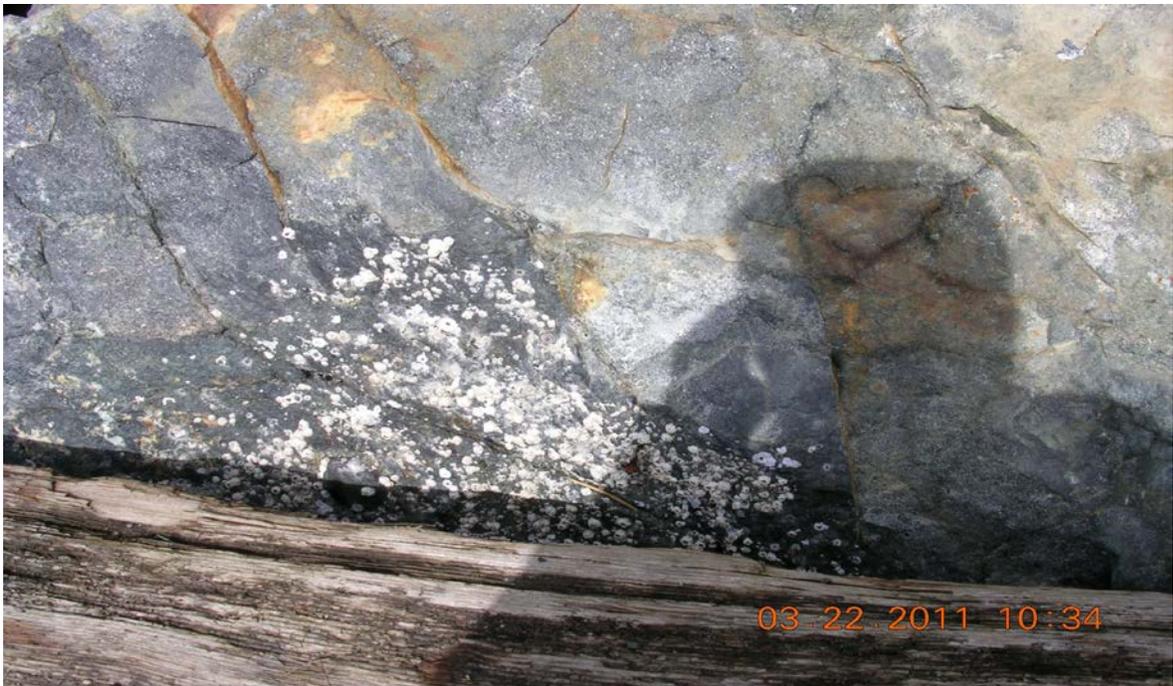
PHOTO 13: Close-up of barnacles on rocks. Taken by Area Habitat Biologist.

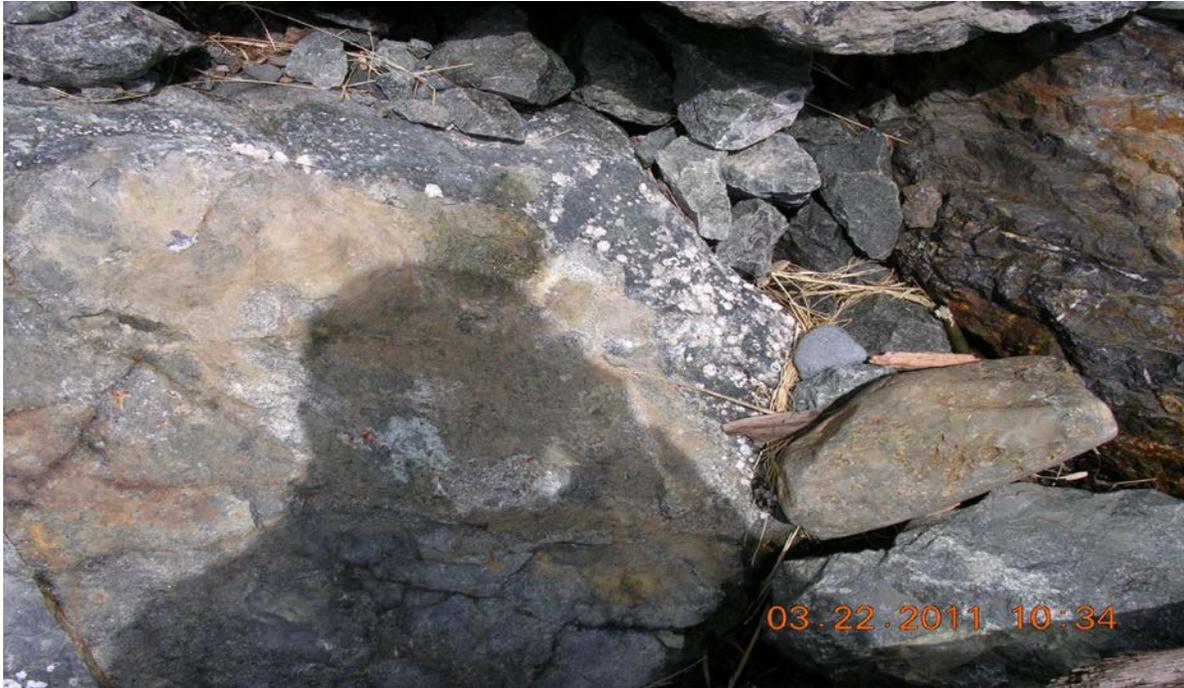
PHOTO 14: Barnacles on rocks. Taken by Area Habitat Biologist.

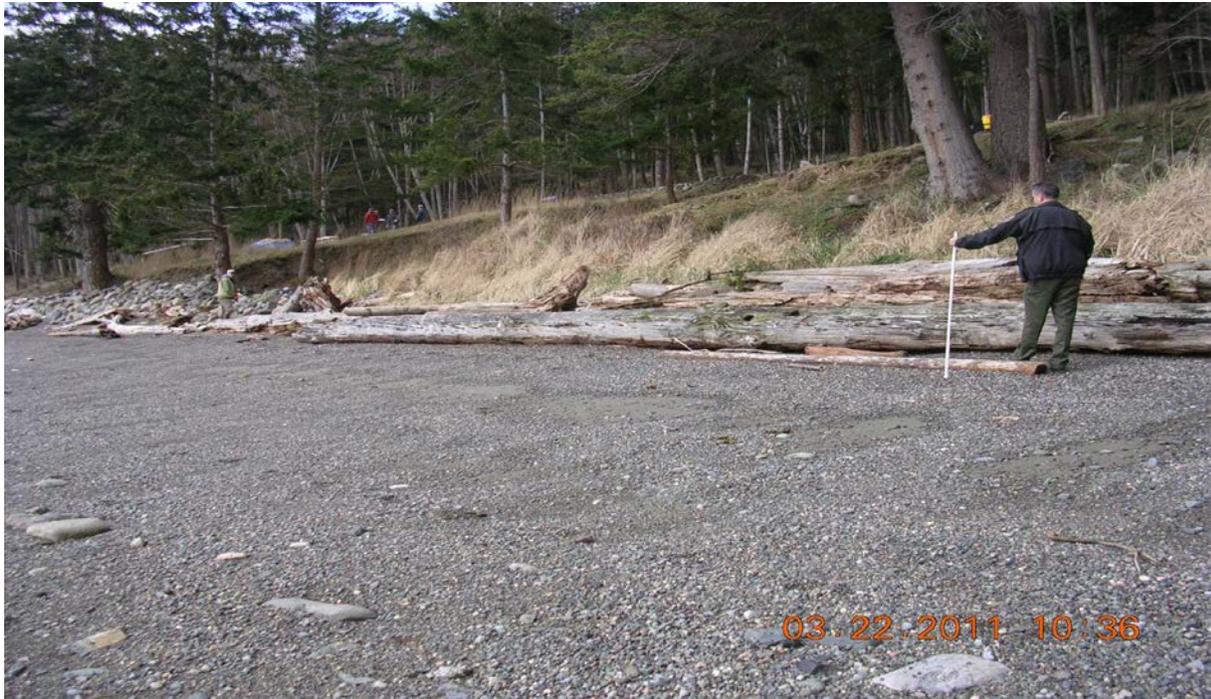
PHOTO 16: Portion of Reach 3 (Total reach 252 lineal ft) showing bankline work to minimize erosion. Taken by Area Habitat Biologist.

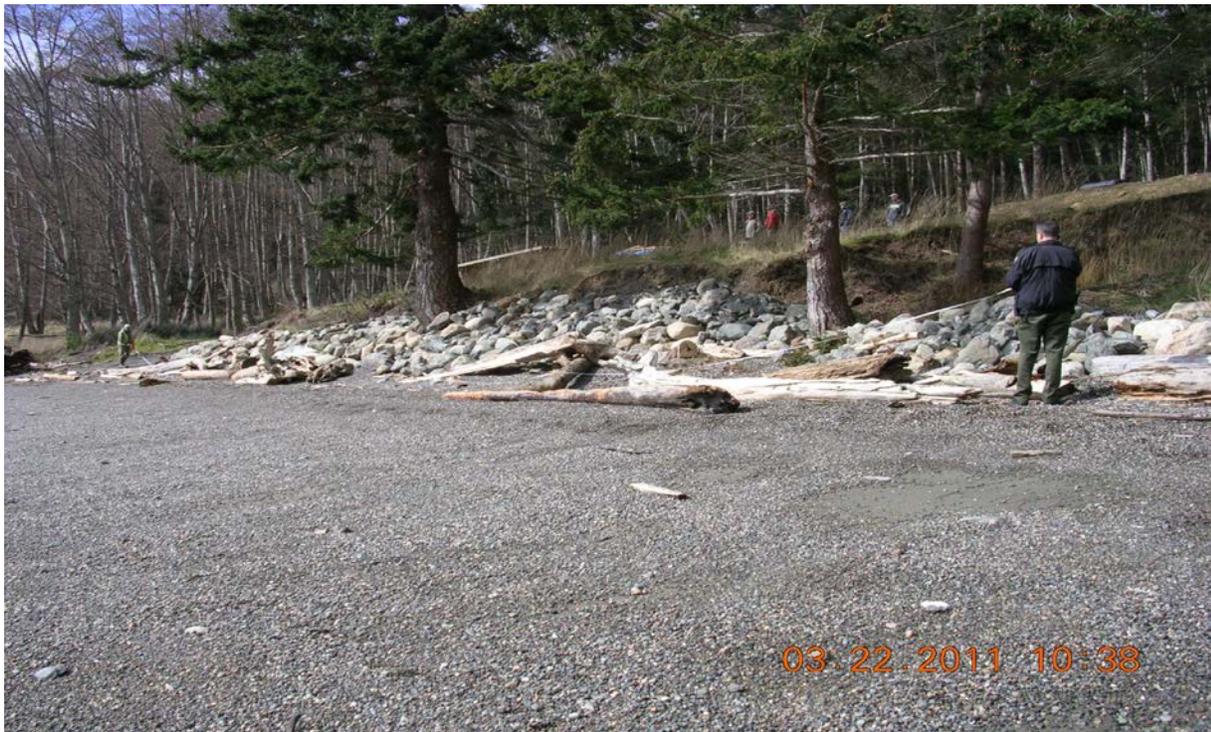
PHOTO 17: Reach 5 (Total 82 lineal ft) with undisturbed shoreline and illustrating what shoreline looked like along this stretch before bulkhead installation. Taken by Area Habitat Biologist.

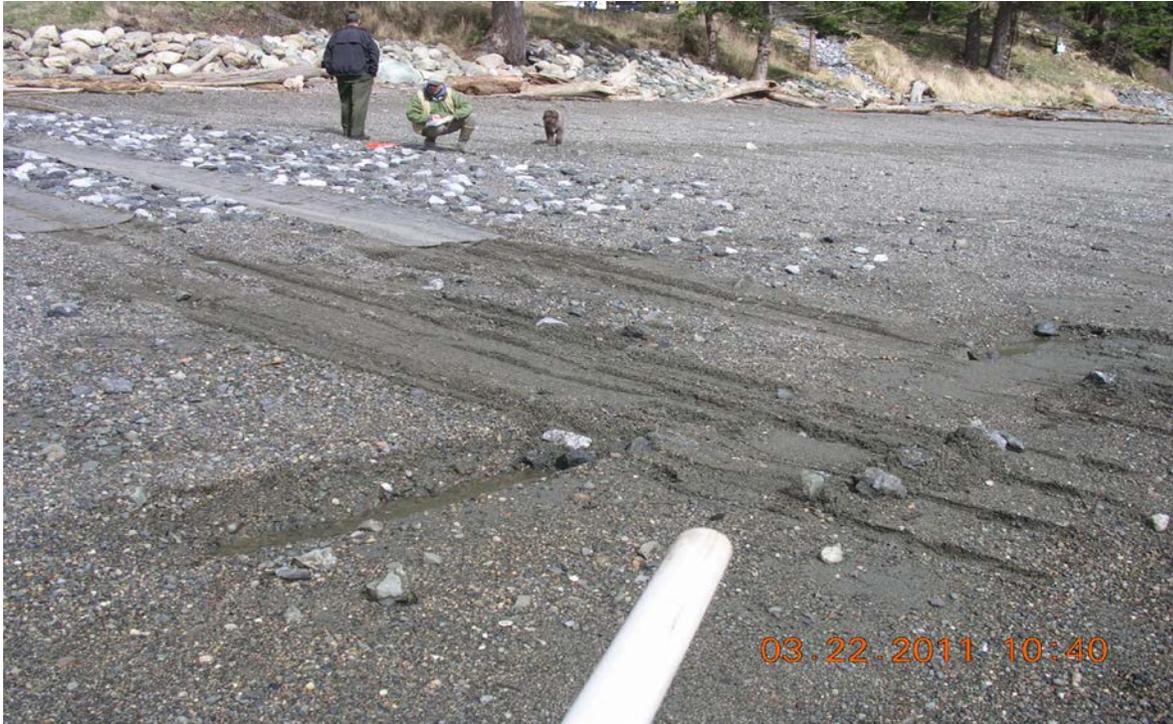
PHOTO 20: Reach 7- Shows barge access ramp constructed with quarry spalls and geo-pads on top of rocks. Boat ramp 30 lineal ft wide by 44 ft long. Taken by Area Habitat Biologist.

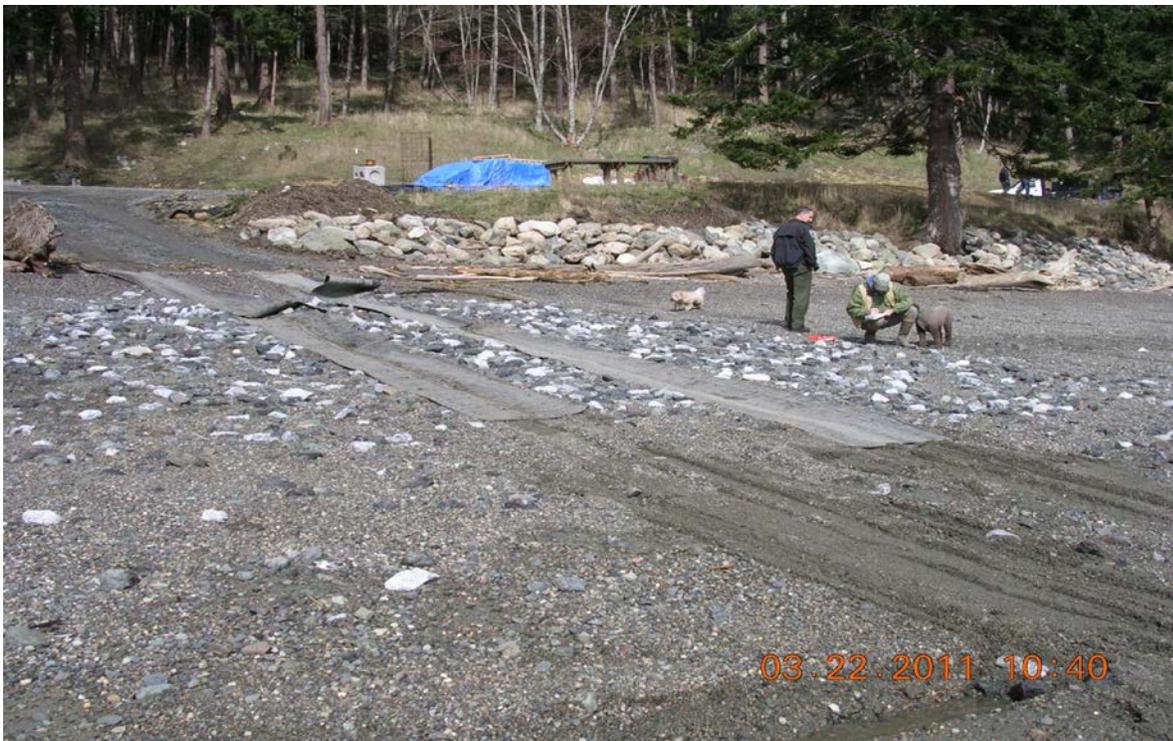
PHOTO 21: Barge access ramp and recent landing activity. Taken by Area Habitat Biologist.

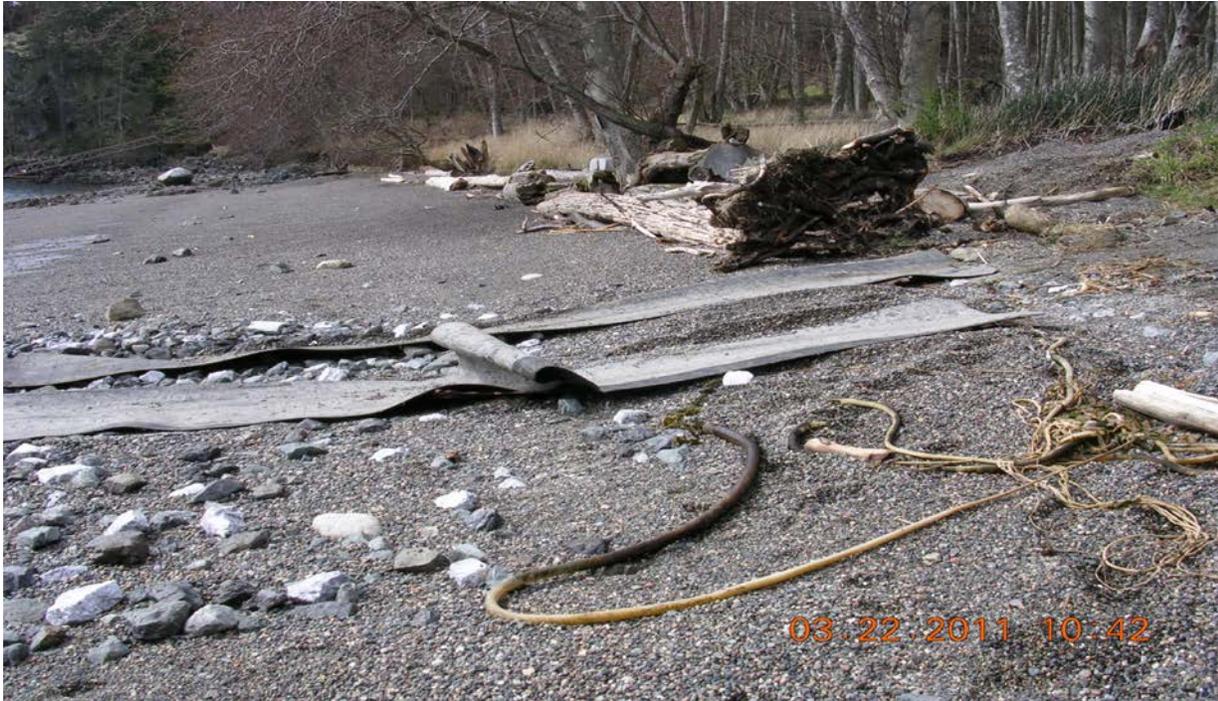
PHOTO 22: Barge access ramp and recent landing activity. Taken by Area Habitat Biologist.

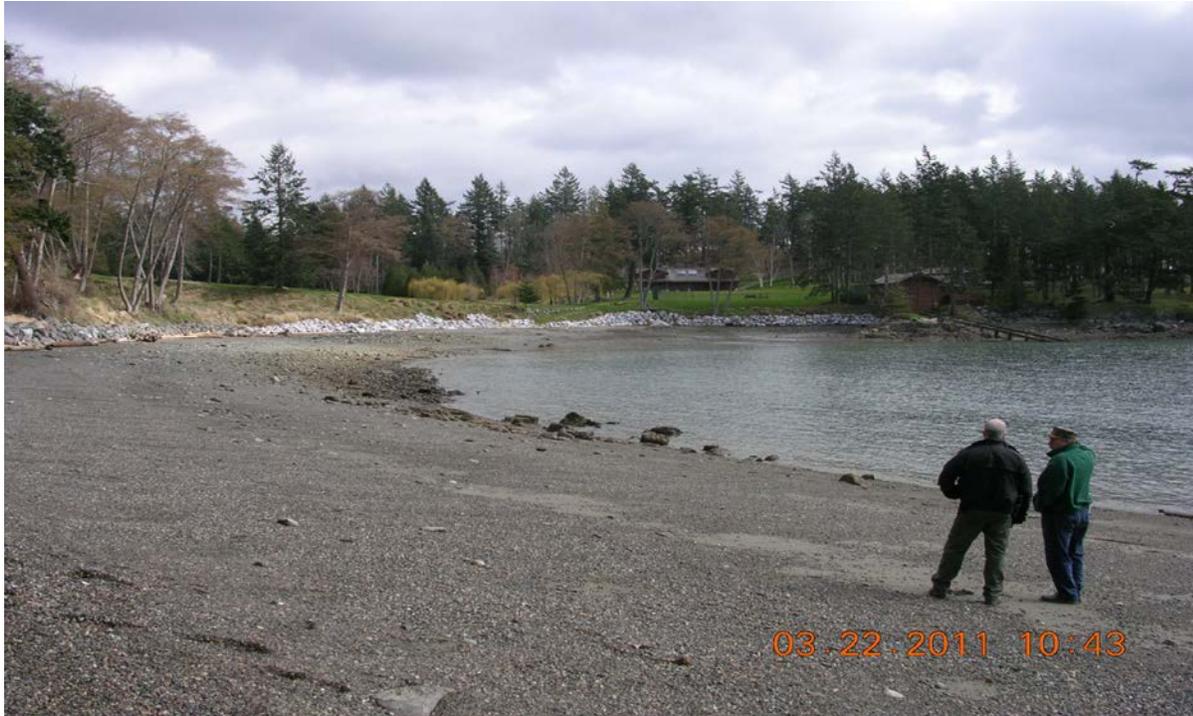
PHOTO 24: View of beach and bulkhead from the west end looking north east. Taken by Area Habitat Biologist.

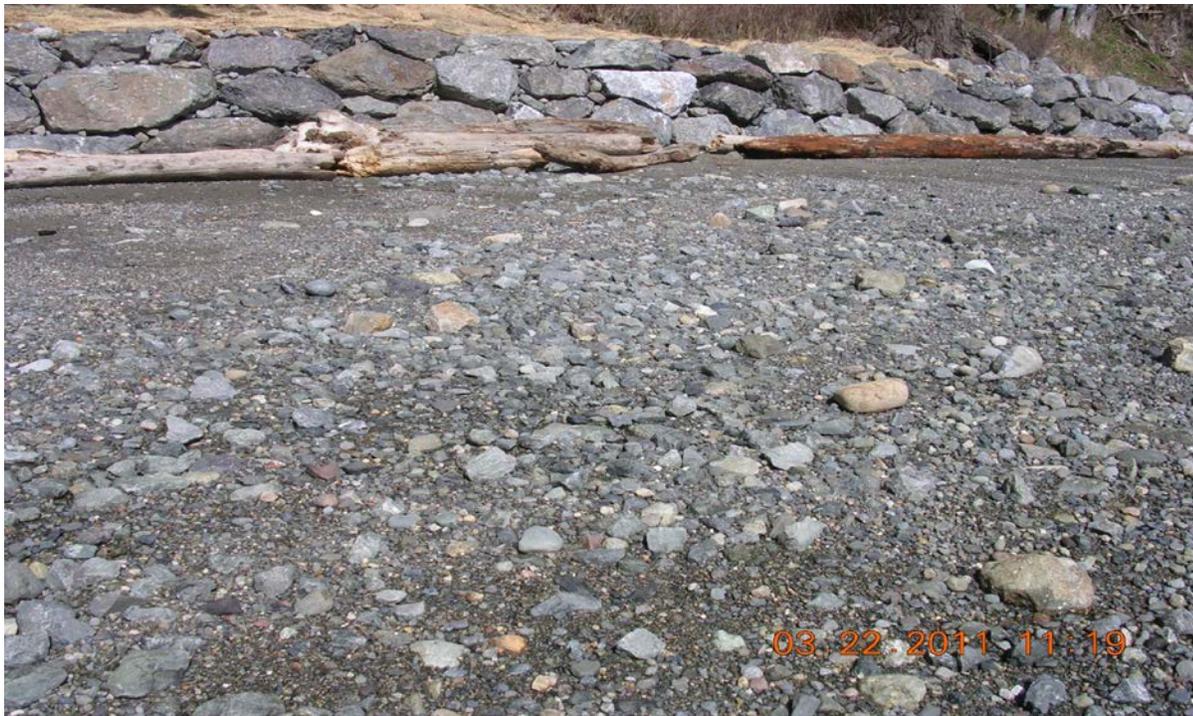
PHOTO 25: View of bulkhead and beach (largely pea gravel and sand) from west end looking east.

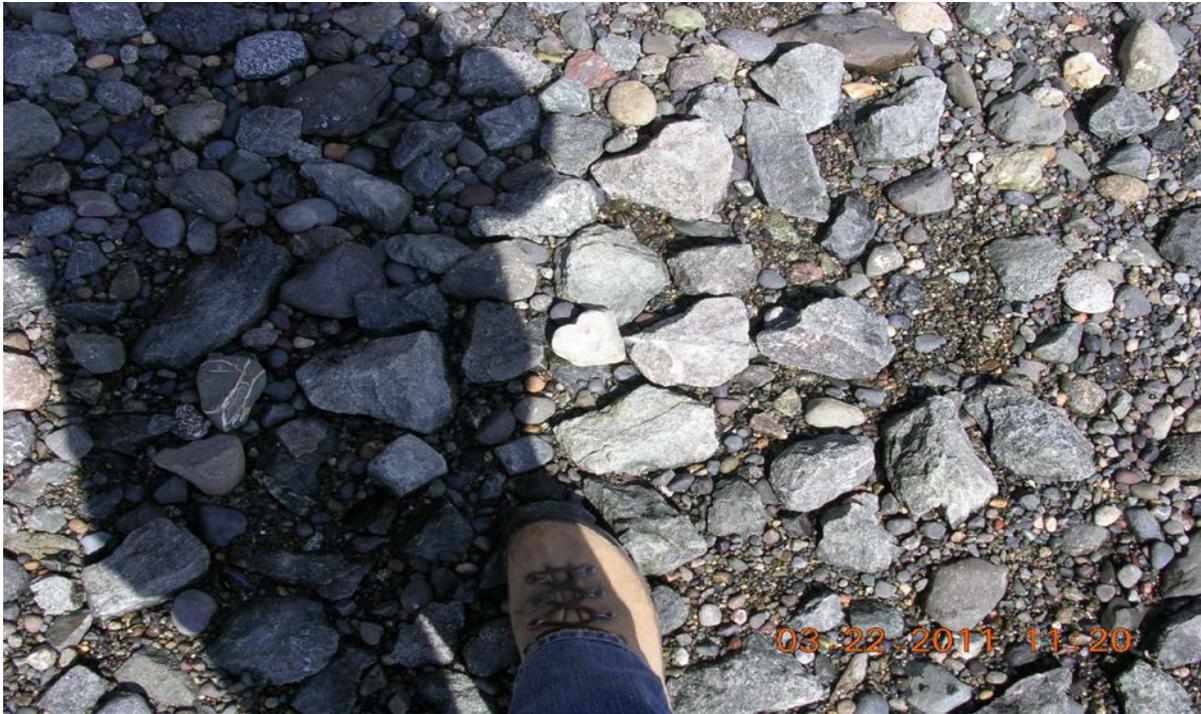
PHOTO 26: Non-native quarry spalls on beach left by barge (do not belong on beach). Taken by Area Habitat Biologist.
