**Illustrative for**  
**Vladimir Shepsis**  
**Testimony**

# **Runstad Property – Shoreline Erosion Protection**

Professional Opinion by Coastal Engineer

Dr. Vladimir Shepsis Ph.D., P.E.

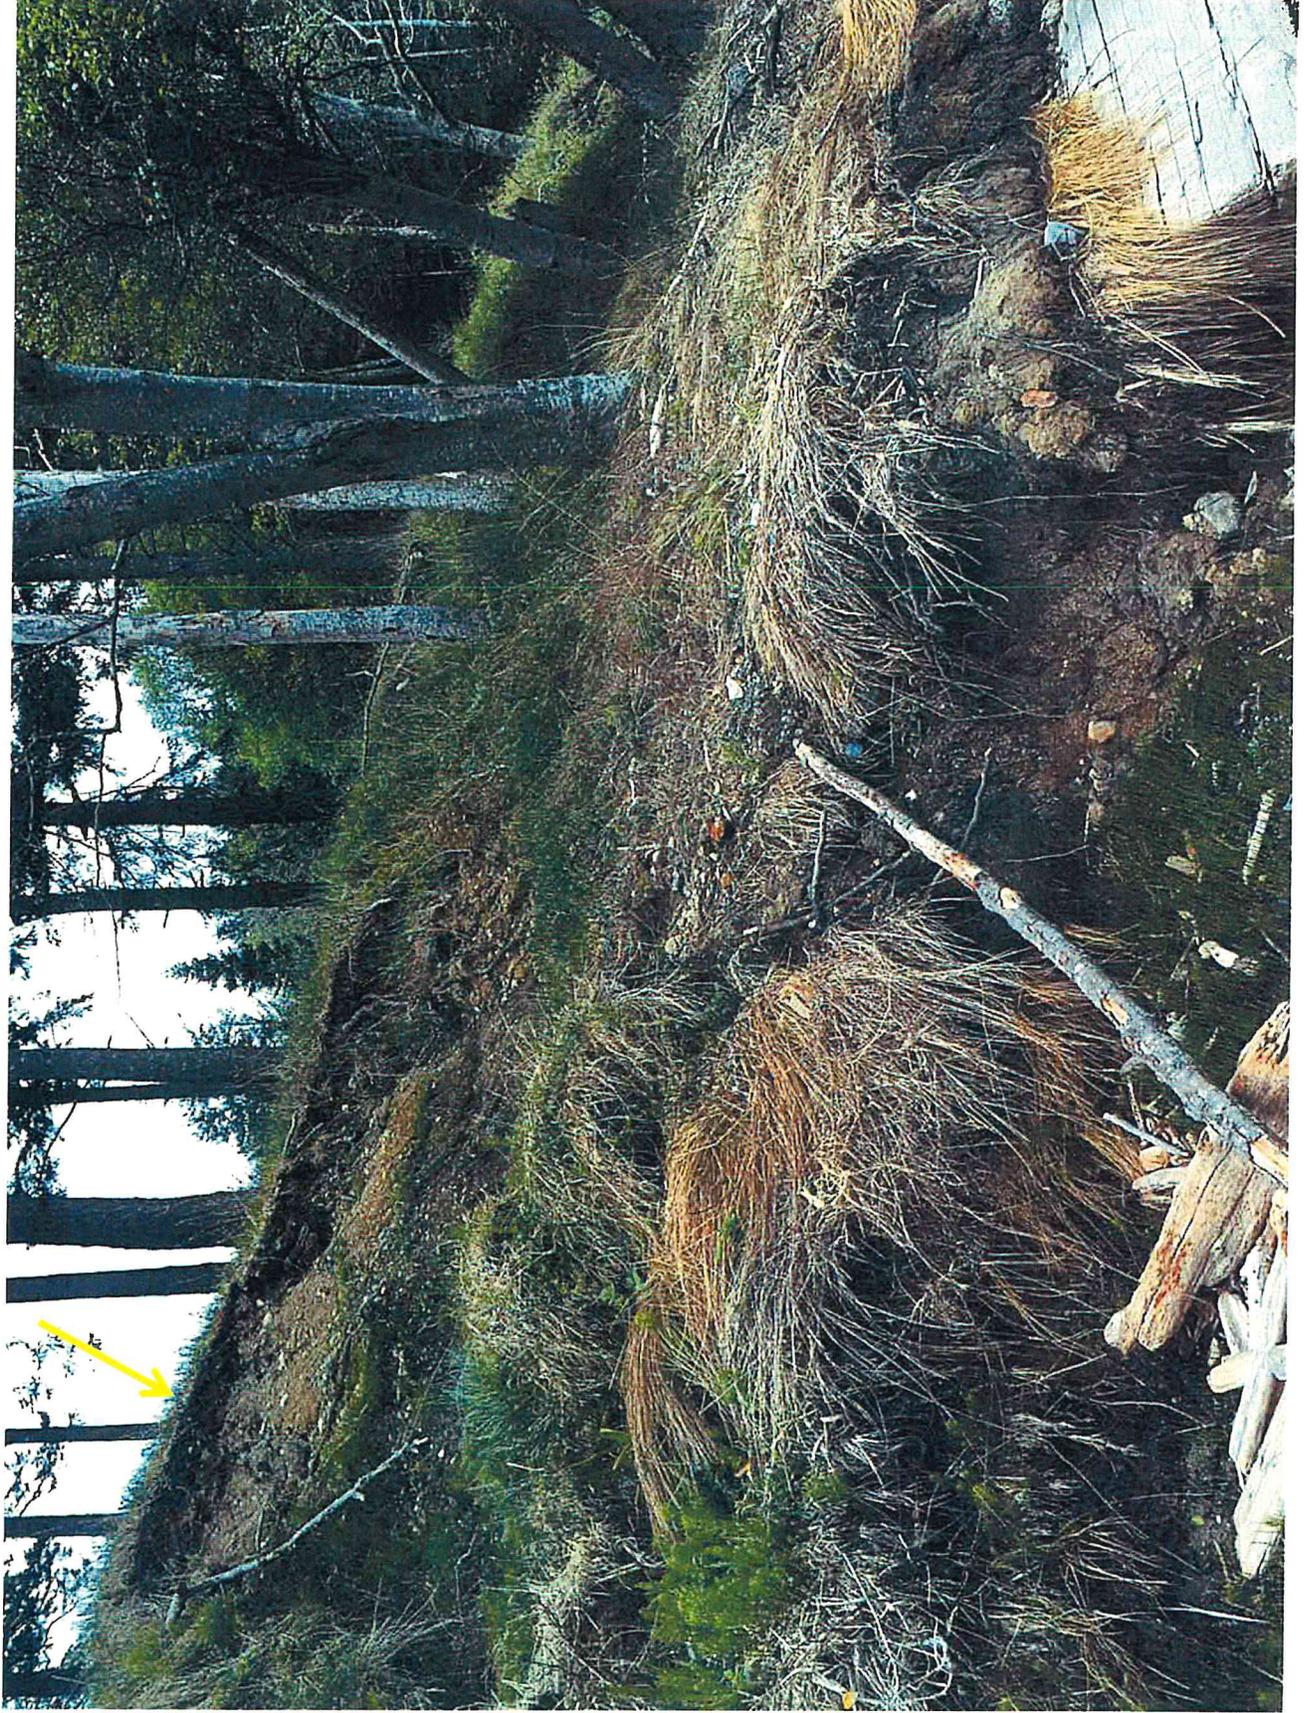
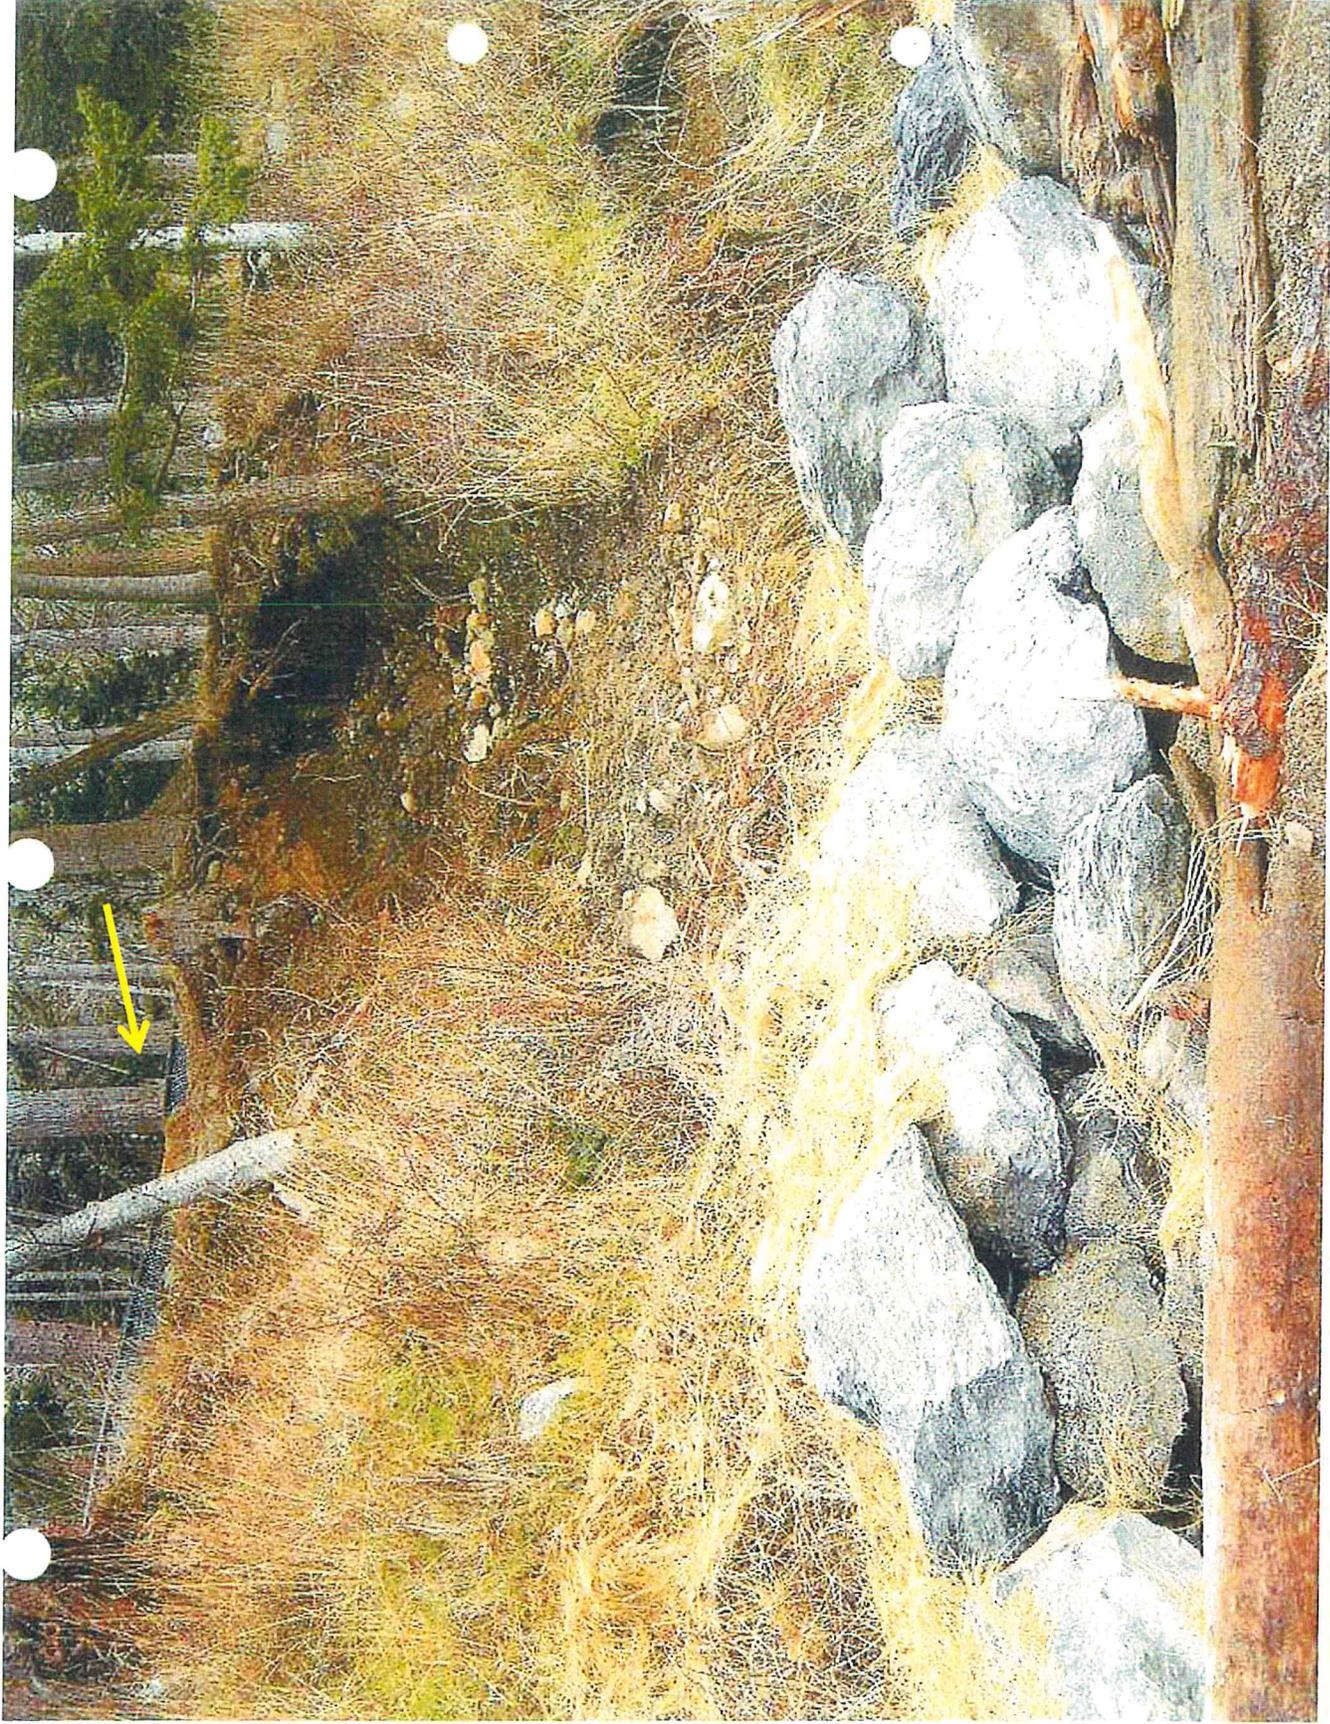
**EXHIBIT D**

**Erosion Upper Driveway  
Reach 3**

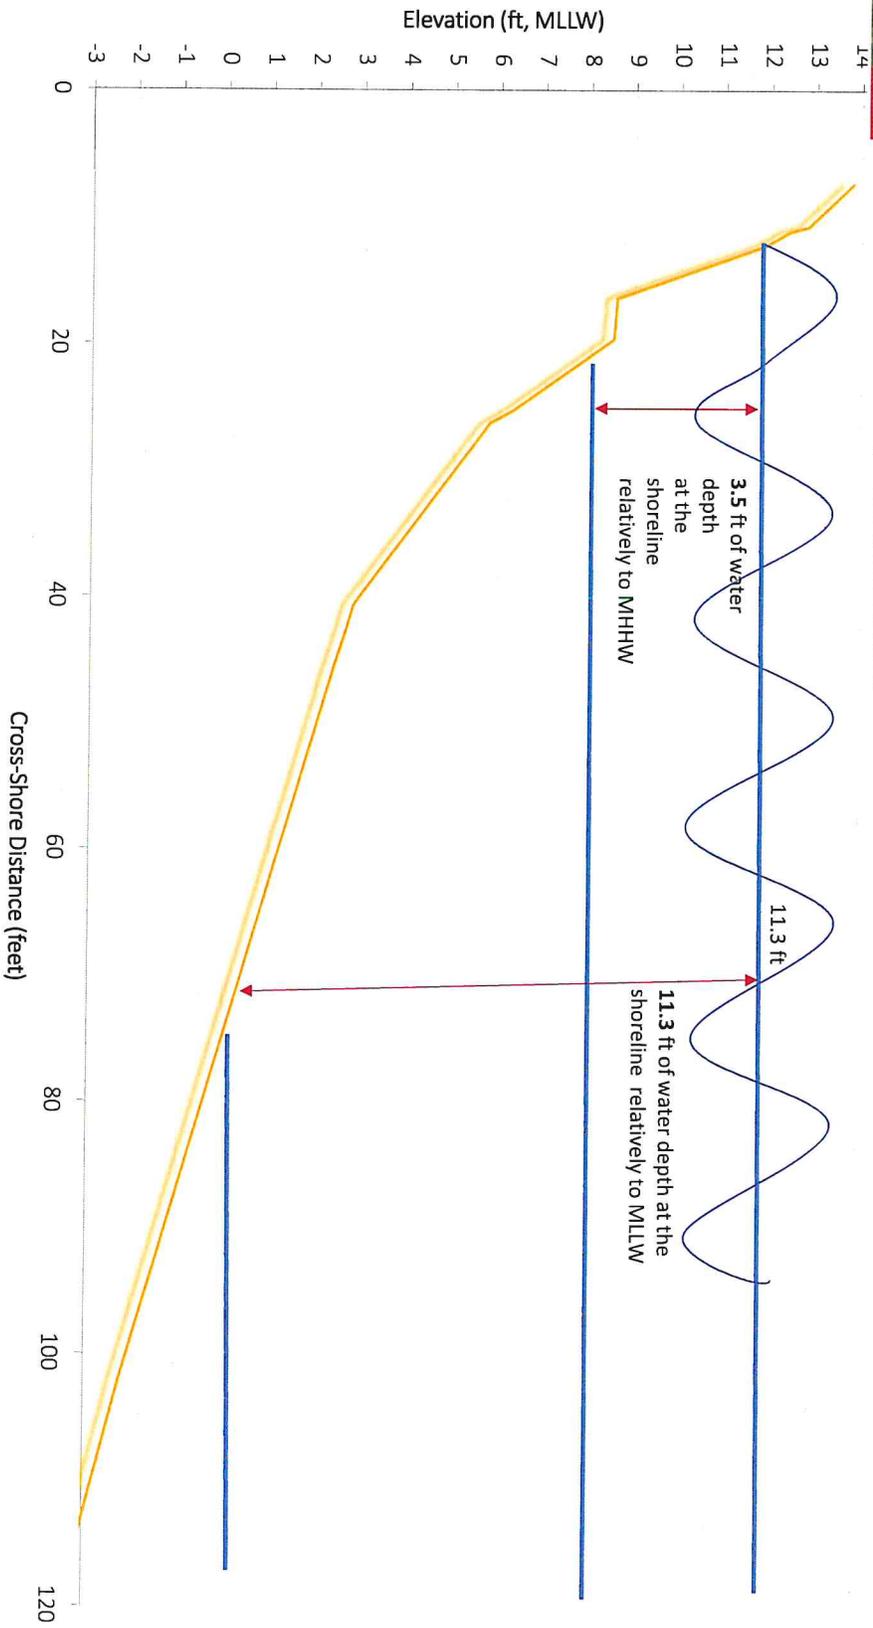
**CHE Report: "during high tide when water depth at the shoreline is 2-4 feet of depth, a significant amount of wave energy that enters the bay is delivered to the bank"**

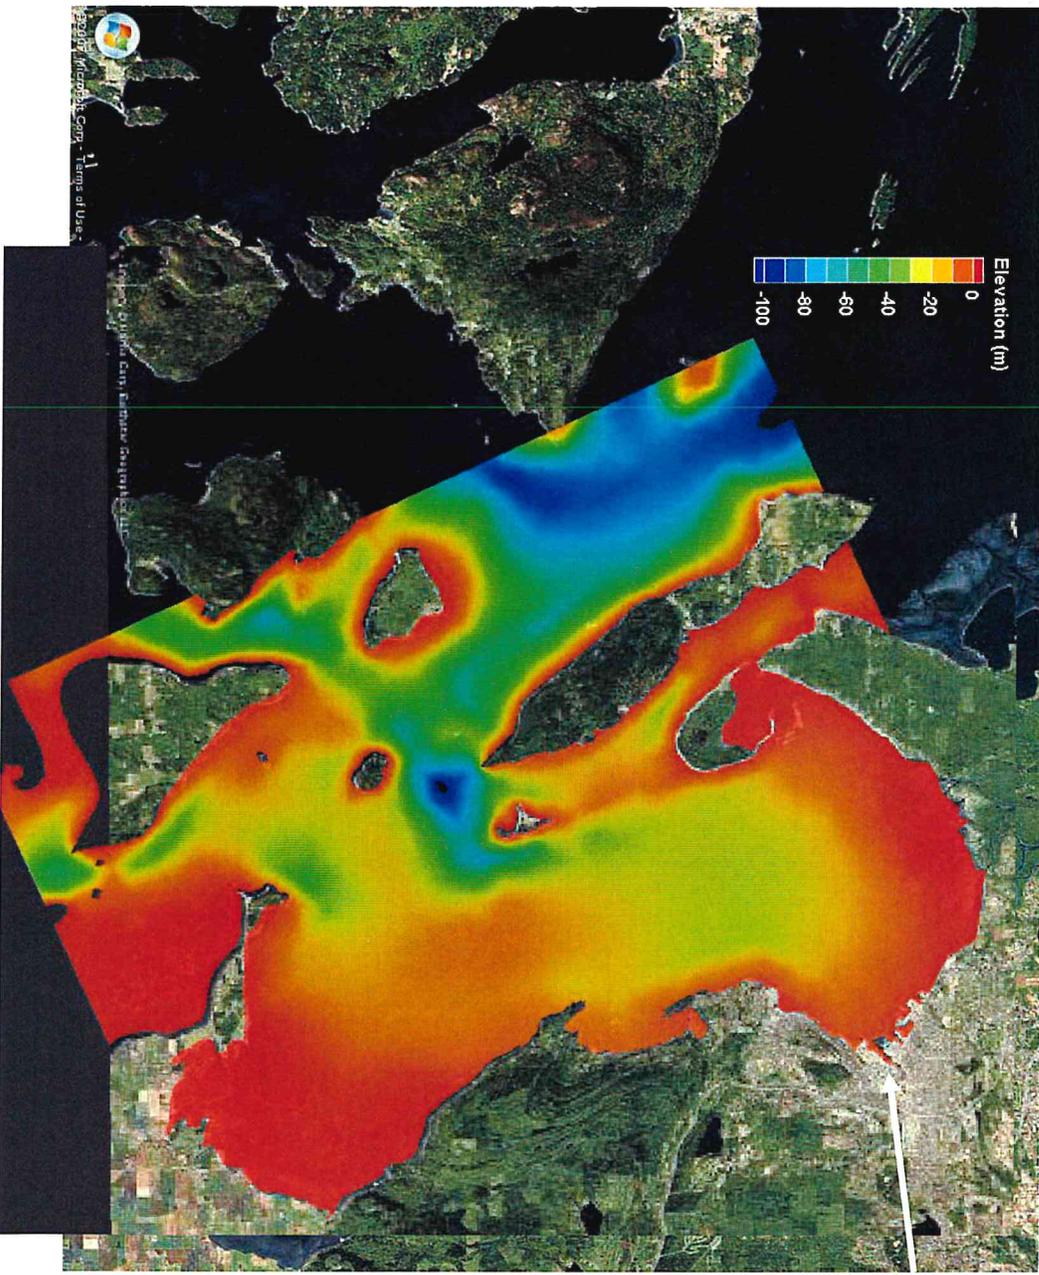
# Bellingham Bay Wave Modeling

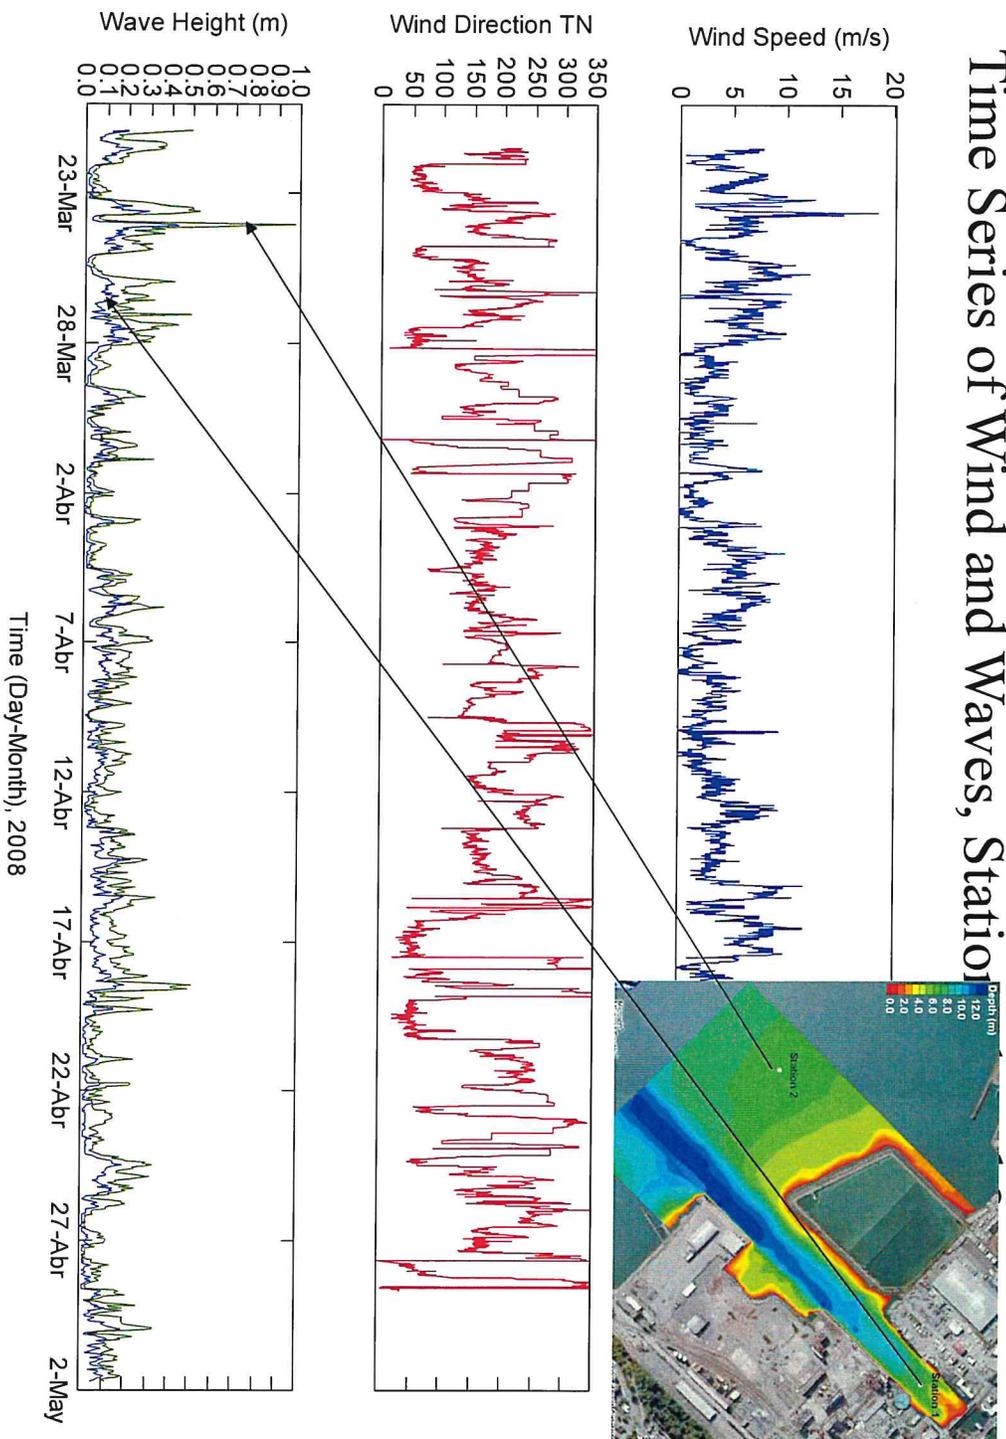
# Time Series of Wind and Waves, Station

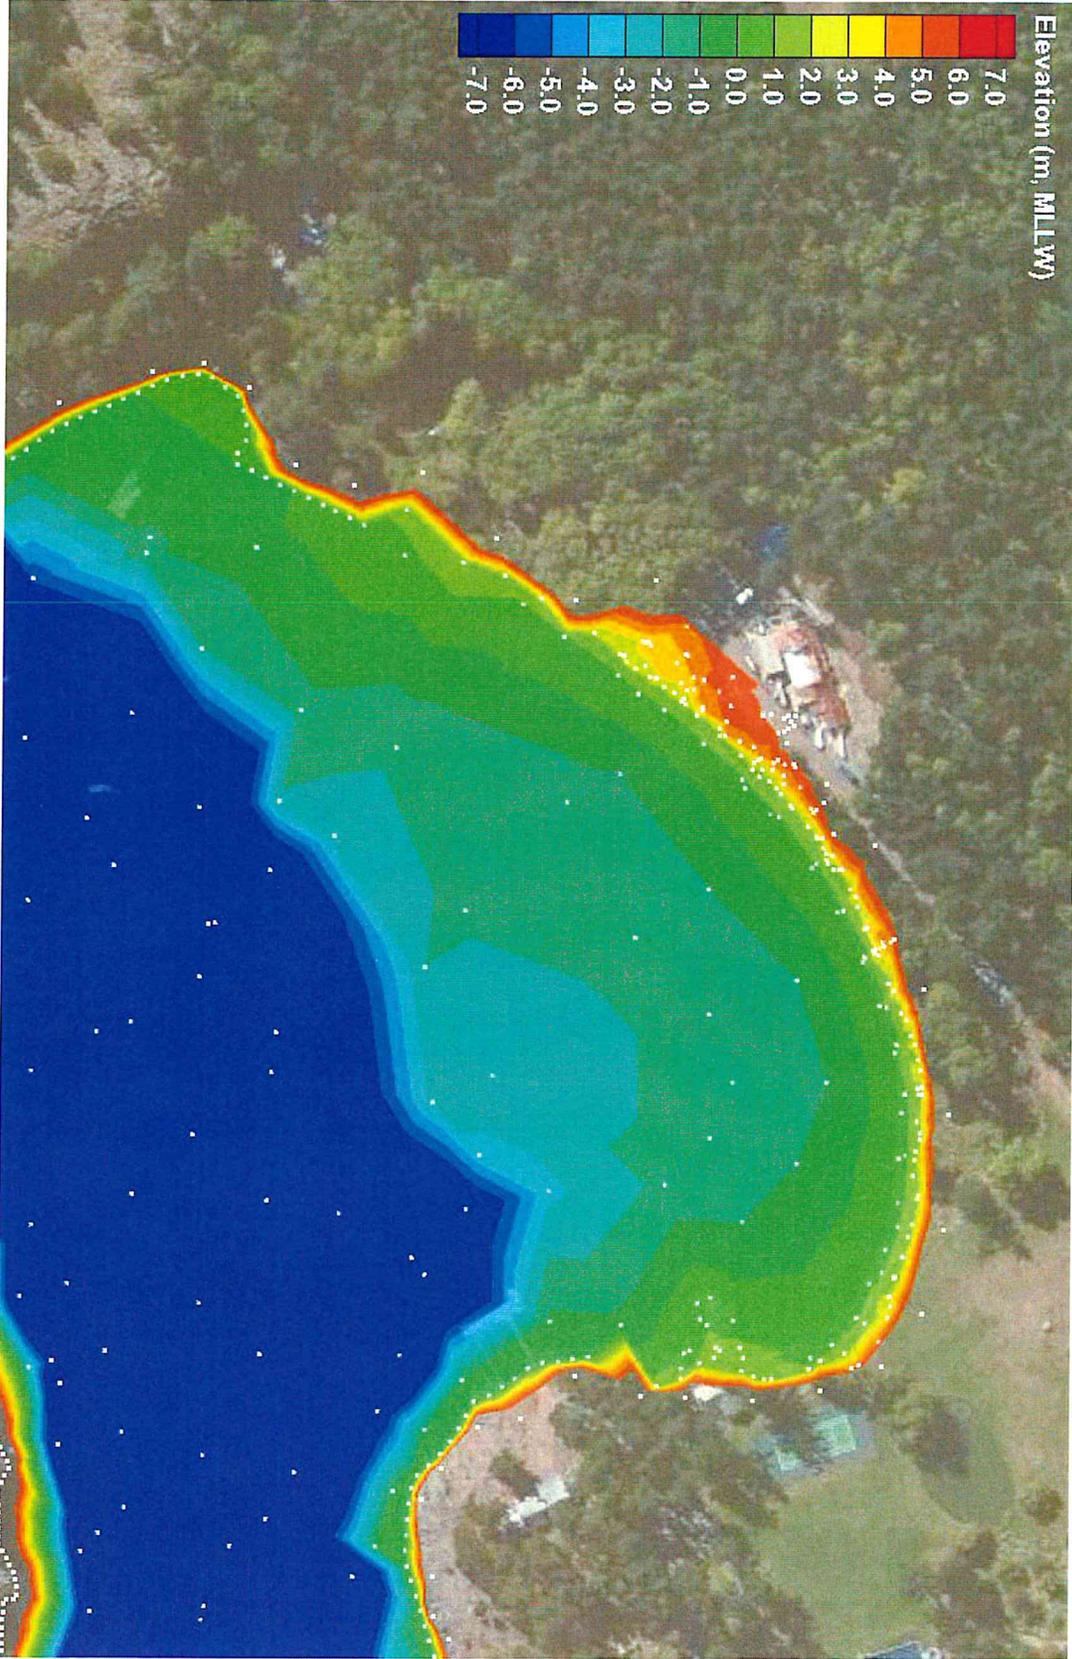
## Comparison between Modeling Results and Measurements

Model Input		Model Output			Measured Waves		
	Wind Speed (m/s)	Wind Dir (TN)	Hs (m)	Peak Period (s)	Peak Dir (TN)	Hs (m)	Peak Period (s)	Peak Dir (TN)
STATION 1	15.2	258.5	0.41	3.98	223	0.41	3.71	222
STATION 2	15.2	258.5	0.94	3.41	253	0.97	3.60	255
