RESPONSE TO SHORELINE INVENTORY REPORT AT  
<http://sanjuanco.com/CDP/docs/SMP/SJC> Shoreline Inventory and Characterization Report  
January 2012 Final.pdf

PROPERTY OWNERS: CLAES AND KATHLEEN EKLUND

TAX PARCEL NUMBERS	ISLAND	DESCRIPTION	MAP INDEX 37 REACH NUMBER
482143002000	Henry Island	Common Land 0.78 acre parcel	Reach No. 234
462811003000	Henry Island	50.52 acre parcel	Reach No. 233

### EKLUNDS' COMMENTS ON THE SHORELINE INVENTORY AND CHARACTERIZATION REPORT SAN JUAN COUNTY – JANUARY 2012 DRAFT ROCHE HARBOR MANAGEMENT AREA

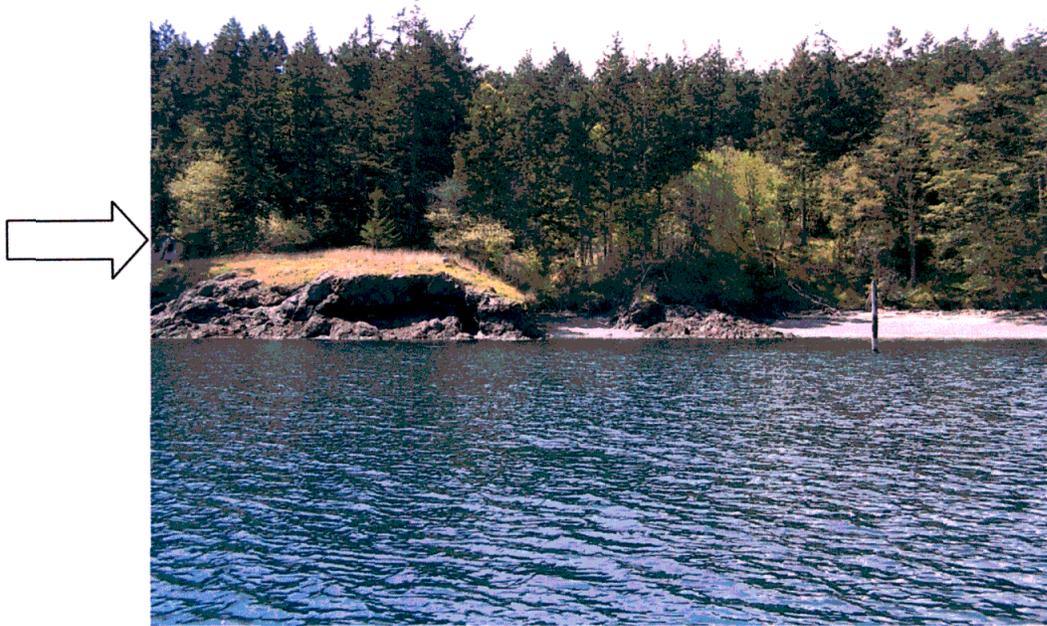
PHOTO 1 (4-22-12) - POCKET BEACH NORTH OF BLM LAND (LIGHT HOUSE RESERVE) ON HENRY ISLAND – Located on the west side of Open Bay. Barely visible on the left side of the photo is the last standing fisherman shack on the BLM land. A single old piling stands near the shore.

**Reach 234** is located on the west side of Open Bay on Henry Island and extends from the BLM land to the end of Open Bay (Map 37A). Natural Sediment Transport Patterns are rated “5” high. This assessment is in conflict with the survey referenced below during the hearing for the Eklund dock proposal. Photos 1, 2, and 3 in Attachment 3 show the pocket beach.

**Map 9A, Shoreline Modifications** - The single piling at the pocket beach is not derelict (as reported by the Friends of the San Juans 2009). The piling is used by the reef net operators who seasonally tie their floats to the piling for short periods prior to and after conducting their fishing in Open Bay near the old fisherman shacks on the shoreline of the BLM land (piling is shown in photos 1 and 2).

**Map 14A, Current Marine Shoreform Types** - The cove on the Westside shoreline of Open Bay on Henry Island has a pocket beach as shown on photos 1 and 2. Refer to comments above regarding Reach 234.

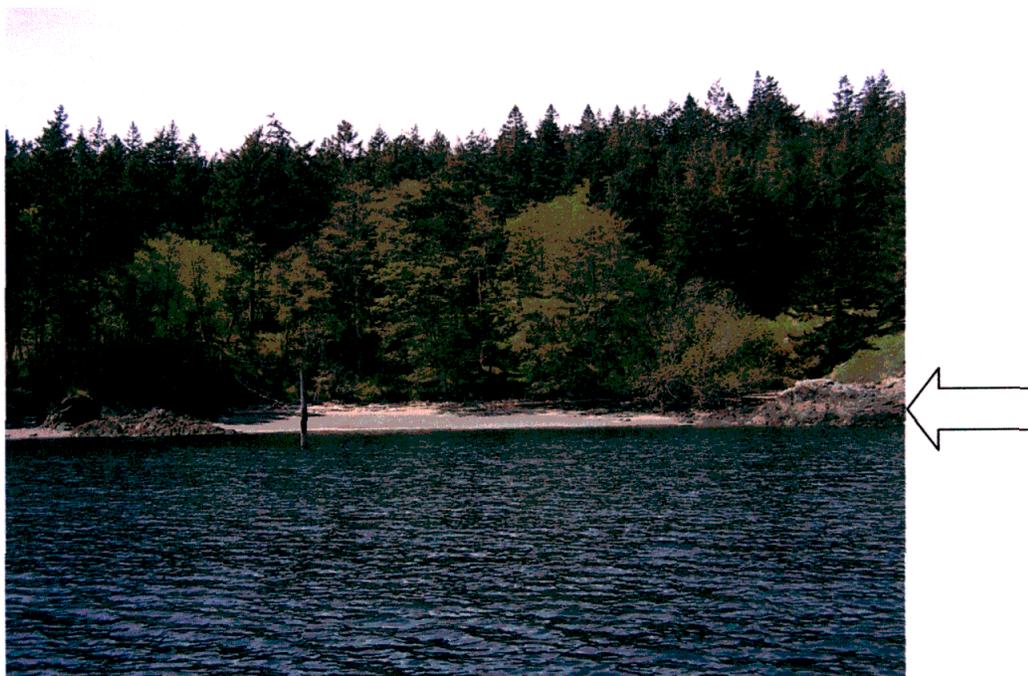
PHOTO 2 (4-22-12) - POCKET BEACH – A dock was approved at the right rock but never built. The Eklund/Hart Common Land is the right half of the photo. The parcel # is 4628110030000. Land is 0.78 acres with 214' of waterfront. Tidelands are owned by Eklunds, Hart, and Waltons.

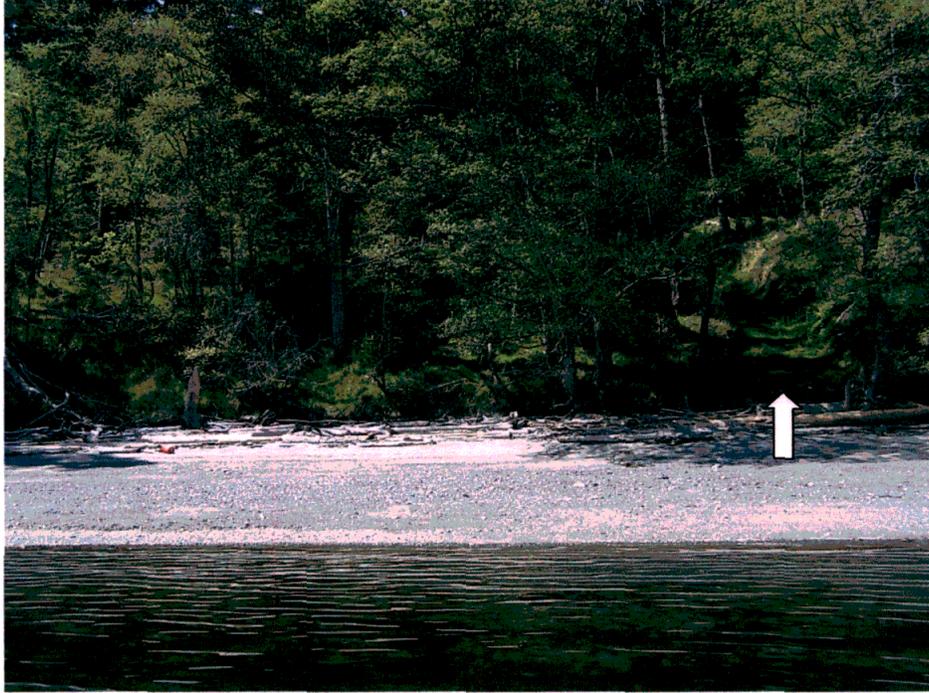
PHOTO 3 (4-22-12) - POCKET BEACH SHORELINE – There are 3 access ramps in the surrounding bank. The Eklund/Hart ramp is marked. This beach is access for 150 acres of land with 4,127 ft. of shoreline. Eklunds can only access their property at this location. Tide at 1.4 ft. at 2 pm.

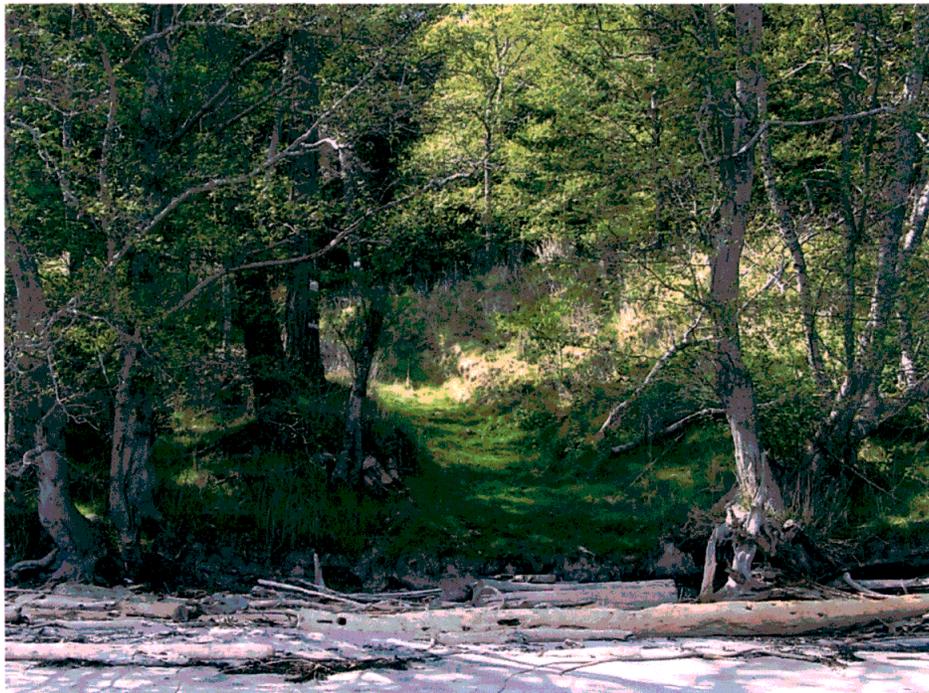
PHOTO 4 (4-22-12) – ACCESS RAMP ON THE COMMON LAND (SJC approved restoration) - All three access ramps were historically developed to support logging operations as evidenced by the many abandoned steel logging cables. See John Bradley 3-22-04 letter in Attachment 2.

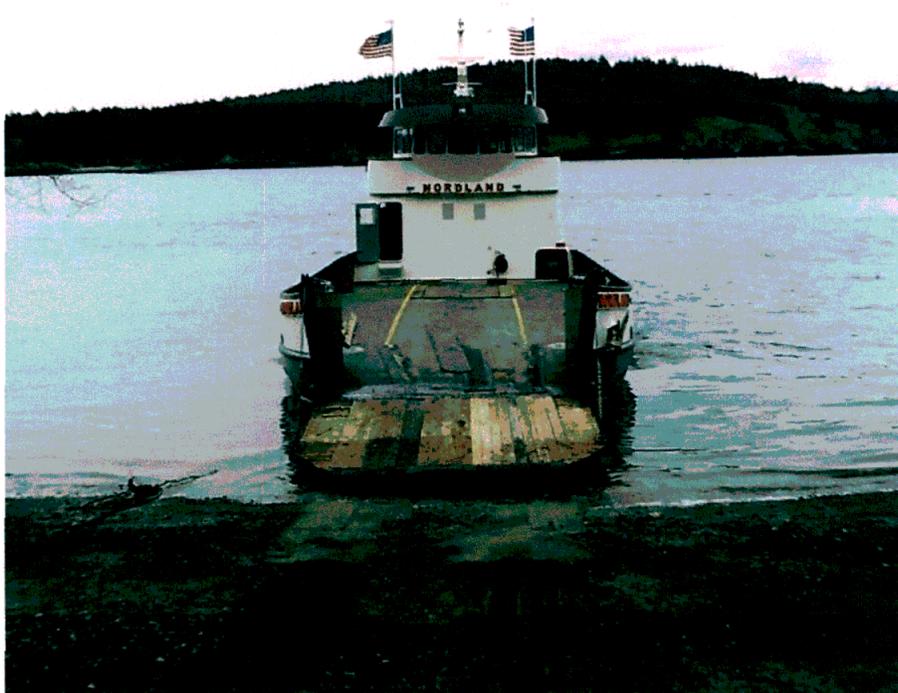
PHOTO 5 (March 1998) – BARGE LANDING – Nordland barge landing on the beach in front of the Common Land access ramp. Materials, supplies, and vehicles have been delivered to this beach by barges over 30 times since 1998. See barge landing list in Attachment 4.

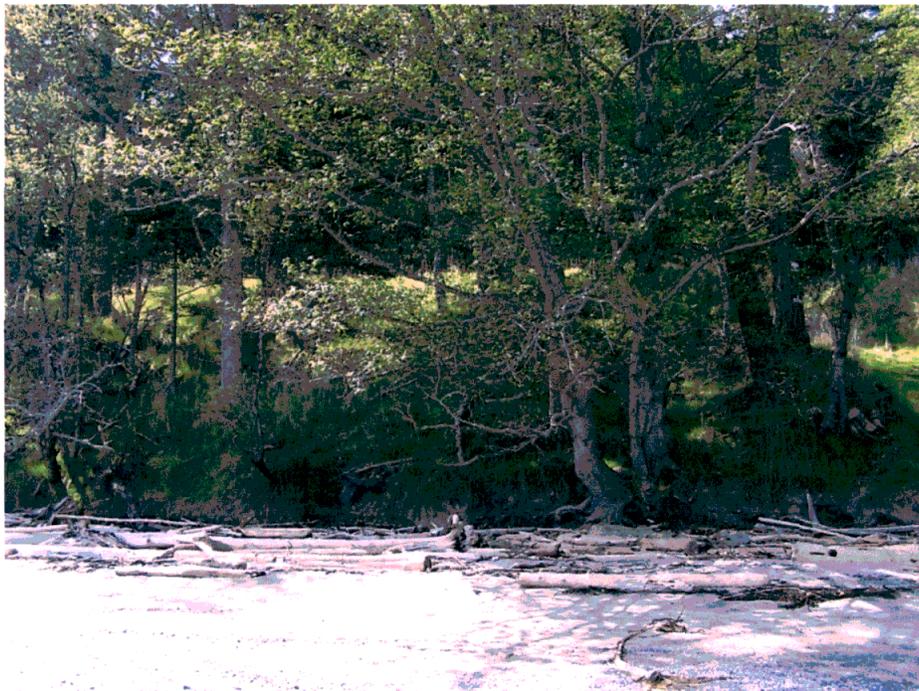
PHOTO 6 (4-22-12) – BANK VEGITATION – This is a photo of the bank on south side of the Common Land access ramp. The dominate tree on the pocket beach shoreline bank is Douglas fir interspersed with red alder. Ground cover is dominated by grass.

would be damp if not soggy, ferns and mosses would be normally abundant and other understory plants would be thicker. Near the pocket beach the dominate tree is Douglas fir interspersed with red alder. Ground cover is dominated by grasses (see photo 4 and 6 of the bank above the beach and photo 7, 8, and 9 for the bench above the bank).

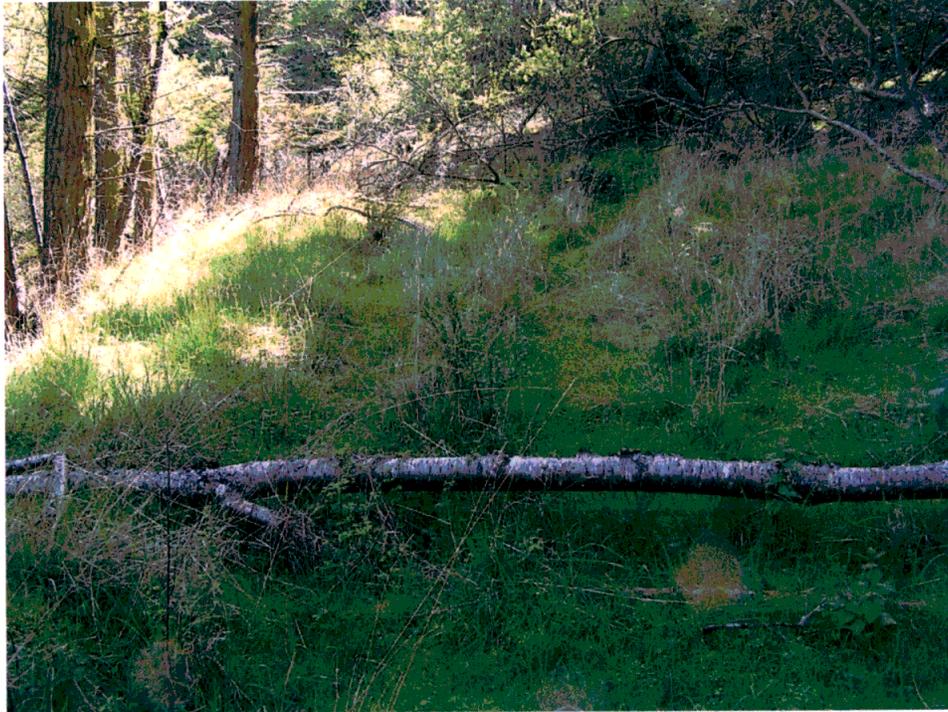
PHOTO 7 (4-22-12) – VEGITATION ON BENCH ABOVE PHOTO 6 BANK.

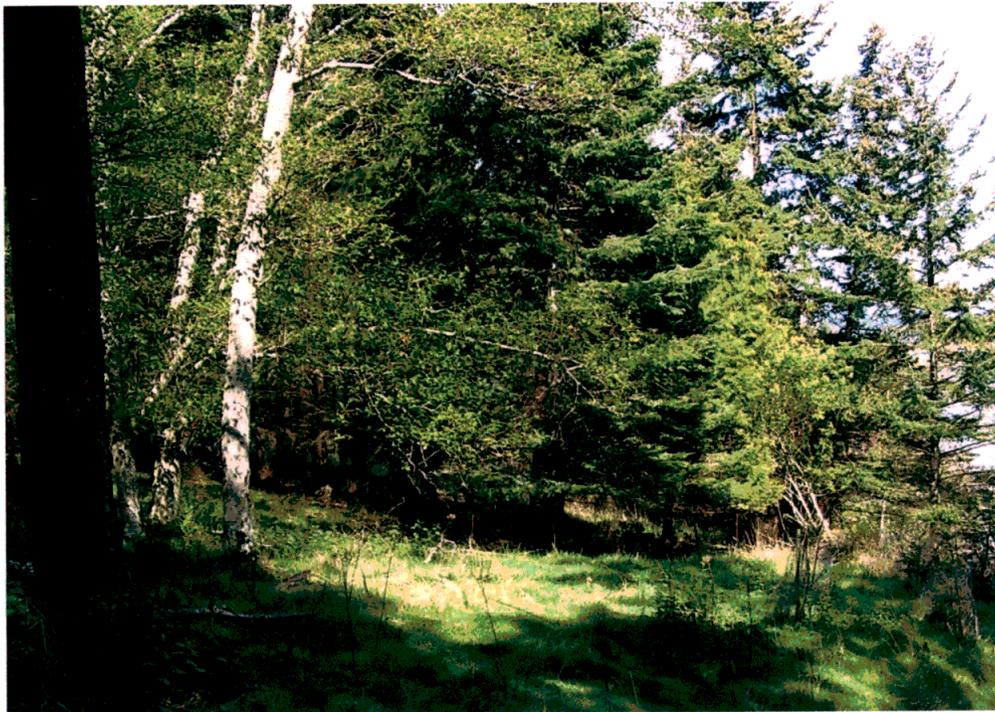
PHOTO 8 (4-22-12) - VEGITATION ON BENCH ABOVE PHOTO 4 BANK.

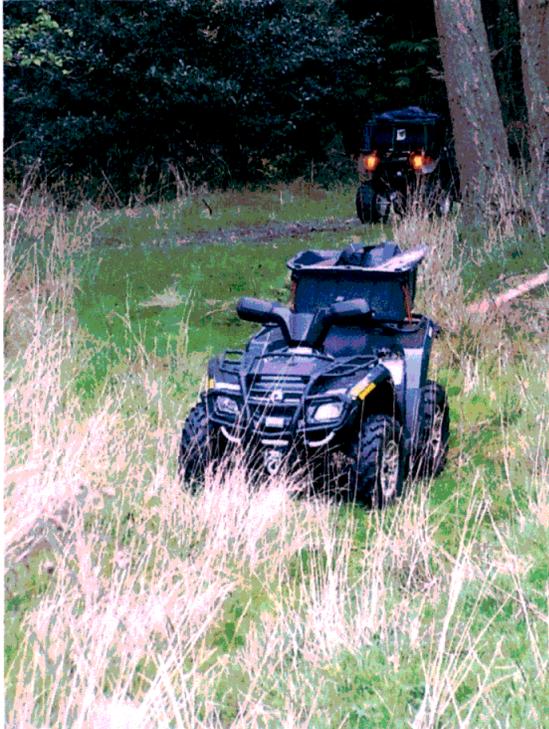
**PHOTO 9 (4-21-12) – TOP OF COMMON LAND LOOKING UP ROAD - Road connects to the Eklunds' 50 acre parcel.**

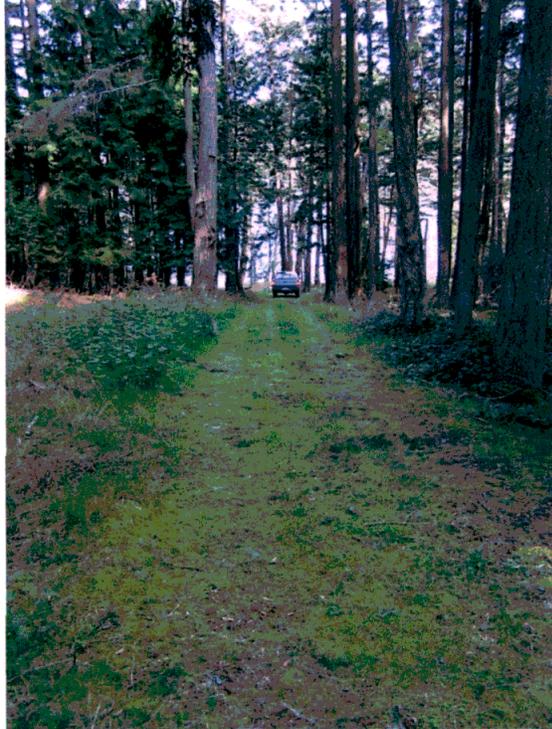
**PHOTO 10 (4-22-12) – GRASS COVERED GRAVEL ROAD - Looking down at truck parked above ramp. Road located on road easement.**

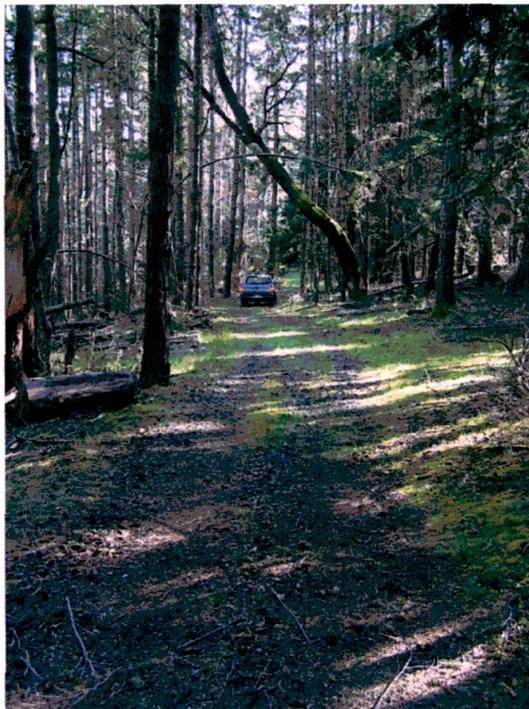
**PHOTO 11 (4-22-12)– ROAD ON EASEMENT All roads/driveways were constructed in 1998 and are covered with gravel.**

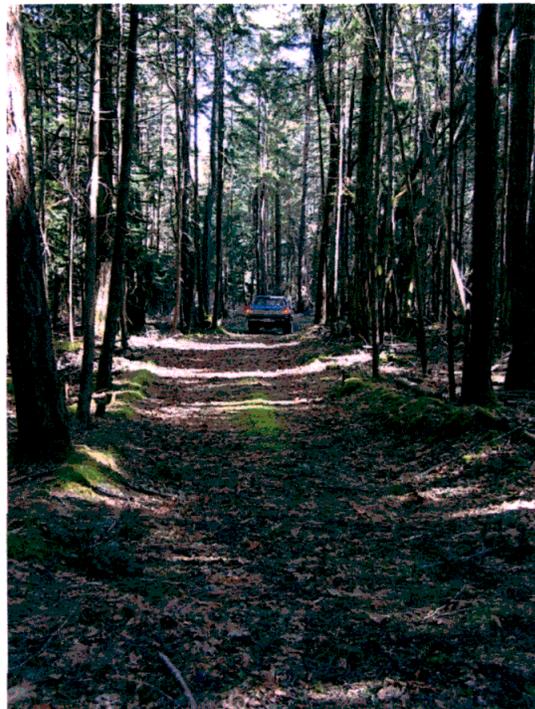
**PHOTO 12 (4-22-12) – GRAVEL ROAD - Located on easement. This section of road was built over an existing logging road.**

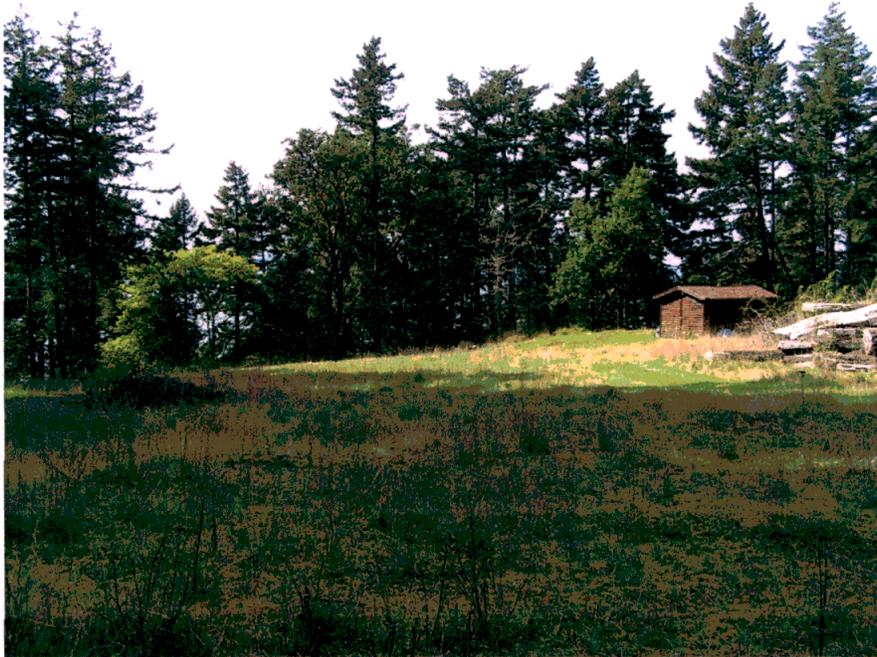
**PHOTO 13 (4-22-12) - PASTURE ON EKLUNDS' 50.52 ACRE PARCEL – 10' X 16' Cedar shed was built in 1999. Storage shed is 600 ft. from the shoreline at an elevation of 283 feet. See Attachment 2 for the location of the shed on the property. Parcel # 462143002000.**

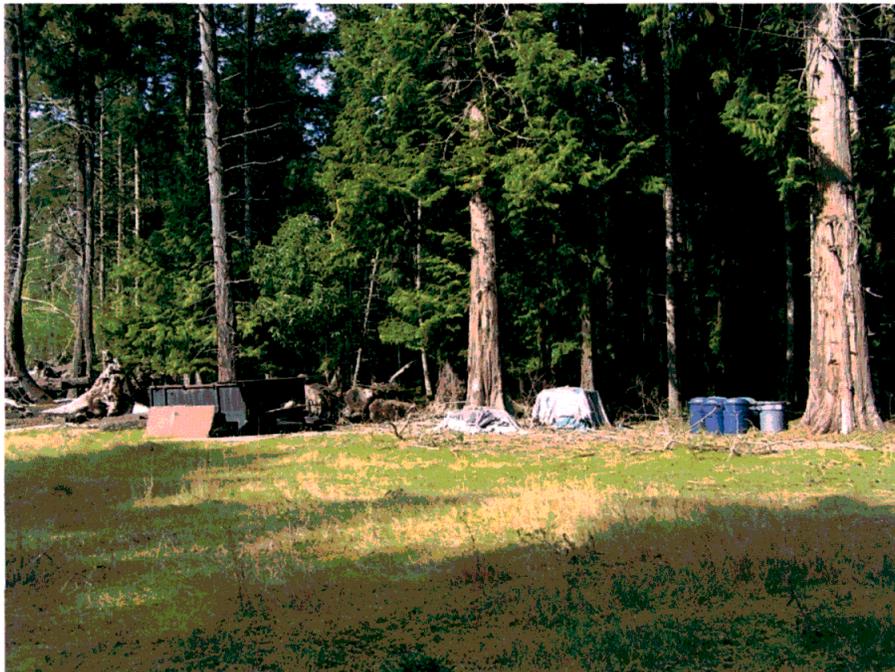
**PHOTO 14 (4-22-12) – EQUIPMENT STORAGE AT PASTURE SITE – The Eklunds store their equipment and materials near the pasture. Water is stored in trash cans and water tanks for fire protection. This property has numerous logging roads and trails for their recreational use.**

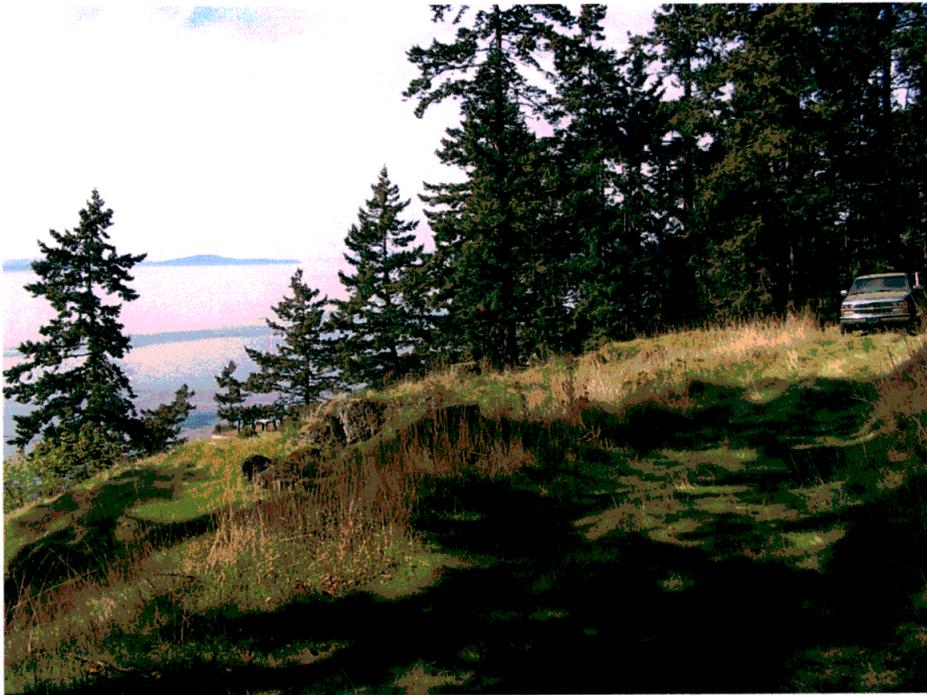
PHOTO 17 (4-22-12) - BUILDING SITE ON WEST SIDE SHORELINE – The truck is at an elevation of approximately 120 feet. Building site and tree plan approved by SJC on 7-14-98.

**Map 17A, Geologic Harzard** - The southern rocky west shoreline of Henry Island is labeled as an intermediate slope on this map. Intermediate designation is between stable and unstable per the DOE Coastal Zone Atlas Stability Map. The Eklunds have observed no instability or landslides on the west side of their property over the last 24 years. It is also labeled as having erosion-prone soils (2003 San Juan County). The Eklunds have observed no soil sheet or rill erosion by water on the west side shoreline over the last 24 years. See photos 17 to 24.

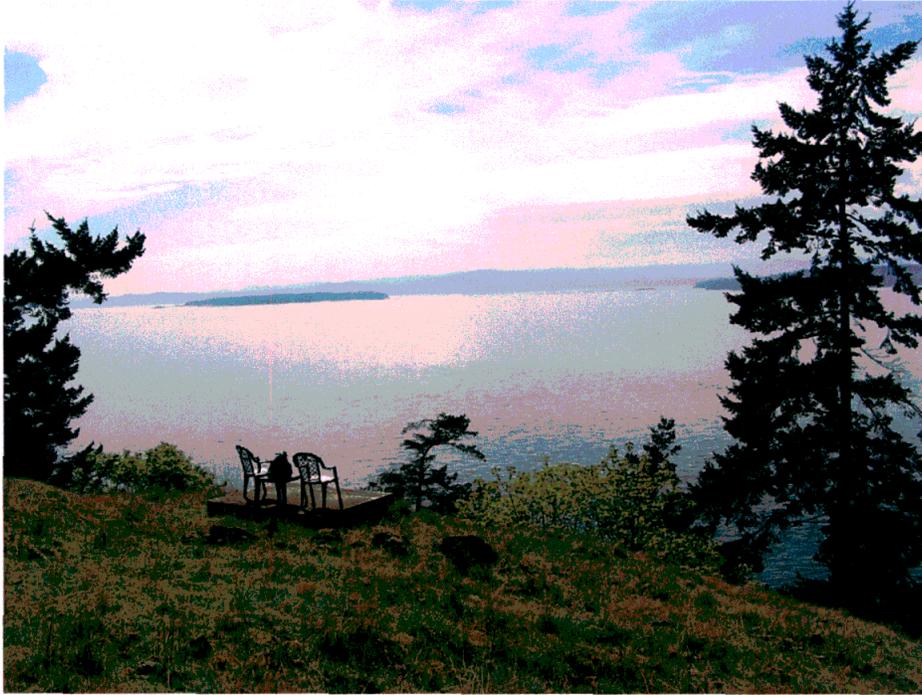
PHOTO 20 (4-22-12) – LOOKING SOUTHWEST OVER THE BUILDING SITE – The Eklunds relax on their redwood 6'x 8' deck on every visit to Henry Island. The deck was built in 1992.

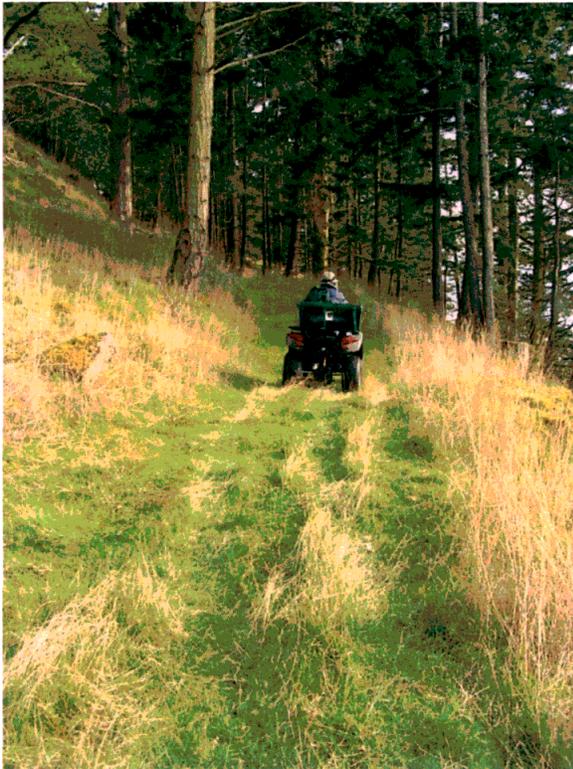
PHOTO 21 (4-21-12) – LOOKING SOUTH ABOVE BUILDING SITE

**Map 12A, Floodplains and Wetlands** - The steep terrain on the west facing shoreline of the southern half of Henry Island cannot be flooded as shown on Map 12A. The west side terrain is shown in photos 15 thru 22. The west side shoreline of Henry Island is not classified as Zone A by FEMA except for the very north tip as shown in the FEMA map in Attachment 4. Note that Haro Strait is not Zone A, but indicates that the shaded areas on the map are Zone A. For

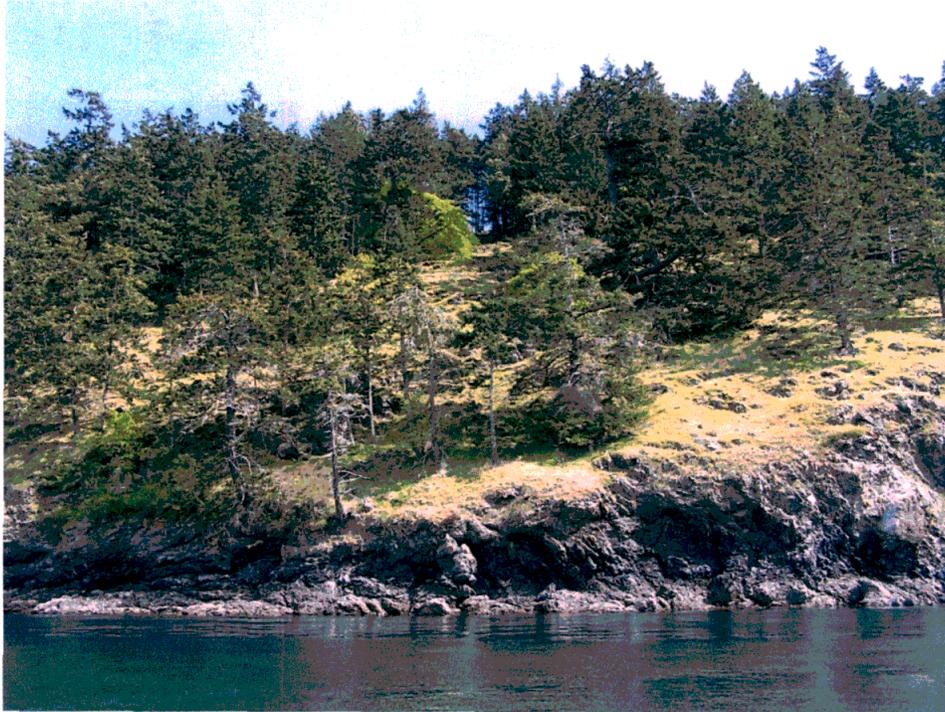
**PHOTO 23 (4-22-12) – LOOKING AT THE BUILDING SITE FROM HARO STRAIT – Building site is at the middle of the photo and at an approximate elevation of 110 feet.**

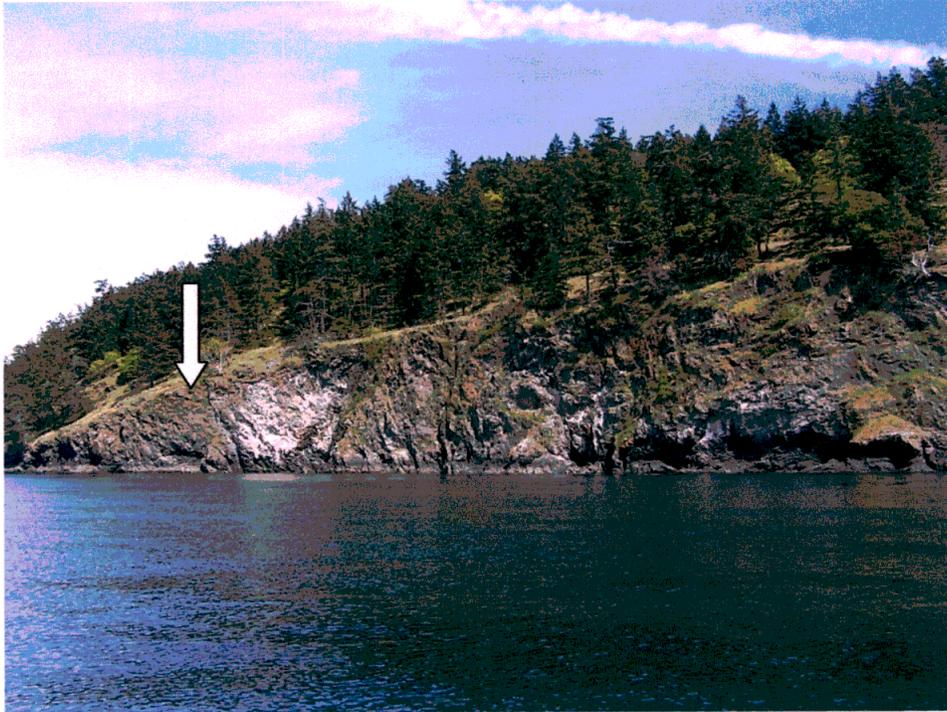
PHOTO 25 (4-22-12) – CLIFF ON HART’S PROPERTY SOUTH OF EKLUNDS’ PROPERTY – Eklund property line is left of the biggest guano area on left side of the photo.

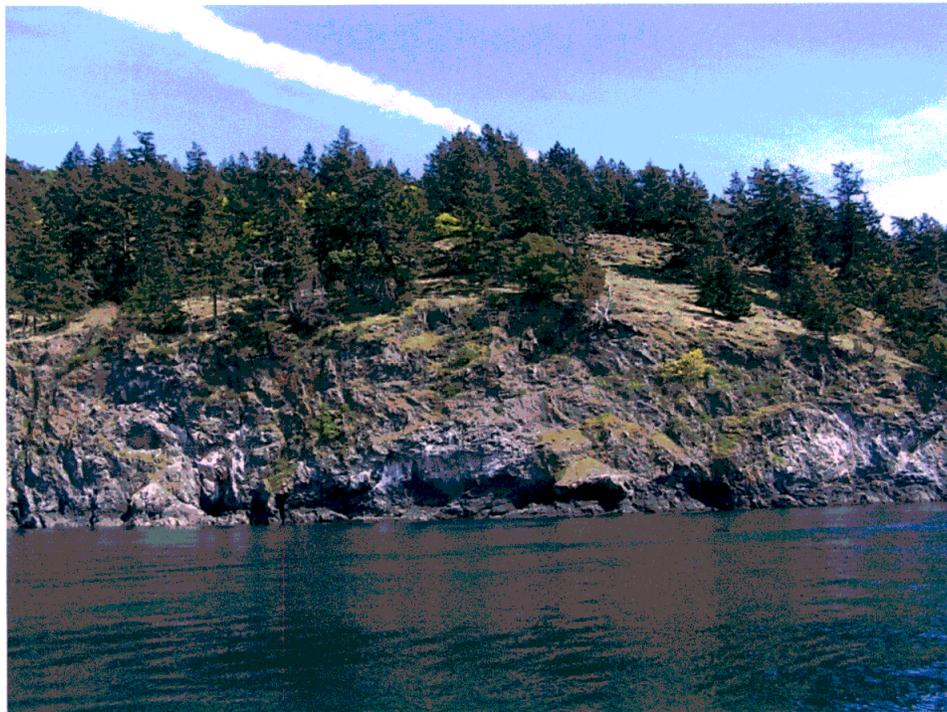
**Map 22A, Priority Habitats and Species Regions** – The southern west side of Henry Island has been designated on the map as cliffs/bluffs PHS Region. The priority habitat is the cliff face which ends at the Eklunds southern property line. The map indicates that the cliff face continues North over 1/3 of the Eklund westside waterfront which it does not. Photos 25 and 26, show that the cliff face is on the Hart property which is south of the Eklund property. The Eklund property line starts on the left side of the white guano area near the left side of photo 25 as marked. The Eklunds shoreline has been labeled on the County Map 14A as a Plunging Rocky Shoreline which is a more accurate description.

PHOTO 26 (4-22-12) – VIEWING PHOTO ABOVE EXTENDED FURTHER TO THE SOUTH ON HART’S PROPERTY.

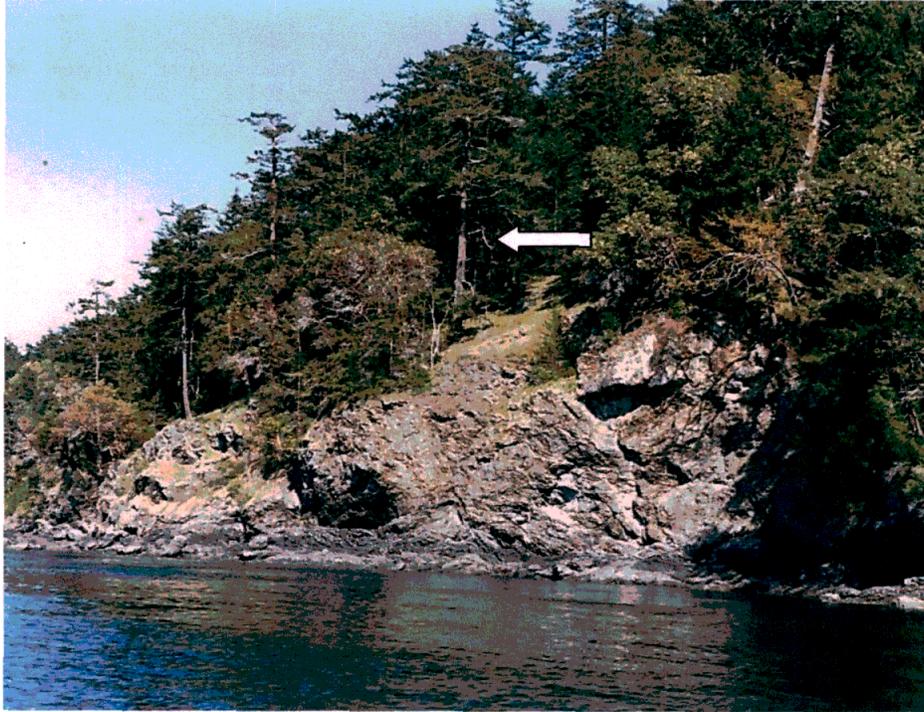
PHOTO 27 (1988) – PHOTO OF BALD EAGLE NEST TREE SHOWN ON COUNTY MAP 24A – The Nest tree was easily identified by the angled dead tree branch. The nest fell down over 12 years ago. The tree fell down several years later. County MAP 24A needs to be corrected.

**Map 24A, Birds and Mammals** – The bald eagle nest shown on the west side of Henry Island in the middle of Eklund's shoreline fell to the ground over 12 years ago. Photo 27 shows the bald eagle tree 24 years ago. The tree was easily recognized by the right angle dead branch near its base. Photo 28 shows the area where the tree once stood. It fell years ago. The County Map 24A needs to be corrected.

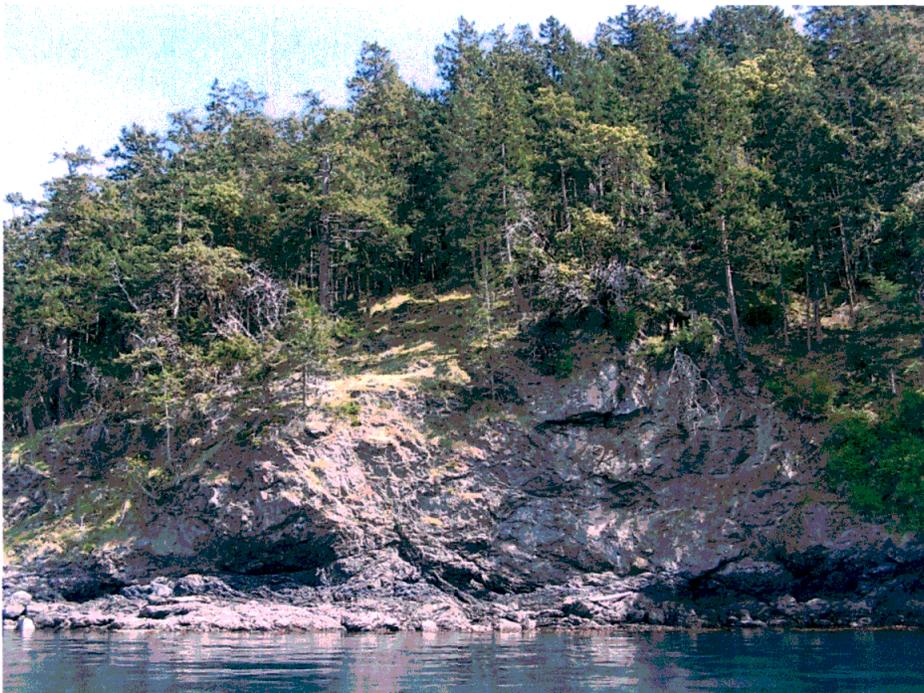
PHOTO 28 (4-22-12) – PHOTO SHOWS THE AREA WHERE THE BALD EAGLE TREE ONCE STOOD.

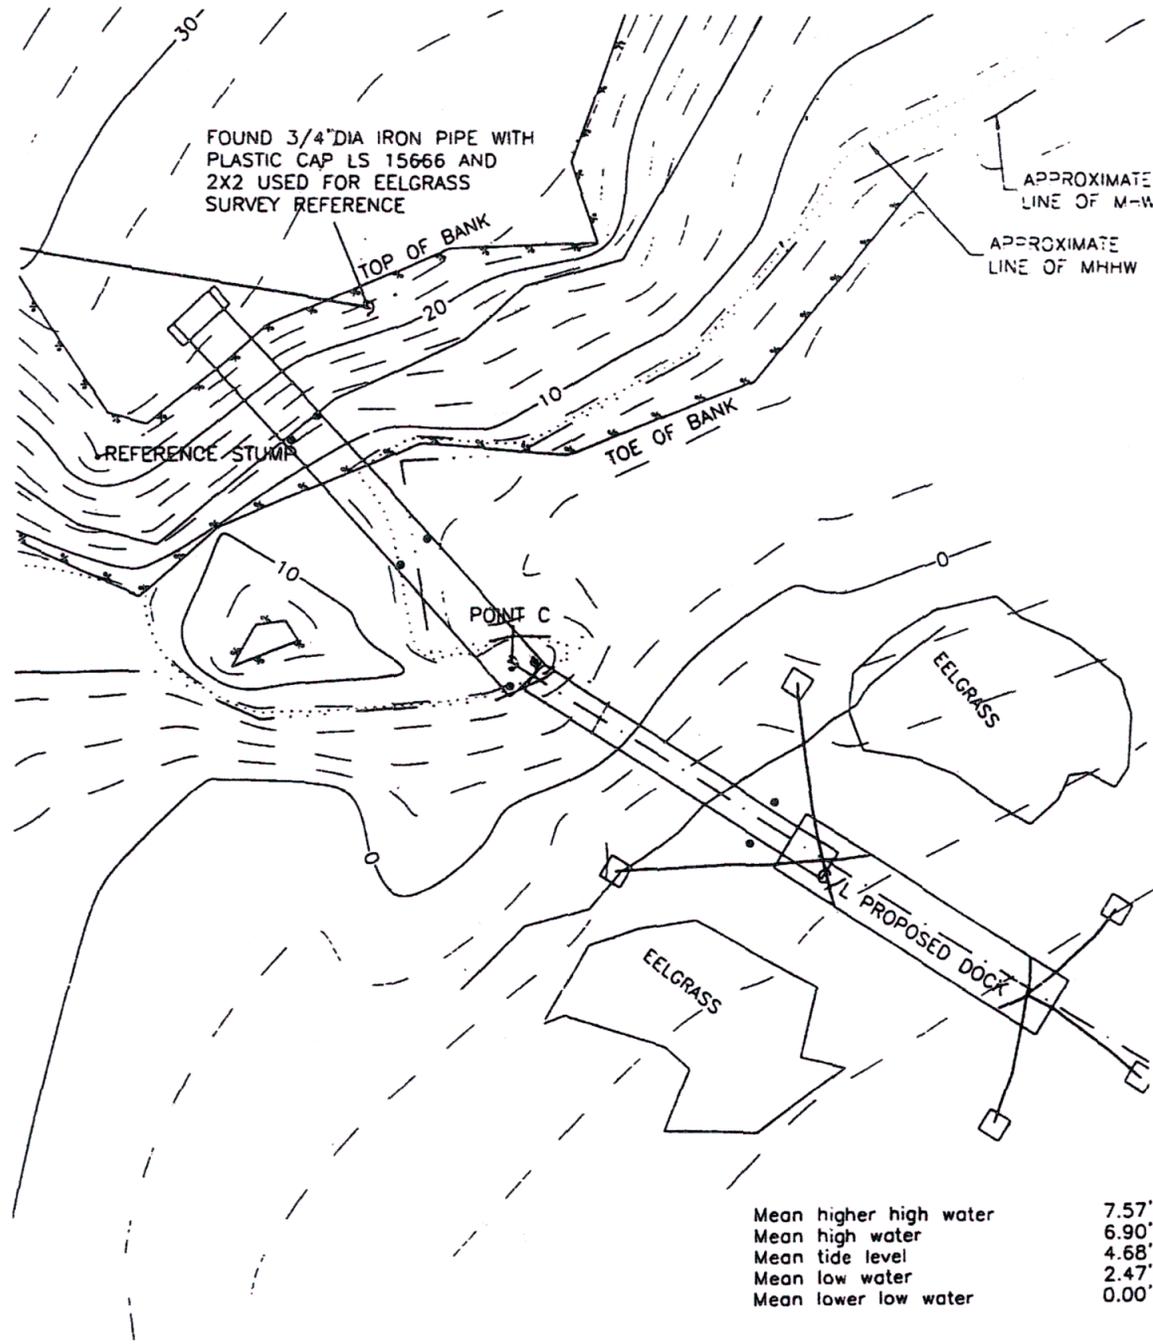
The proposed dock structure consists of a 65-foot long fixed pile pier and a 45-foot long ramp going down to a 40-foot long floating dock. The proposed fixed pier will be 6 feet wide, the ramp will be 4 feet wide, and the float will be 8-feet wide (Project drawings are presented in Appendix A). The float will be anchored with five concrete float anchors. The fixed pier will be supported by the shoreline and six piles. The ramp will be supported by the pier and two piles. The central 2 feet of the proposed float will be covered with grated decking to allow passage of light to the water.

Piles will be 10 inches in diameter and made of coated steel. Piles will not be installed with a pile driver. Holes will be drilled in the rock substrate, the piles set in place, and then grouted in. Holes for four of the eight piles will be drilled by hand drills and will take up to 3 hours each. The remaining four pile holes will be drilled with a Numa rock drill, and will take about 15 minutes per hole. The six most landward piles will be drilled in the dry at low tide.

Mean higher high water	7.57'
Mean high water	6.90'
Mean tide level	4.68'
Mean low water	2.47'
Mean lower low water	0.00'
