Map of eelgrass biodiversity surveys (blue) and eelgrass disease surveys (red) in False Bay Pocket and Middle Bays, summer 2016.

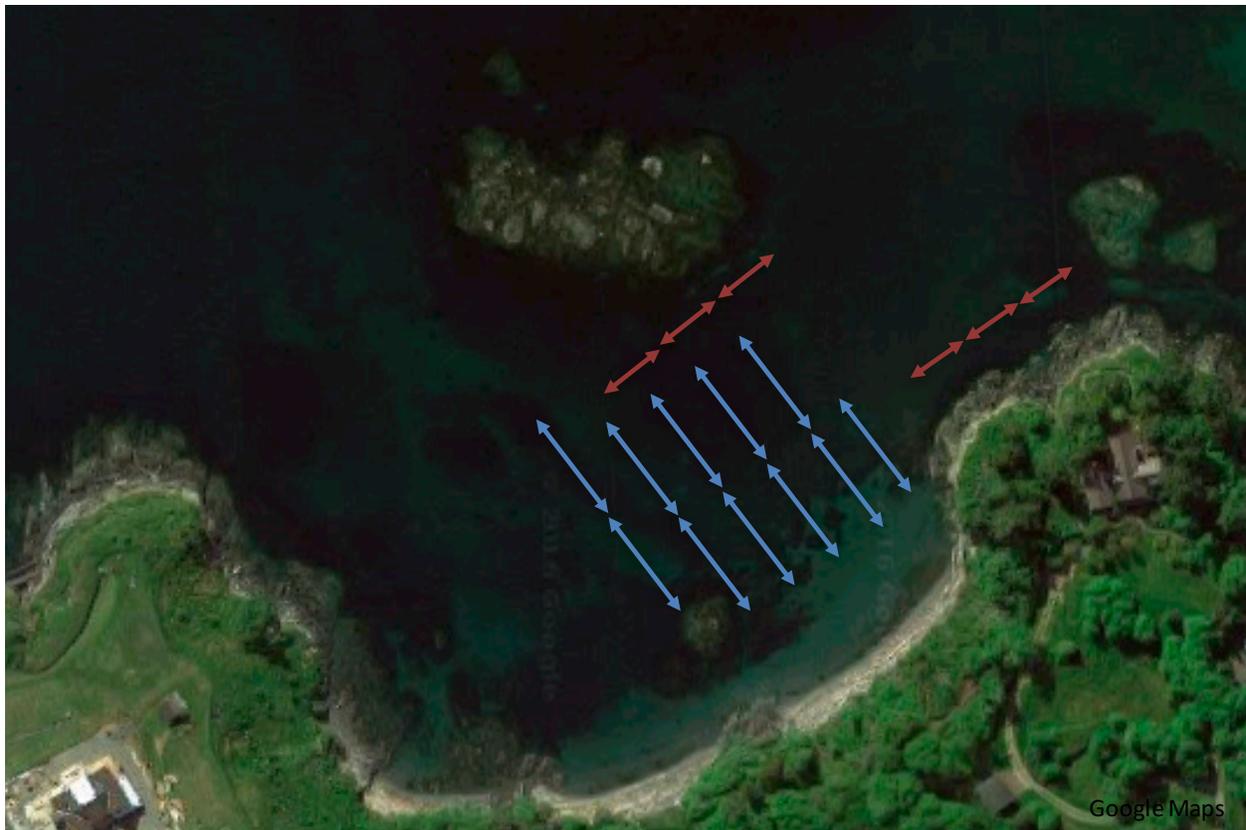
The eelgrass bed is present under most of the blue arrows where the biodiversity surveys were conducted. The red arrows represent the locations of the replicated eel grass health surveys conducted in the eel grass bed.
